MASTER PLAN - 2001

# The Golf Courses at Incline Village Championship Course

KYLE PHILLIPS GOLF COURSE DESIGN SEPTEMBER 2001

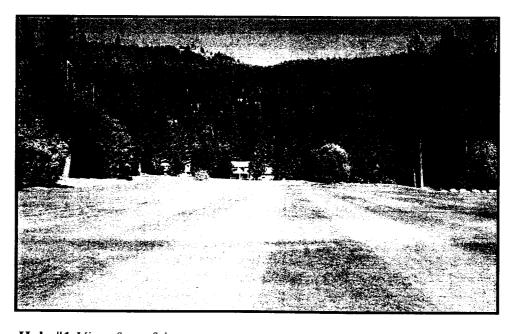
**Green:** The green complex suffers from a lack of visibility from the fairway. The entire complex should be relocated to the right. During this process the green contours should be redesigned to accept shots from a slightly different angle. (See Green Sketch)

**Hole #1**-View from fairway.

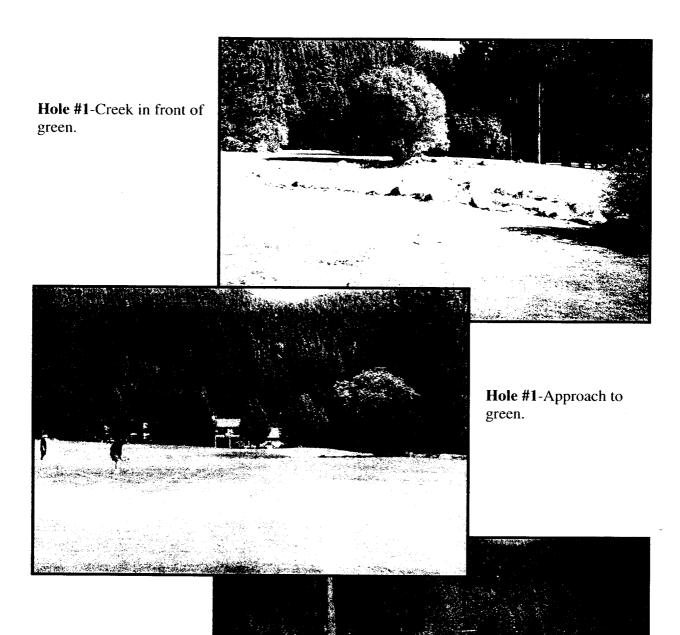
**Bunkers**: The two right side fairway bunkers are barely visible from the tees. These bunkers should be rebuilt and relocated slightly to increase their visibility. A third fairway bunker should be added to the left side of the fairway closer to the green. This hazard will help defend the left side from long hitters without increasing the difficulty from the average players standpoint. The two left greenside bunkers are barely visible from the fairway and are pinched too close to the cart path on the left side. These bunkers should be relocated and reshaped to fit the newly proposed green complex.

Hole #1-Bunkers left of green.

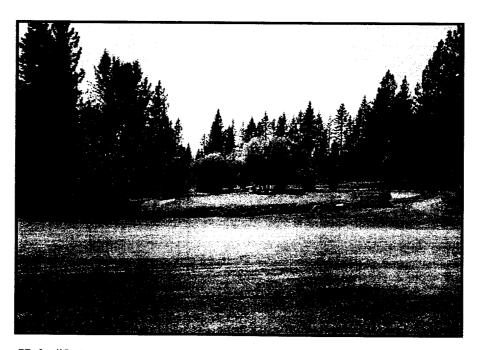
Hole #2-Approach to green.

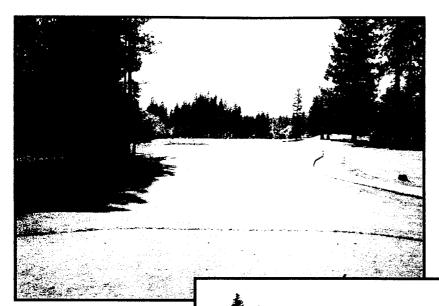
Hole #2-View from tee.

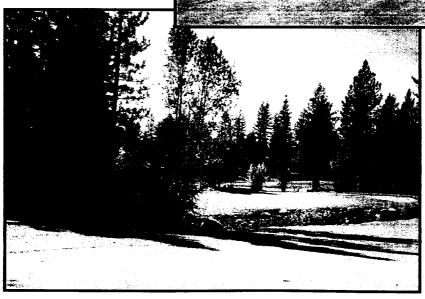
Hole #2-Close-up view of green from left side of fairway.

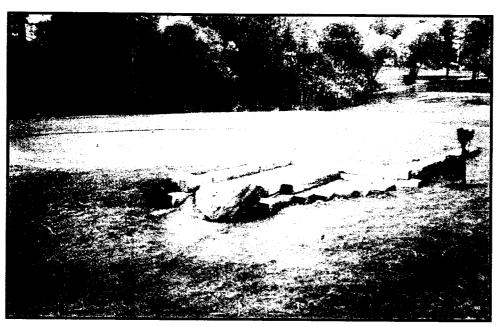
**Other:** The railroad ties and boulder next to the tees should be removed, as they do not fit the overall style of the golf course. There is a turnaround built into the cart path that serves no purpose and should be removed.

Hole #3-Front tee.

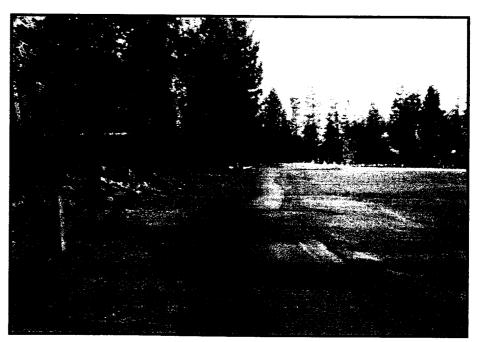
**Bunkers:** The left side fairway bunker is located outside of the cart path. This bunker should be removed and mounding should be added inside the cart path to hide it from the tees. Two new fairway bunkers should be added inside the dogleg on the right. This change in fairway bunkering will help differentiate this hole from #16, which plays very similar. The two greenside bunkers should be reshaped in the same location.

Hole #3-Cart path with fairway bunker in the distance.

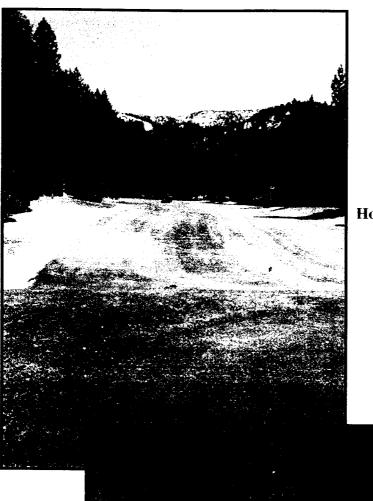
**Other:** The creek fronting the green looks very artificial. It should be either reshaped with rocks removed or piped and filled.

Hole #4-Creek in front of green.

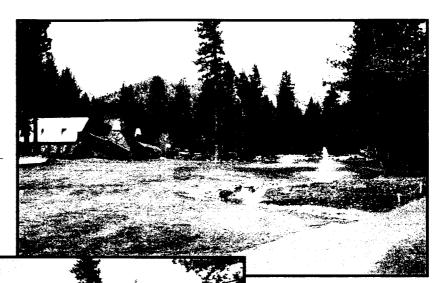
**Other:** The existing pond and fountain look out of place and should be removed and filled in. This area will be improved significantly by replacing this pond with a dramatic bunker.

Hole #9-Close-up of pond.

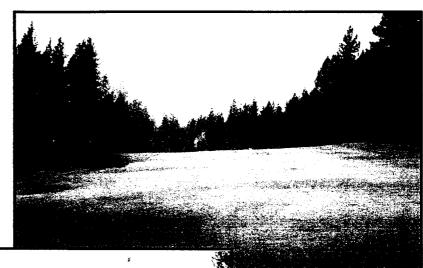
Hole #11-View from fairway. Green just becoming visible.

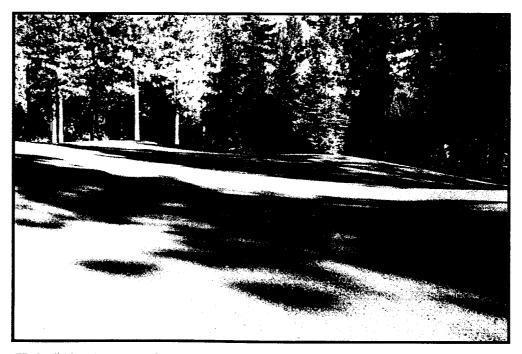
Hole #12-Close-up of green showing original RTJ green contouring.

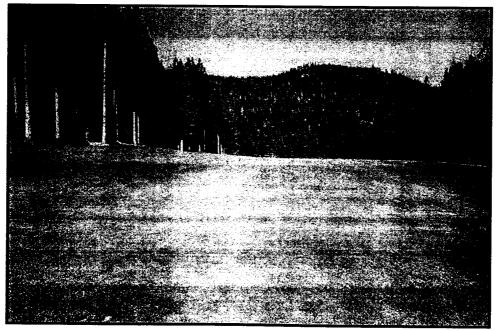
**Green:** The green should be elevated slightly to improve the visibility and playability of the hole. Current elevations should be measured and recorded and the new green contours will be designed to better fit the changes in bunkering.

Hole #14-View from fairway. Green is blind.

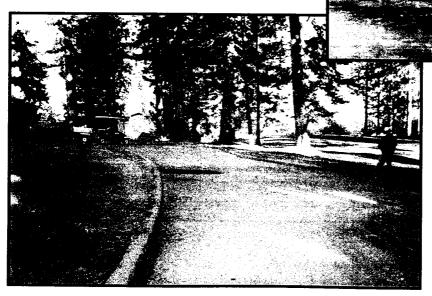
Hole #14-Cart path between #14 green & #15 tee.

**Other:** The cart path transition from #14 green to #15 tees is currently very awkward. The path should be relocated in front of the two back tees on #15. This will allow carts to make an smooth and easy turn from #14 green to the tee area.
