3.4.3 Lift Station Rehabilitation and Capacity

This WRRF condition assessment includes evaluations to identify the current condition, capacity, performance issues and safety status of the facility components along with the capability to meet the District's needs into the near and long-term future.

4.5 Water Resource Recovery Facility (WRRF) Condition Assessment

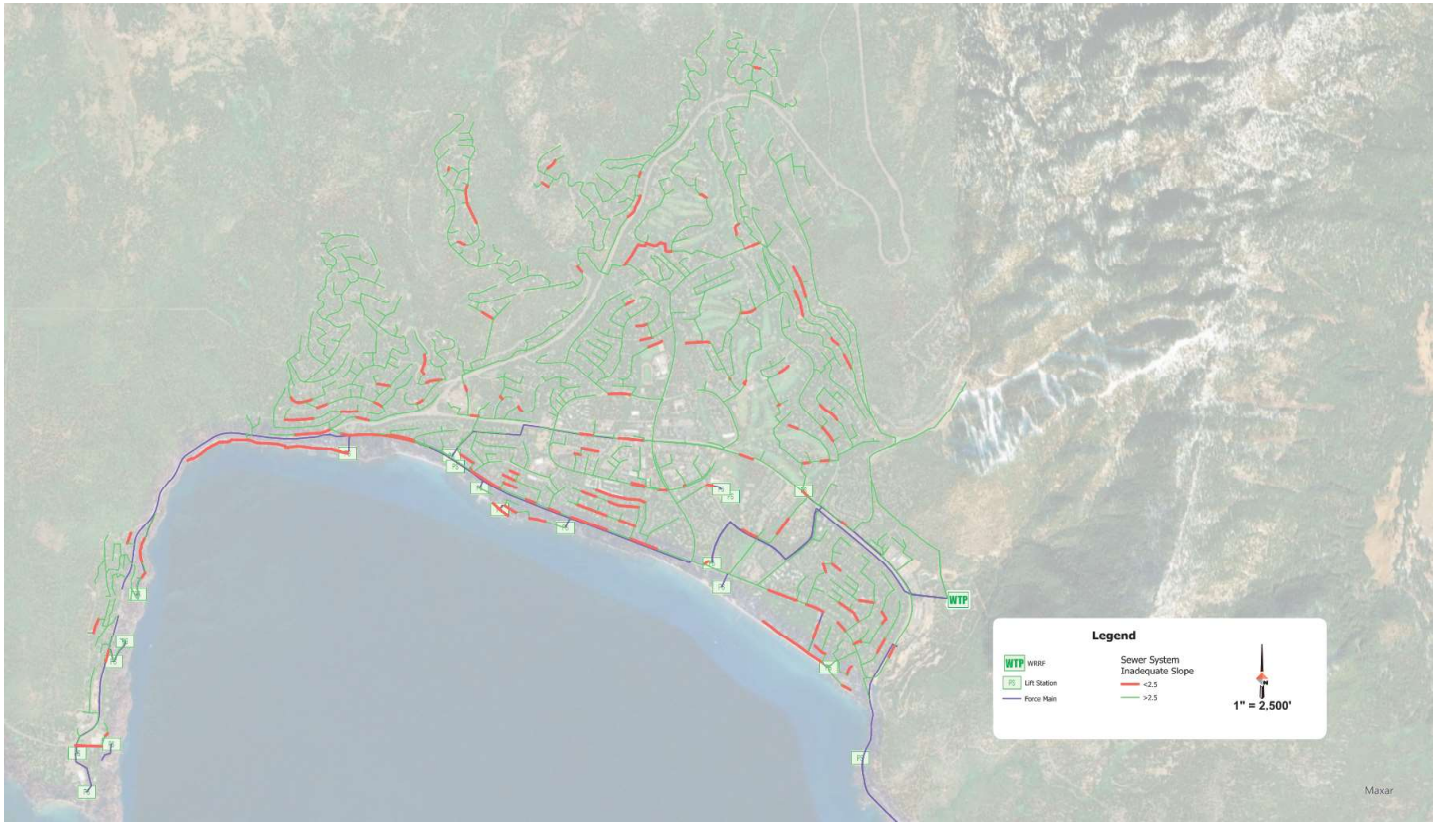
Figure 24: Gravity Sewer Mains with Inadequate Slope

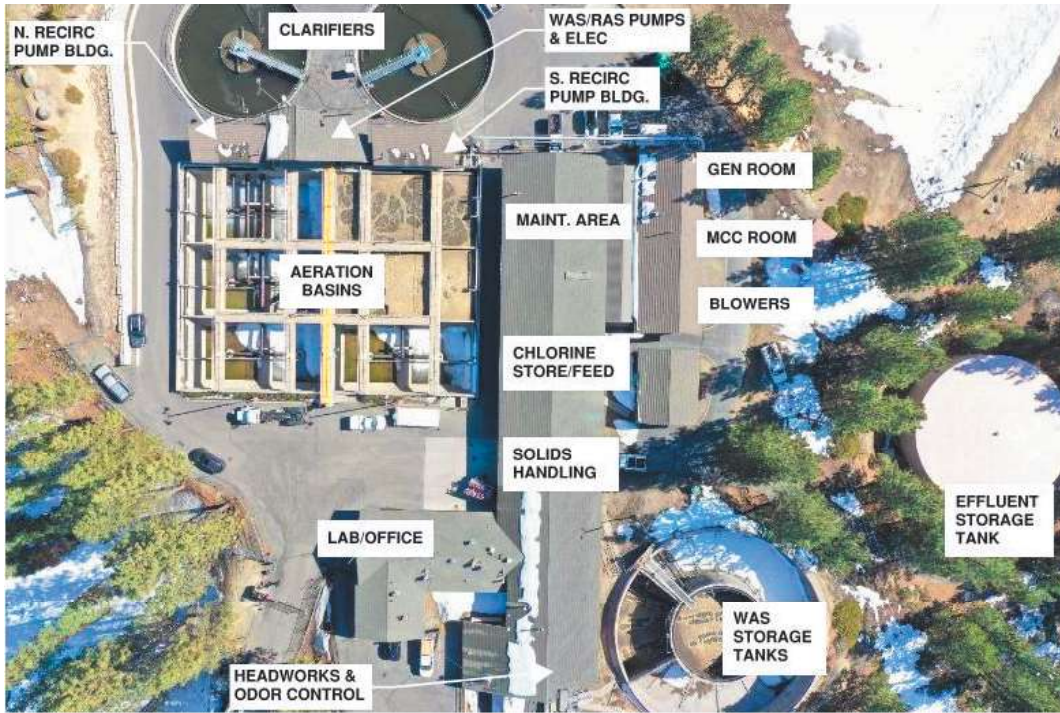
Figure 25: Water Resource Recovery Facility–Site Overview

The current treatment process train includes raw influent flow metering, fine screening, grit removal, secondary biological treatment, clarification, and disinfection along with waste sludge digestion and mechanical sludge dewatering. Figure 25 includes a site overview of the overall WRRF.

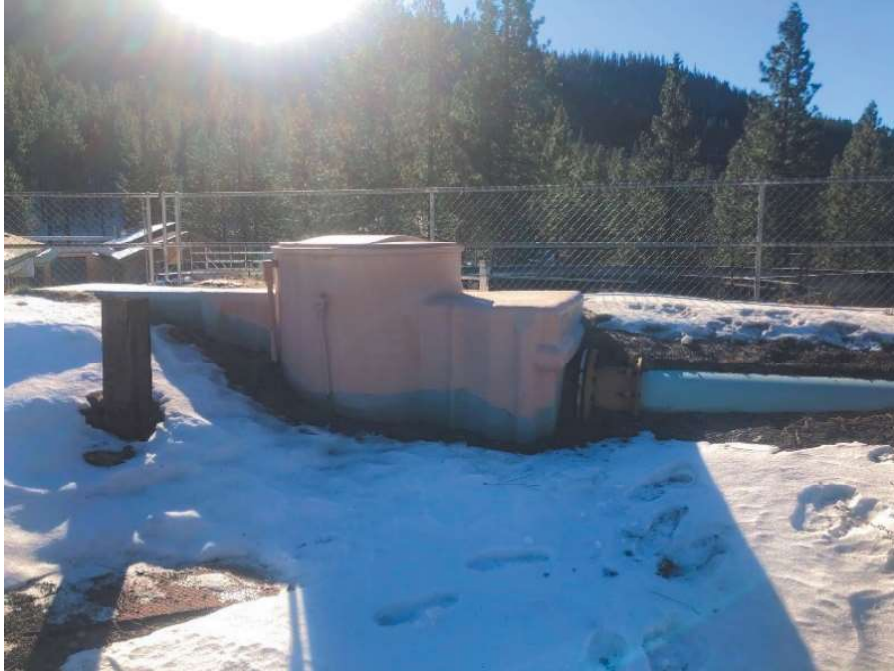
Wastewater arrives at the WRRF through a sewer force main from the SPS-01 and SPS-08 lift stations and a gravity sewer inverted siphon from the Sewershed 000. After combining at a manhole at the edge of the property the wastewater passes through a Parshall flume flow measuring device shown as in Figure 41 and then through concrete flow channels en route to the single automatic influent screening equipment. A composite sampler is also in place to pull influent wastewater samples from just below the flume structure, and a total suspended solids (TSS) sensor is also located in the influent channel.

Figure 41: Influent Parshall Flume

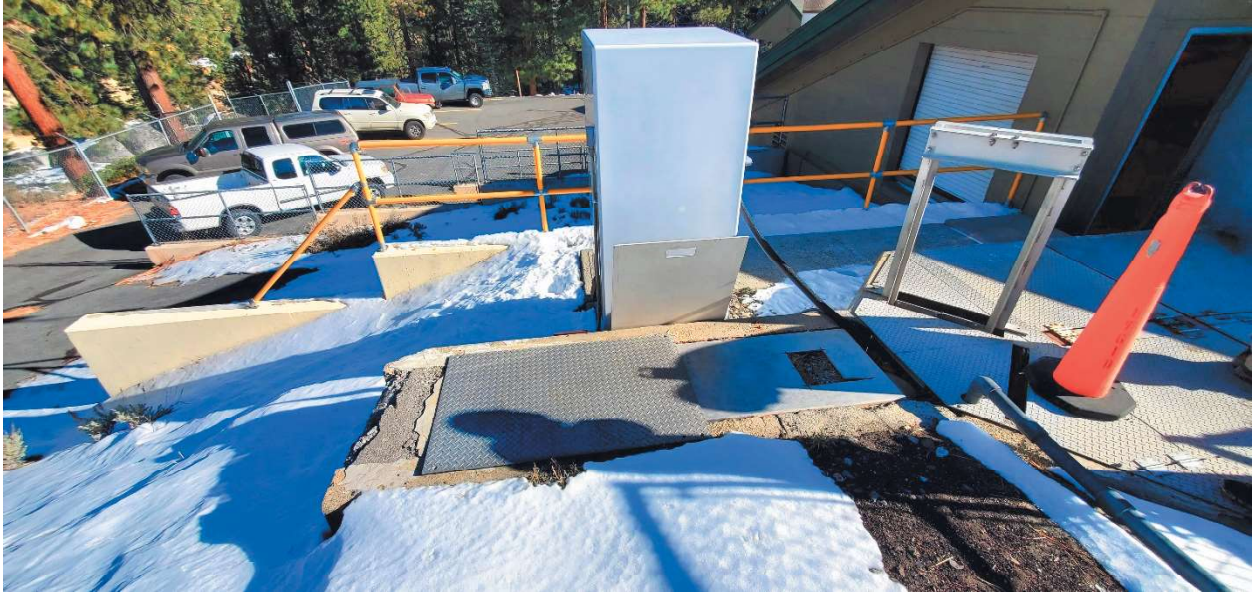
Figure 42: Influent Channels, Composite Sampler Weather Enclosure

The concrete influent channels show signs of concrete degradation on both the inside and outside concrete surfaces. The exterior degradation (Figure 42) may be from freeze-thaw cycles, whereas the interior concrete degradation is likely from exposure to hydrogen sulfide and other compounds in the wastewater, along with general erosion from the flow of wastewater and debris across the concrete surfaces.

Concrete: Preserving and repairing the degraded concrete to slow the rate of decay will protect the reinforcement rebar from exposure and subsequent corrosion. As the concrete spalling extends and reaches depths of ½-inch plans should be made for isolating, cleaning, and application of a cementitious and/or epoxy, polyurethane or polyurea coating to extend the life of the concrete. The later synthetic coatings tend to require very dry and well-prepared surfaces whereas sprayed or troweled on cementitious and grout repair materials do not require completely dry surfaces for effective bonding and curing.

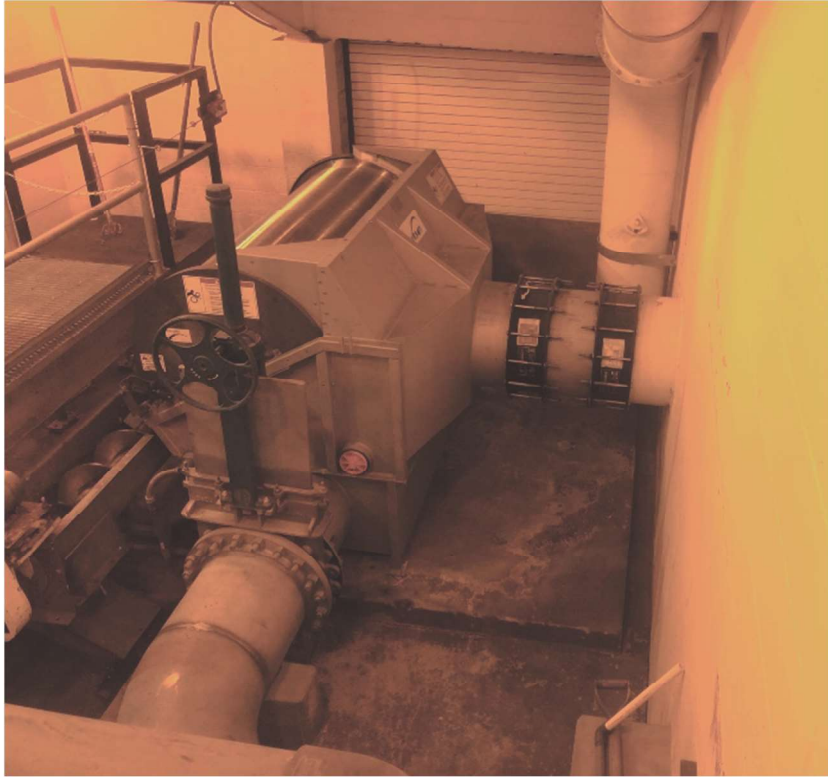
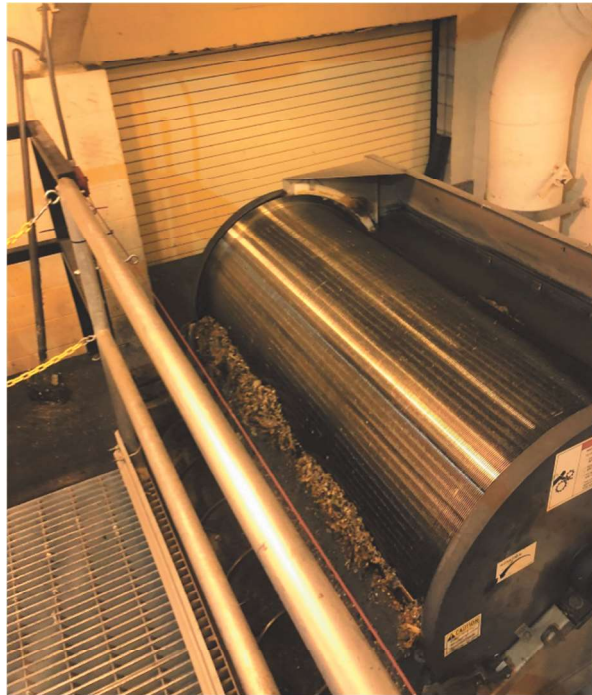
The lack of redundancy poses a risk to downstream equipment and an operations challenge for any period with the automatic screen out of service. Further, when bypass is required, the downstream processes accumulate debris requiring manual effort to clean equipment and remove the debris, exposing operations staff to the host of safety issues handling such debris. These efforts to collect and dispose of bypassed debris and effort of repairing equipment come with a cost and associated safety risks, where a second, redundant screen would eliminate the same. The automatic screen is installed in a small, enclosed room, making removing the screen for maintenance difficult. Figure 44 and Figure 45 illustrate the automatic fine screen, and Figure 46 illustrates the coarse screen in the bypass flow channel.

Figure 44: Headworks, Rotary Drum Screen (inlet/outlet)

Figure 45: Headworks, Rotary Drum Screen

Figure 46: Headworks, Manual Bar Screen (Bypass)

As identified in Section 6.2 it is recommended that a basis of design report for the second screen be completed in 2026, with a target to complete the second screen installation in 2027.

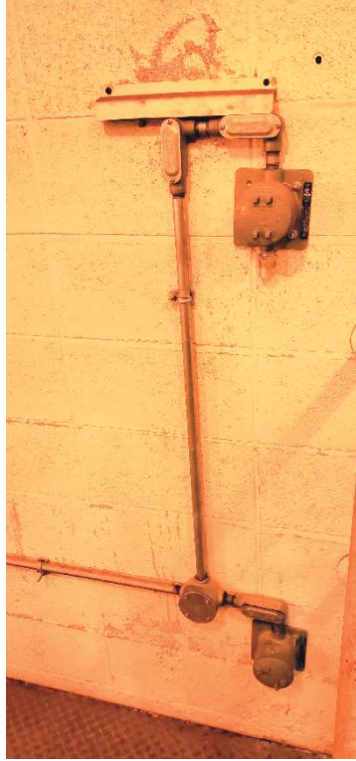
oil reaching the plant and filling this space with potentially volatile and explosive gas. This event illustrates the exact purpose of the gas monitoring system and the need for adequate ventilation and monitoring equipment to keep operators and the minimize the potential for ignition or explosion of accumulated volatile gases. It should be noted that the gas monitoring system was recently replaced in December of 2023.

Figure 47: Hazardous Gas Monitor System Sensors (H₂S & Low Oxygen)

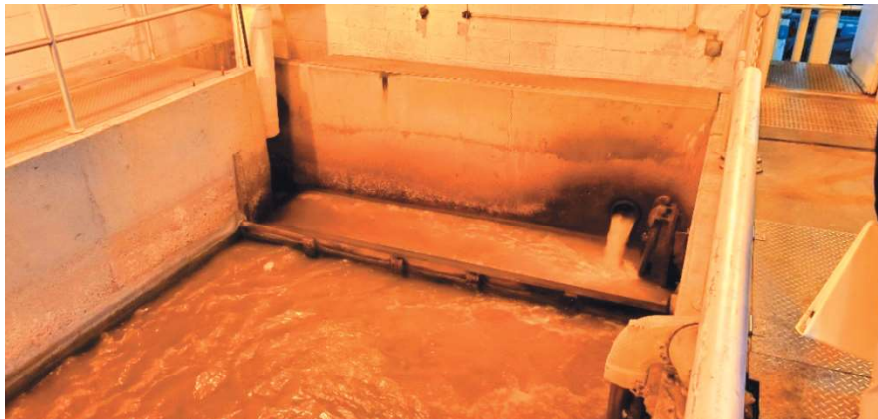
The grit removal facility includes one aerated grit chamber. Influent that passes through the microscreen flows into an aerated, sloped bottom grit chamber. Air is added and controlled to gently roll the influent to settle out the grit. An air lift system, on timers, conveys the grit from the bottom of the grit chamber to a settling hopper, the separated grit is conveyed up an incline auger then into a cart destined for disposal to a secured landfill. The compressed air for the air lift pump function is provided from a side stream from the blower also providing air to the sludge holding tanks. Thus, there are no other grit pumps in the system to remove grit from the grit chamber. The air lift system pulls grit from the chamber hopper solely through the air lift system.

Figure 50: Grit Chamber & Outlet to Aeration Basins

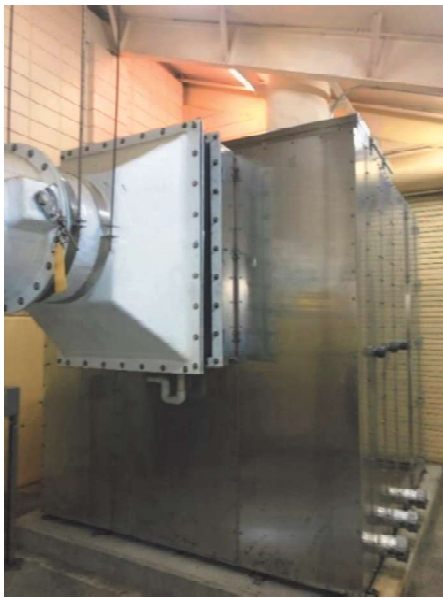
The existing deep bed scrubber (DBS) adsorption system manufactured by Purafil Filtration Group replaced a previous wet scrubber odor control facility. The existing system uses no chemical and relies on manufactured and proprietary media for adsorption of odors prior to discharge to atmosphere. Aside from periodic replacement of the media, the system requires little maintenance, is much safer to operate than a chemical scrubber, and performs for the purpose it serves. The system is in good condition and not specific deficiencies are apparent with the system overall. Further, the media was replaced in July 2023

Figure 51: Odor Scrubber

Figure 52: Odor Scrubber Media

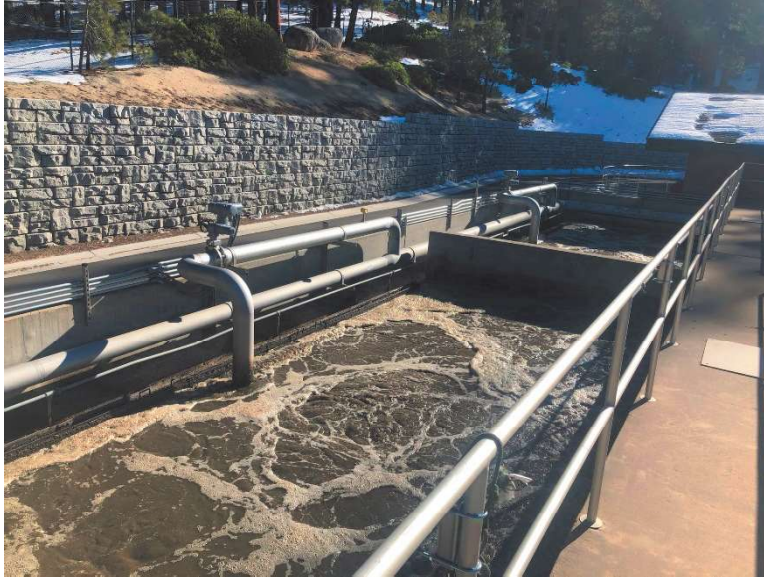
Figure 53: North Aeration Basins, Under Aeration (N-2, N-3)

The target dissolved oxygen concentration is generally around 1.9 to 2.0 mg/L though at times when the oxygen demand is higher during warmer process water temperatures in the summer months, the blowers and aeration system have trouble maintaining 2.0 mg/l. The surface of the aeration basins become very violent, and the water surface nearly reaches the above walkways, as softball size bubbles become prevalent as the blower discharge air flow rate increases and the open control valves open farther.

The larger bubbles are not as efficient in oxygen transfer as compared to many small bubbles with greater aggregate surface area for transfer to occur into the water. Generally, the violent surface agitation and aeration is an indication something is not right in the process, as the aeration pattern should not result in significant agitation at the surface in any condition. A few items possible contributors to this condition are as follows:

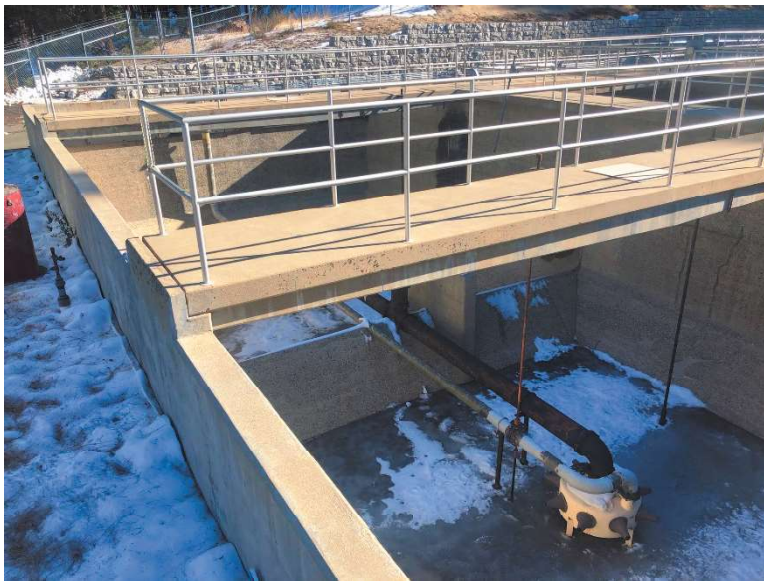
Figure 54: North Aeration Basin & “Jet Cluster” Diffuser, Empty (N-1)

- If there was anything substantially wrong with the jet clusters, the issue would likely be more common. The jet nozzles appear in good condition and appear to be replaceable apart from the overall cluster assembly.

Similarly, the aeration jet clusters are a combination of a steel “pot” with either steel or fiberglass/composite jet nozzles. Some minor signs of rusting are present on the outside of the visible jet clusters but for 30 years of service the coating on the jet cluster appears to be holding up well.

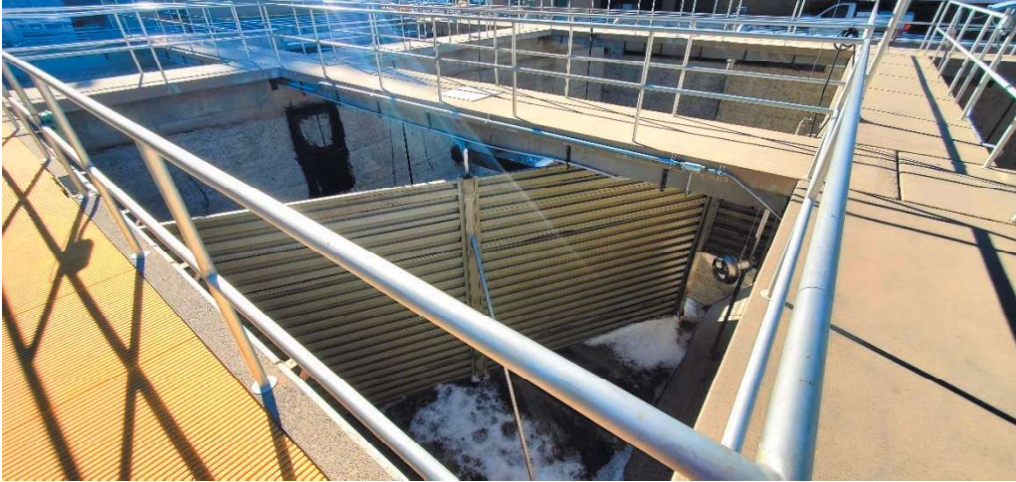
Figure 55: Aeration Basin, Anoxic Zone & Mixer (Basin S-2)

The center aeration basins (N-2, S-2) include a baffle wall in the inlet corner of the basins to separate this area of the reactor from the aeration system. The isolated section, along with a submersible mixer, provides an anoxic zone ahead of the aerobic zone, effectively reducing the volume of the tank under aeration and the total time under aeration. The baffle acts to reduce residence time and inhibit nitrification.

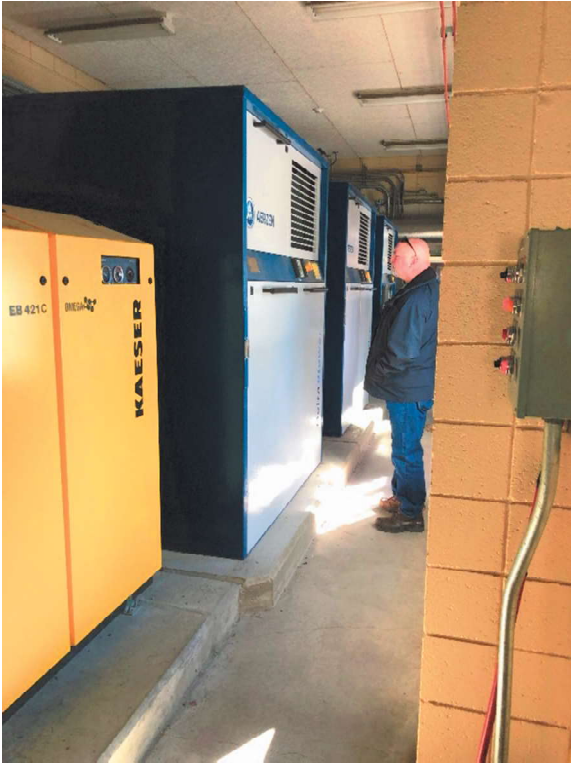
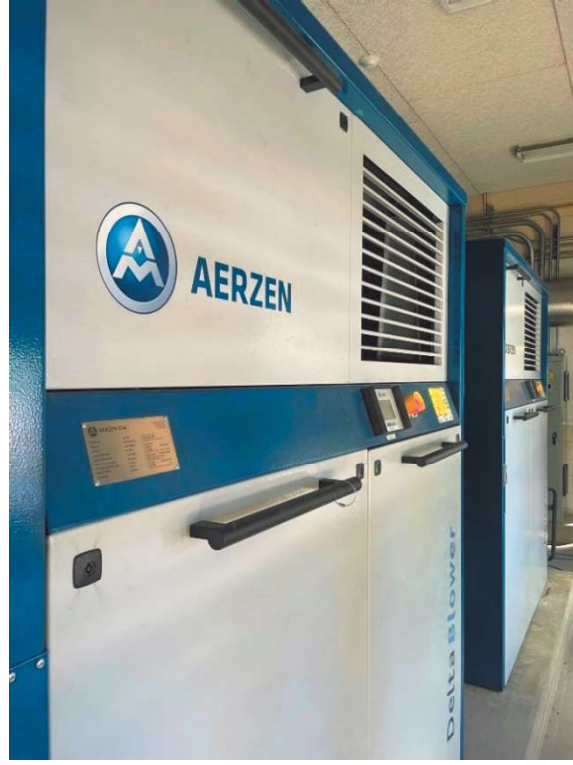
Aeration control to each aeration basin in operation is based on the dissolved oxygen in the aeration basin, as measured through dissolved oxygen probes (YSI/Xylem) suspended in the aeration basins. The air input is modulated through both the variable speed drives on the blowers and modulating flow control valves on the individual air supply headers to each aeration basin. Each aeration basin header includes a mass flow meter to measure the air input and throttle or open the control valve according to the target dissolved oxygen concentration in the respective aeration basin. The overall blower speed is modulated based upon the discharge pressure on the blower(s) in operation. As an individual aeration basin modulating valve throttles to reduce the air input into the basin based on the D.O. probe, the pressure at the blower increases, allowing the blower speed to slow down to meet the reduced air flow demand. The rotary lobe positive displacement blowers are shown in Figure 56 and Figure 57, and the blower capacities are shown in Table 65.

Figure 56: Aeration Basin Blowers and Blower

Figure 57: Aeration Basin Blowers/Enclosures

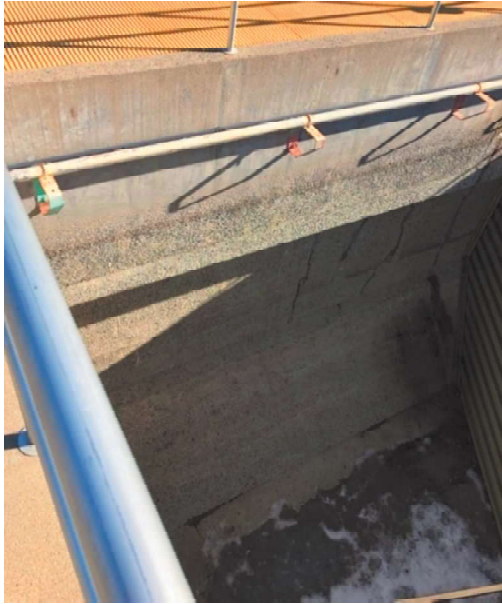
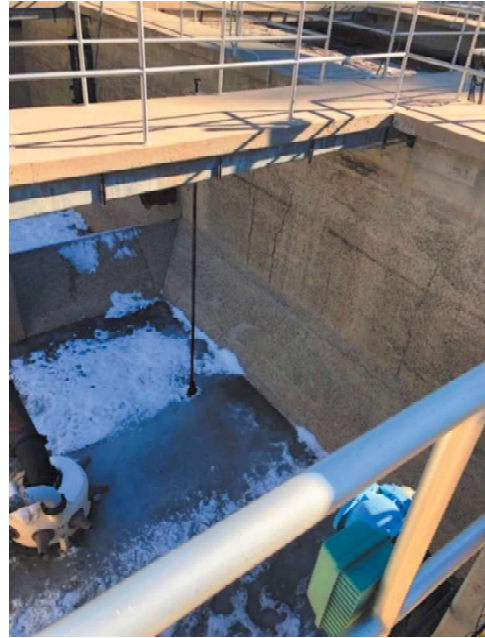
A visual and non-destructive assessment was performed of exterior structures. The plant was operating so a full assessment of structures or tanks filled with liquid was not feasible. Several aeration basins were not in use and were visually observed. The aeration basins have a lack of cement paste matrix in areas as the aggregate is exposed below the normal liquid level as seen in the figures below. Exposed reinforcement, large cracks or delaminations or spalling were not observed; however, some cracks were observed. The minor cracks in the basin walls were unable to be accessed for measurement and the concrete was not sounded with a hammer. As the surface of the concrete continues to deteriorate or crack, concrete spalling and exposed and rusting rebar could initiate. Once the rebar begins to rust, the concrete near the rebar will continue to spall leading to more exposed rebar.

Figure 60: Aeration Basin Concrete Erosion

Figure 61: Aeration Basin Concrete

Figure 62: Walkway Concrete Damage

Figure 63: Walkway Concrete Damage

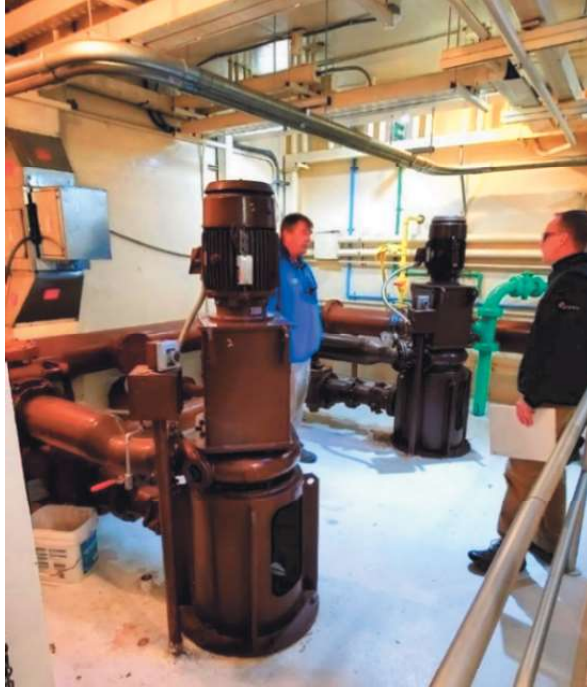
Figure 64: Return Activated Sludge (RAS) Pumps

The plant has two RAS pumps that discharge through a mud valve into the raw wastewater influent channel between the aeration basins and mixes with influent ahead of the aeration basins. The RAS pumps are located on the middle floor of the mechanical building and are powered by variable frequency drives (VFDs). The VFDs are controlled by set points based on the percent of influent flow from the plant control system. The pumps can also be run manually if needed. The specifications of each Return Activated Sludge Pump are listed below.

The RAS pumps were modified with a project in 1997 to replace the original pumps installed in the 1971 project with two new Wemco Hydrostat screw centrifugal pump. The return sludge pipe from the clarifiers connects into a manifold in the pump room such that either pump could recycle sludge from both clarifiers though the general operation is to allow one of the RAS pumps to work directly with the corresponding clarifier. Operating in an alternative configuration is reported to not provide for appropriate flow splitting between the two clarifiers. The pumps and equipment are in good condition. Adequate isolation valves, check valves, pressure gauges are in place along with a TSS meter on the common manifold.

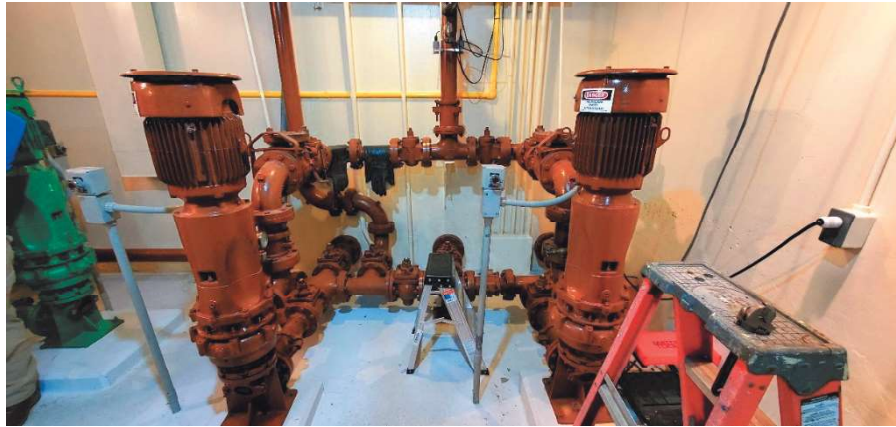
Figure 65: Waste Activated Sludge (WAS) Pumps

The Waste Activated Sludge (WAS) Pumps convey sludge out of the bottom of the clarifier and discharges to the WAS storage tanks. The WAS pumps are operated intermittently to remove excess activated sludge in order to achieve the desired volume of sludge in the mixed liquor based on plant process needs. The plant has two WAS pumps that are located on the bottom floor of the mechanical building. The pumps are controlled by a timer that is controlled by calculated figure based on the target solids retention time for the facility. The general specifications of each pump are outlined below.

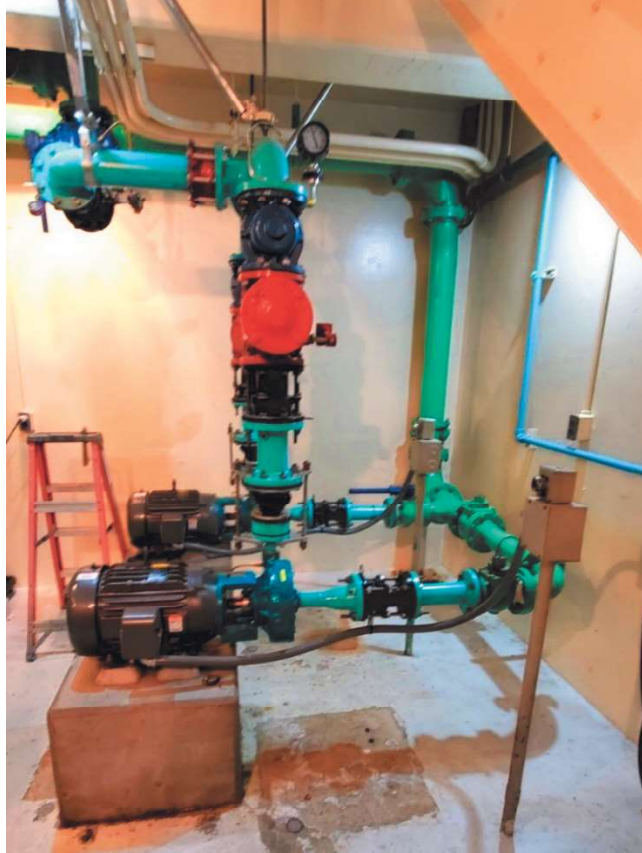
Figure 66: Plant Utility Water (non-pot) Supply Pumps

The two plant water pumps are newer end suction centrifugal that replaced two horizontal split case pumps. The combined discharge pipe includes pressure gauges and a pressure regulating valve to allow regulation of the downstream pressure. These pumps have no VFDs or pressure tank to control stopping and starting or pump operating speed control. One pump or the other runs continuously to supply the continuous water needs throughout the plant. Each pump has isolation valves on the suction and discharge and check valves, all in good condition.

One of the pumps runs continuously to supply water to the point of use in the facility including spray nozzles at the headworks automatic screen, nozzles in the aeration basin mixed liquor outlet channels and spray nozzles in the clarifiers, both for management of foam. This reuse water is not used in the polymer make up water for the centrifuges in the solids handling building, where potable water was required for this equipment. The reuse water is pulled from the clarifier effluent collection channel adjacent to the main pump building and the mixed liquor distribution channel structures preceding the clarifiers. The effluent does not go through any filtration prior to using and the relatively low TSS has not caused issues with the larger nozzle openings plugging such as in the headworks screen.

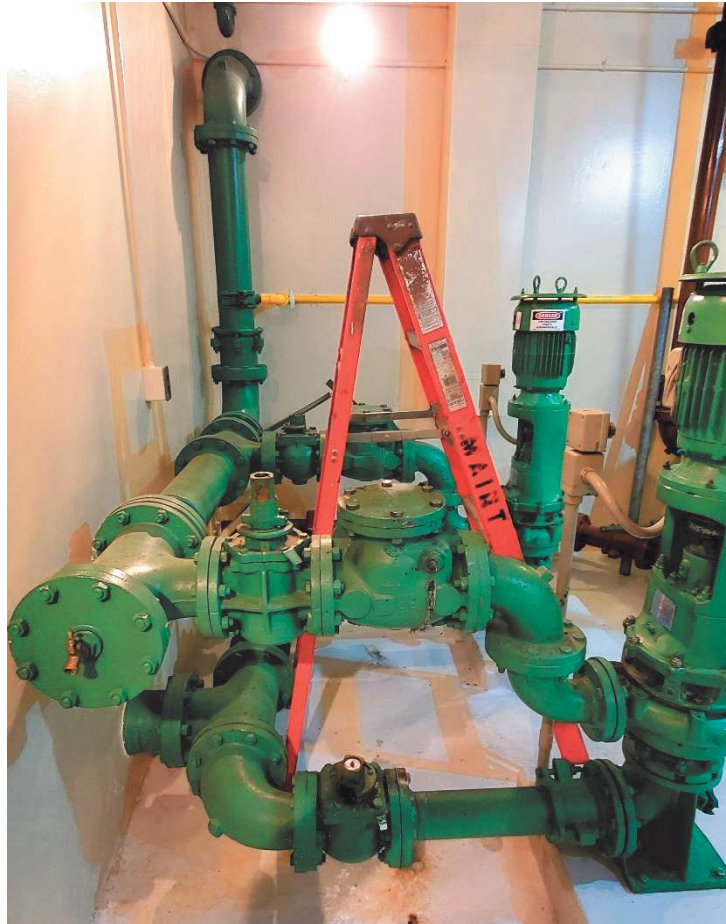
Figure 67: Plant Waste Pump Station

The plant waste pump station collects water from the facility bathroom, miscellaneous floor, tank, and process drains, and scum from the clarifiers and pumps the flows back to the front of the WRRF, entering the influent channel upstream of the headworks screen. The pump system was constructed with the aeration basins and pump building in 1971. The pumps and piping appear in good condition with no noted deficiencies. This pump system does not have a flow meter included on the discharge line. The total volume relative to the remainder of the influent in small and flow monitoring calculated on pumping rates (i.e., pump curves or wet well draw down tests) multiplied by the pump run times would provide a sufficient indication of the total volumes returned to the front of the plant. The duplex pump system is shown in Figure 67, and Table 72 summarizes the record capacity of this pump system.

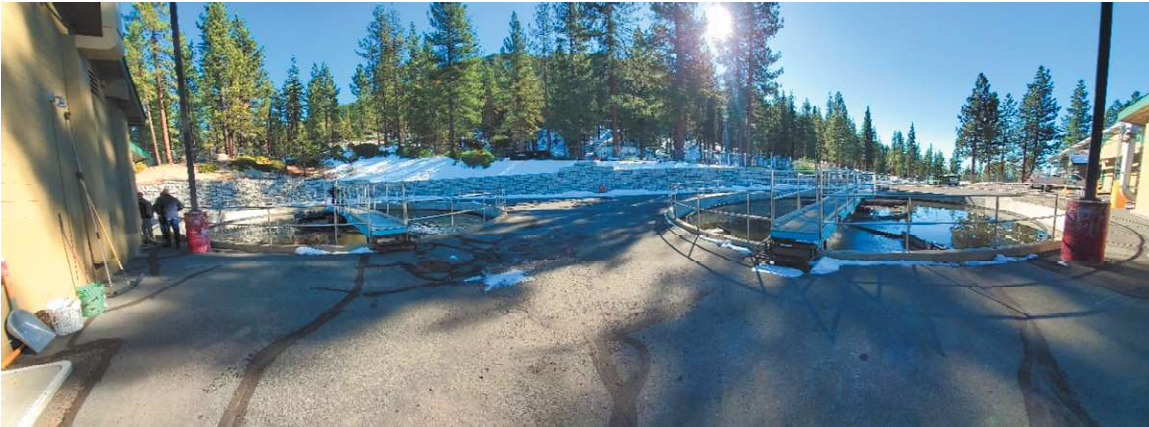
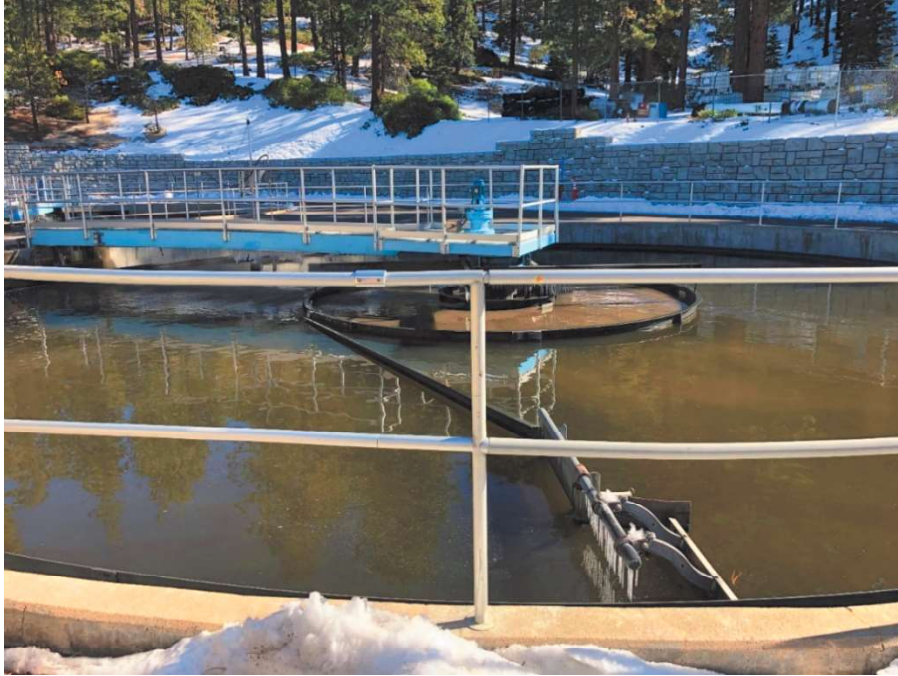
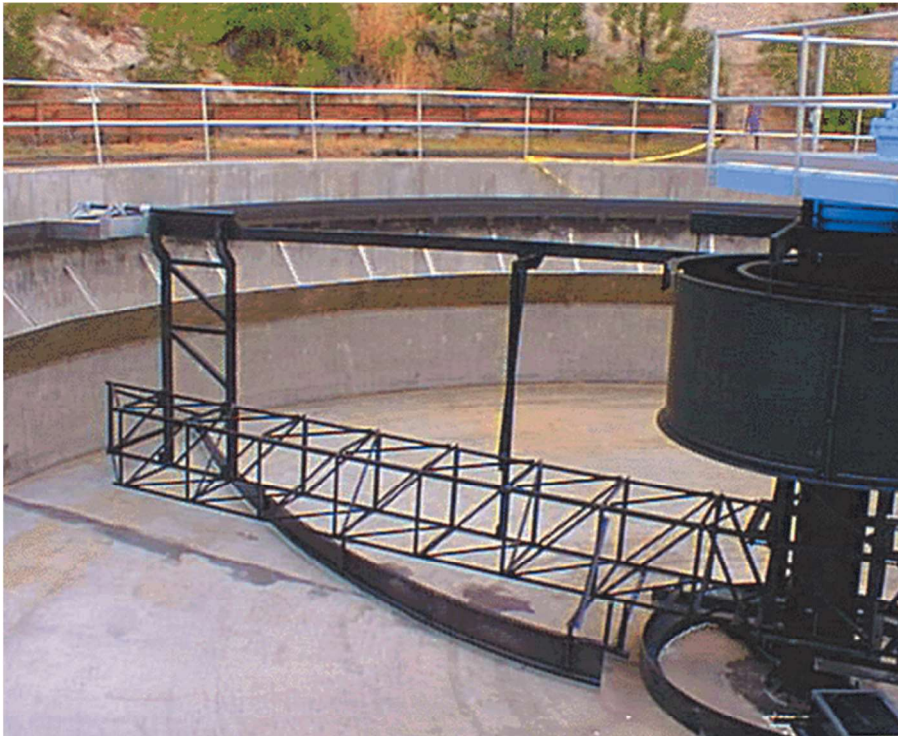
The secondary clarifiers are illustrated in Figure 68, Figure 69, and Figure 70. Table 73 includes a summary of the clarifier equipment.

Figure 68: Secondary Clarifiers

Figure 69: Secondary Clarifier

Figure 70: Secondary Clarifier Mechanism (example similar to IVGID)

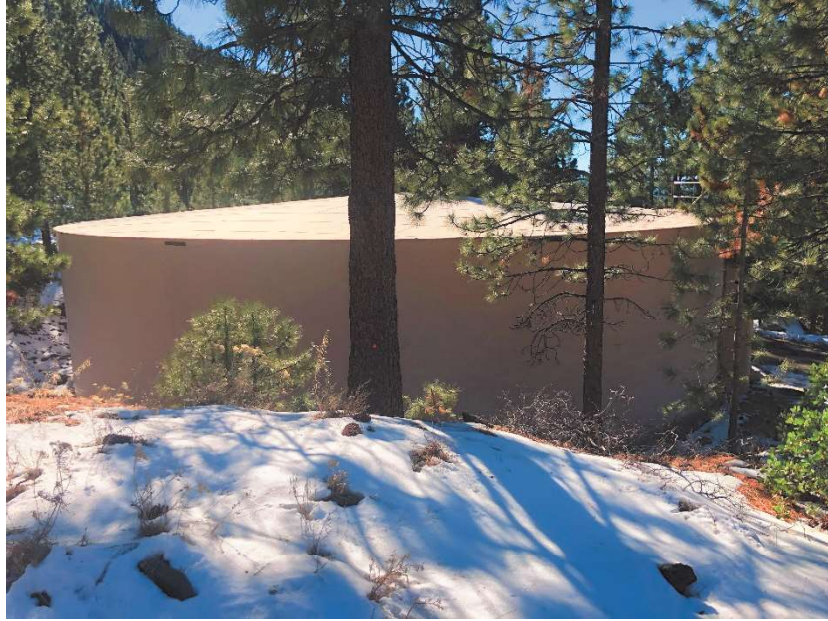
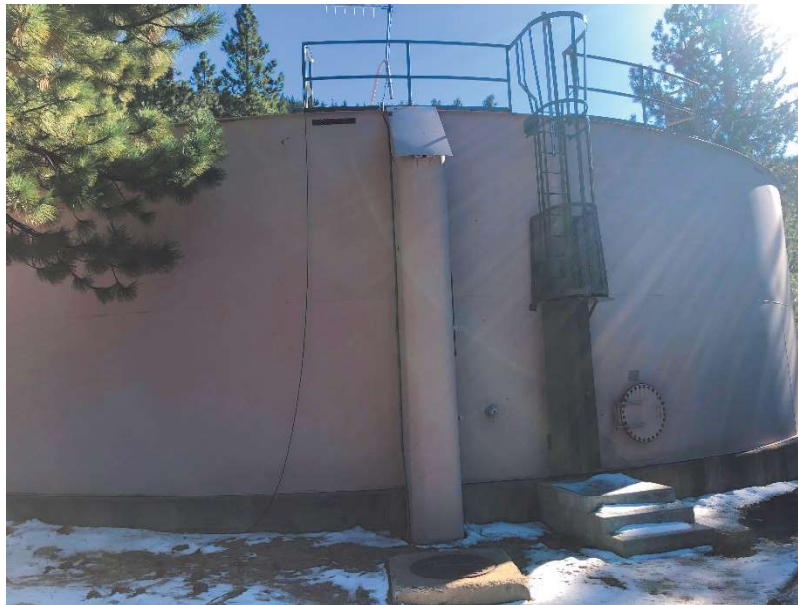
The storage tank picture in Figure 74 and Figure 75 is reported to be in poor condition with the interior coating beyond the life of the coating system. Removing the facility from service is complicated in having no alternative storage to provide both the chlorine contact time and the operational storage needed for the effluent pump station operation. Thus, maintenance is very difficult, as removal of the tank from the overall operation effects the effluent pump station, particularly when sewer flows into the facility are lower.

IVGID has plans in development for an additional effluent storage tank to replace or supplement the existing tank and allow rehabilitation of this existing tank at the District's discretion.

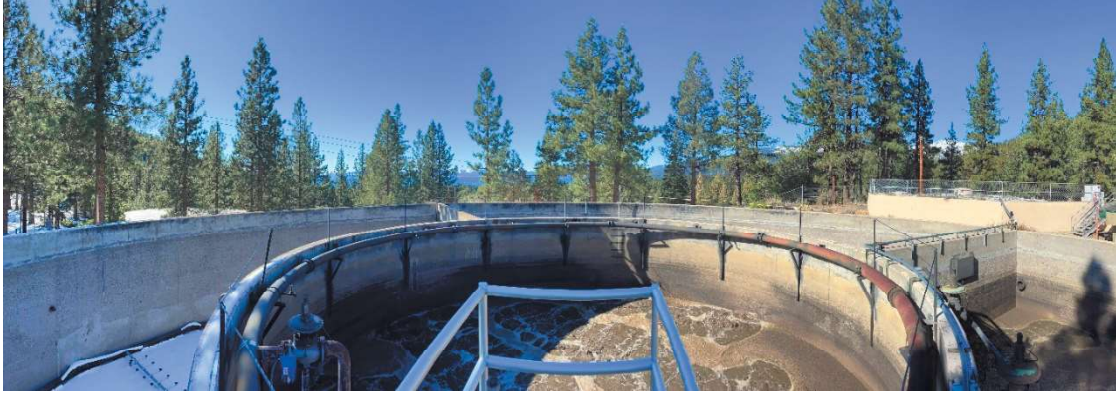
Figure 77: Center Sludge Holding Tank

The tanks are currently used to store WAS before entering the Solids Handling Building and going through the dewatering process. There are three separate storage tanks within the holding facility #1, #3 and #4. WAS is pumped from the bottom of the secondary clarifiers into one of the three holding tanks. Air is supplied from Blower #4 in order to keep the sludge from going septic and providing a moderate level of actual digestion.

In earlier iterations the tanks included a WAS thickening stage. WAS directed to the center tank (old clarifier) and then processed through a centrifuge and then to one of two other sections of the solids holding tanks storage tank termed as Digester #1 and Digester #2. The final of the four (4) tank zones was for storage of the digested sludge for batching to the other two centrifuge units for final sludge dewatering. The purpose was to reduce the volume of water sent through the final dewatering equipment while conditioning and thickening the sludge to closer to 1.5%. This process has not been used for many years. The thickening centrifuge had mechanical issues and has not operated since. Thus, the four areas of the solids holding tanks are all used as aerated sludge holding tanks and sludge at approximately 0.5% solids is pumped to the two other centrifuges for successful dewatering.

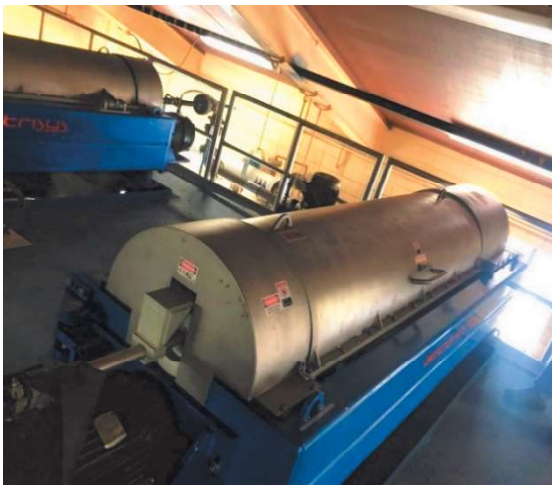
Figure 81: Dewatering Centrifuge

Equipment Name	Make/ Mod	Flow Capacity	Head Capacity	HP	Volts	Phase
Centrifuge 1	Centrysis/CS18-42P	110 GPM	N/A	75	480	3
Centrifuge 2	Centrysis/CS18-42P	110 GPM	N/A	75	480	3

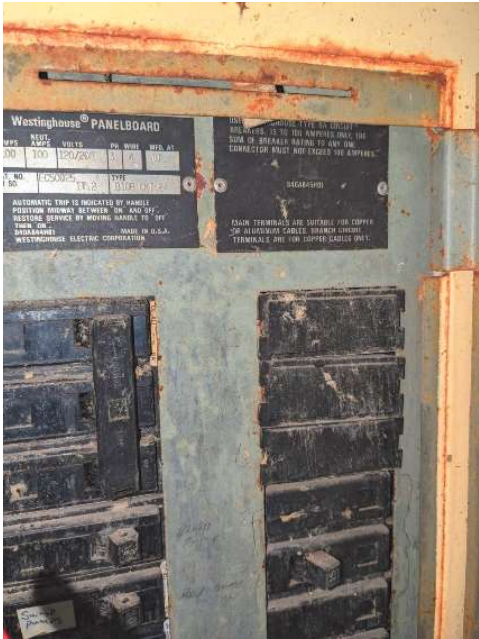
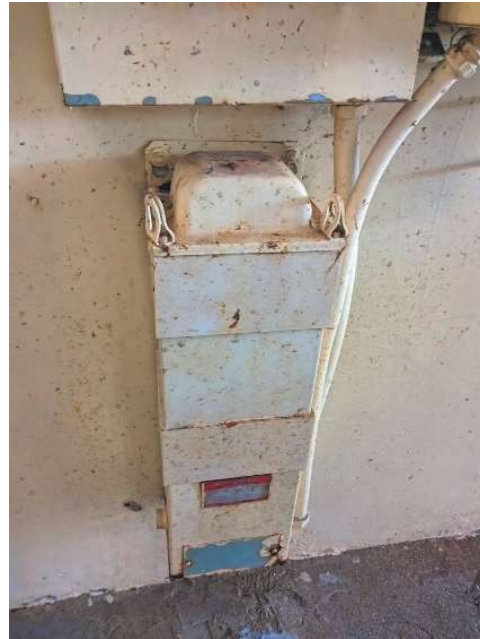
IVGID has been maintaining and replacing parts as needed but would benefit from a more proactive approach in equipment replacement to avoid unplanned outages and hazardous situations caused by aged equipment and installations conforming to outdated codes. Reliable and constant operation of the electrical distribution system is crucial to the WRRF. An example that illustrates the need for maintenance and/or replacement are some of the panelboards and dry-type transformers in the facility. The photos below show the corrosion effects after many years in service.

Figure 84: Panel Board Corrosion

Figure 85: Transformer Corrosion

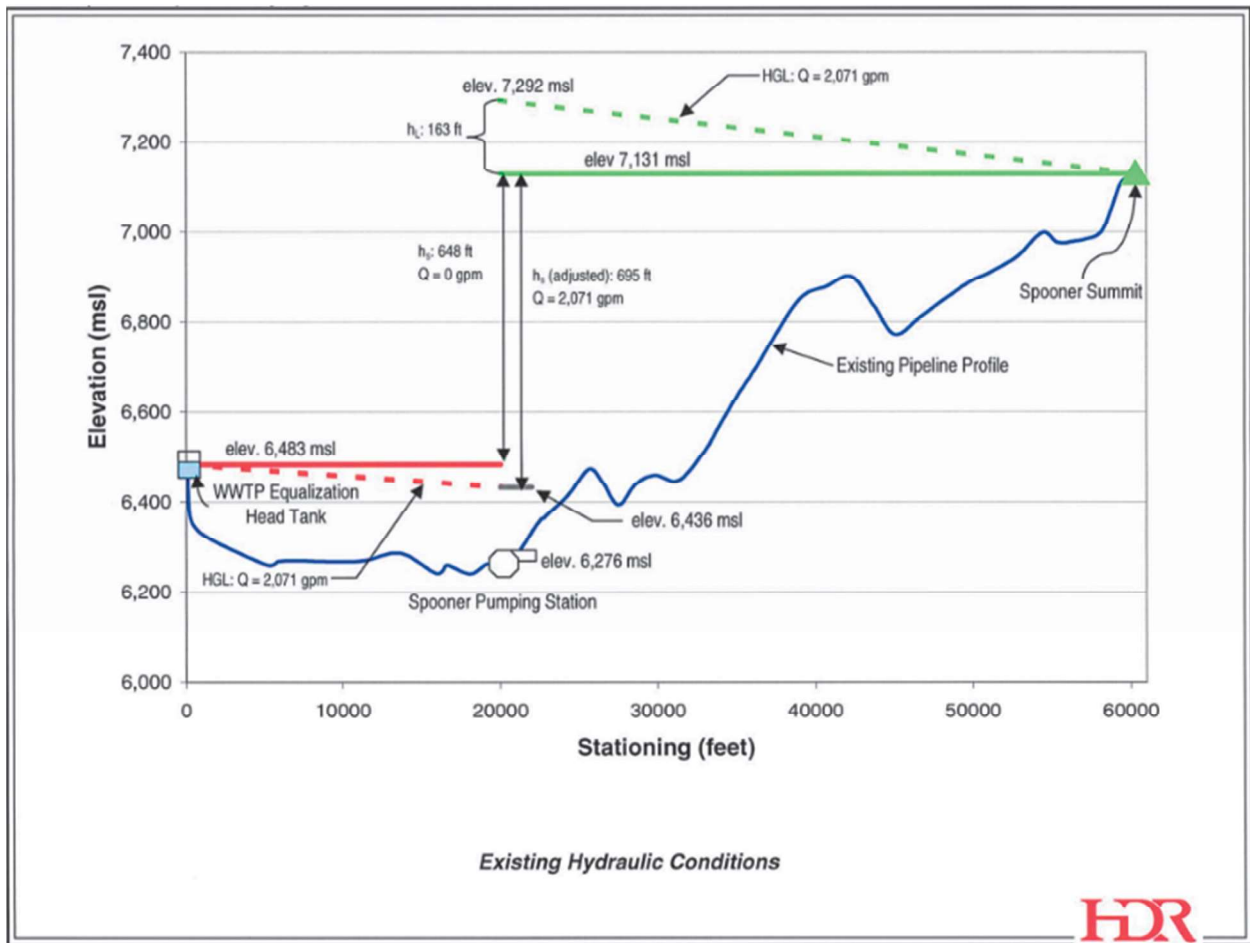
Figure 86: Effluent Export System Hydraulic Profile

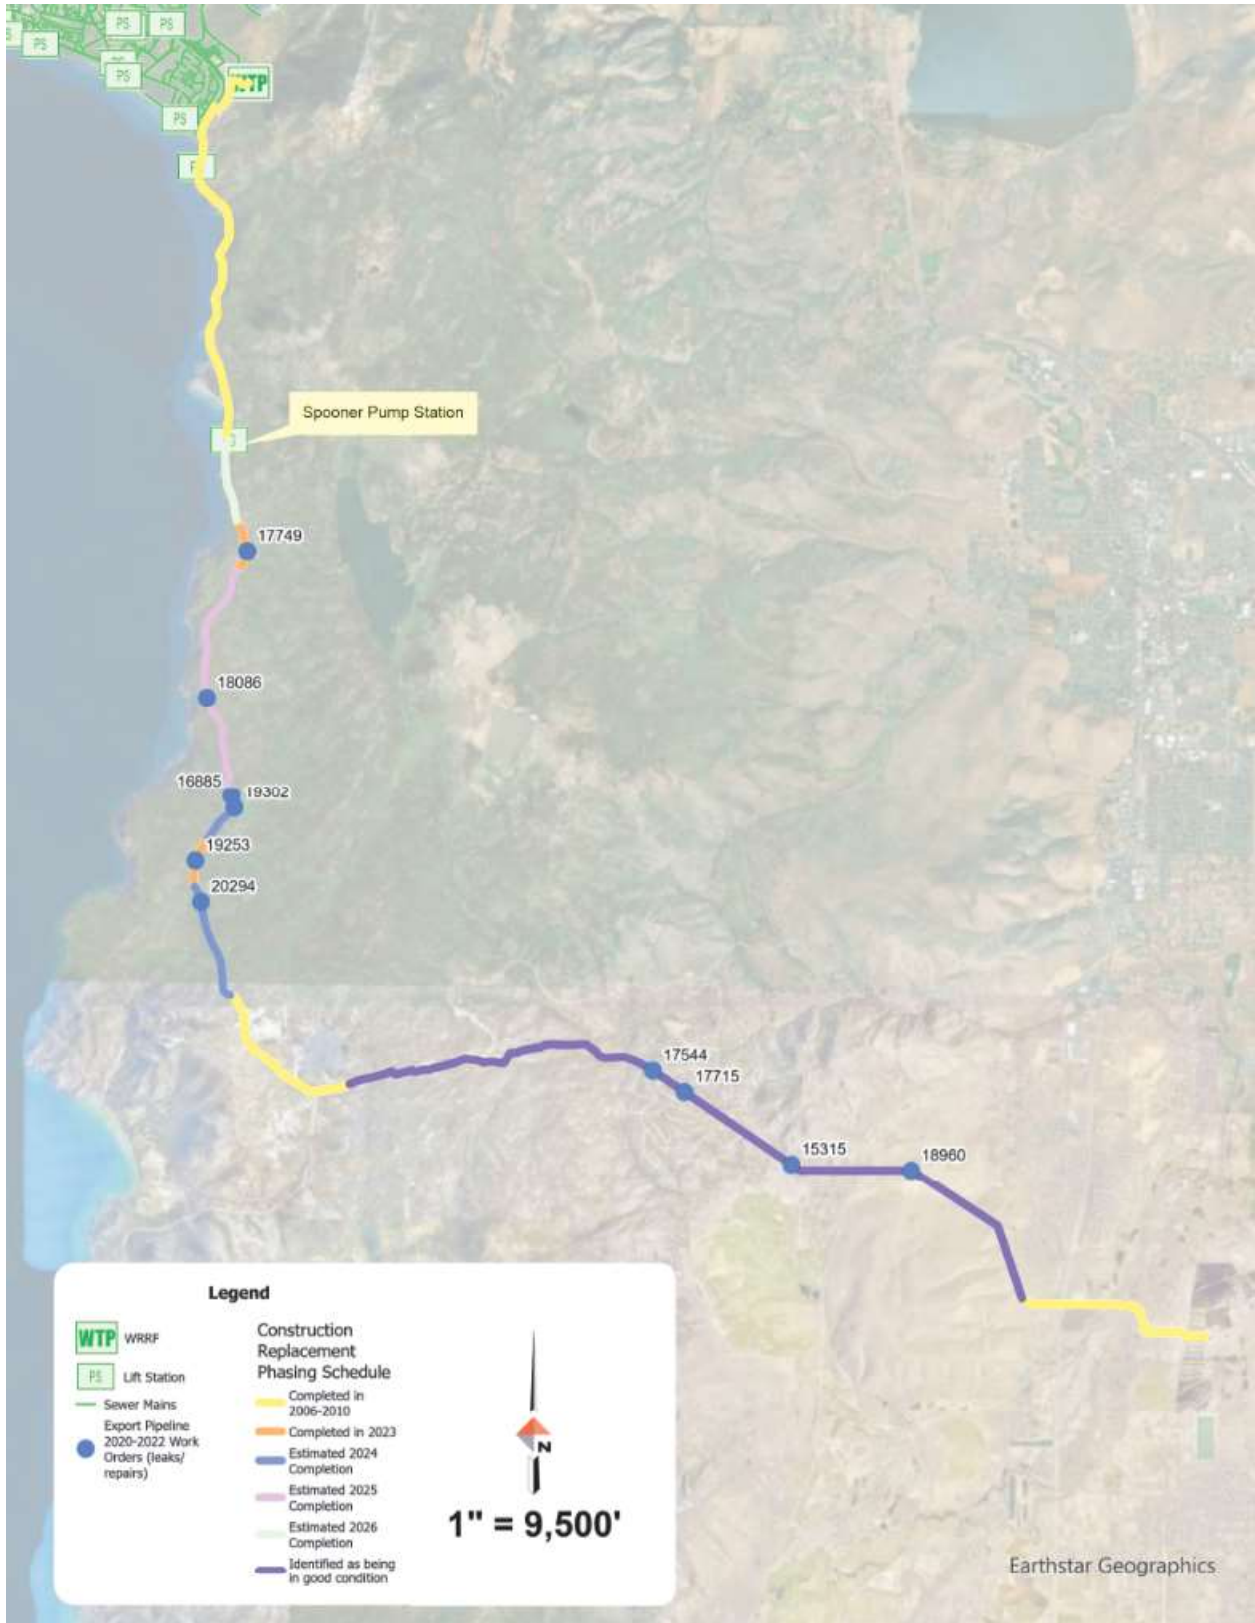
Figure 87: Export Pipeline Leaks /Issues (2020-2022)
