Incline Village Beaches Site Analysis

Incline Village Beaches Site Analysis – Existing Conditions

Existing Conditions Analysis-Incline and Ski Beach
(includes Hermit Beach)

Existing Conditions Analysis-Burnt Cedar Beach

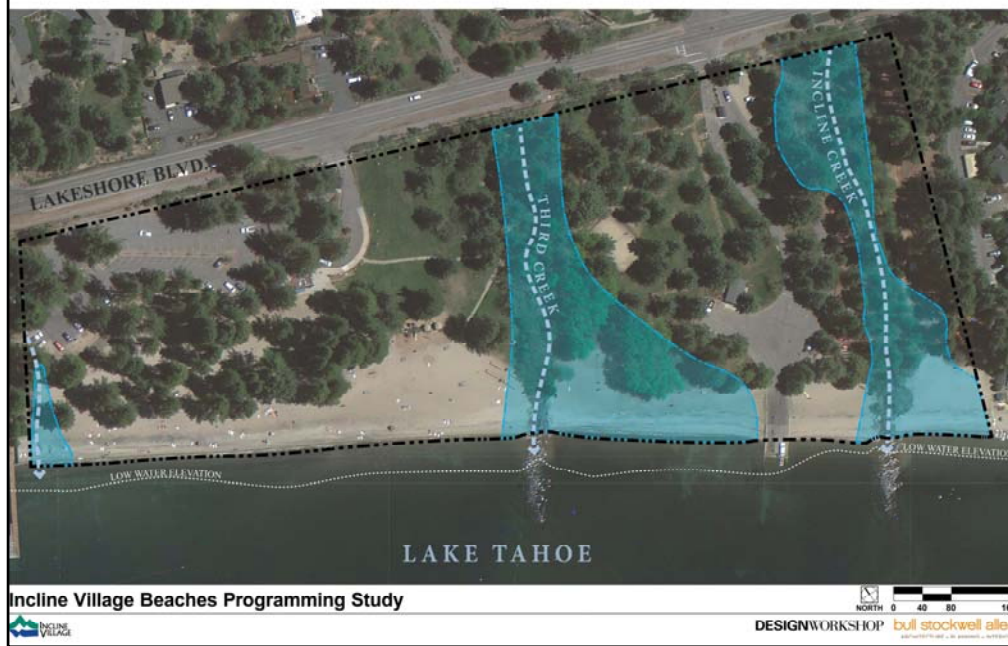
- Incline Beach/Ski Beach/Hermit Beach area is comprised of approximately 13 acres.
- The beaches are bisected by creeks that effectively separate the various uses allowed at the three beaches (swimming/motorboats/non-motorized boating)
- The property is bounded on the north edge by Lakeshore Blvd. on the west by residential uses and on the east by the Hyatt Resort.

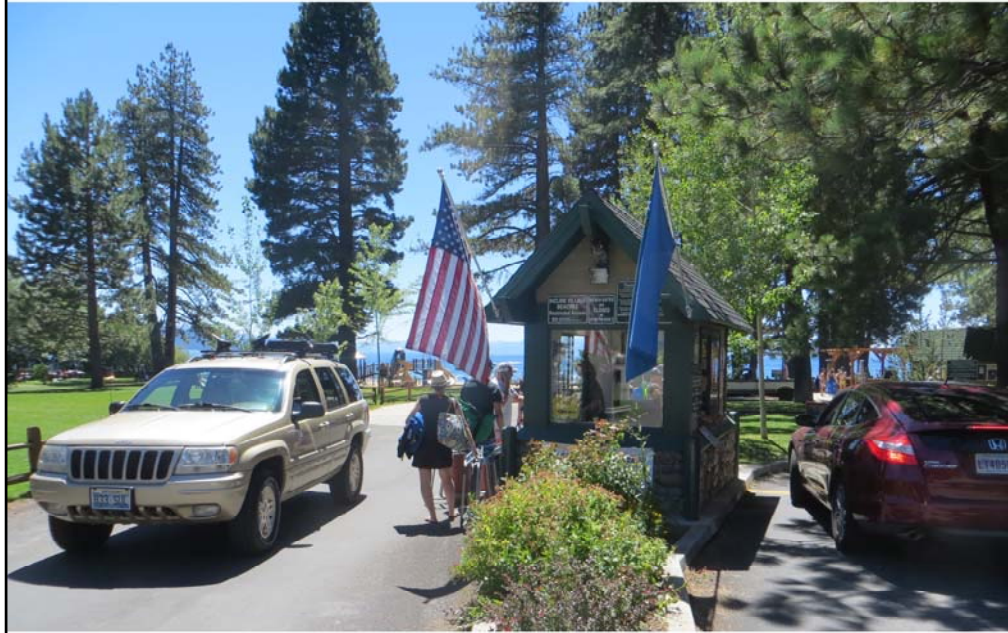
Entry/Circulation/Parking: Guard Shack

- Controlled entrance to the beach
- Offers an obvious location for guests to orient themselves and to be provided with information about the facilities.
- One disadvantage of the current arrival process is that on busy days traffic is prone to backing up onto Lakeshore Boulevard while guests are processed at the guard shack.
- Congestion at the entry gives the impression that the beach is full and also creates some potential traffic safety and emergency access issues.
- Safety concerns at the entry because guests must stand in the outgoing drive isle while they wait to check in at the beach.

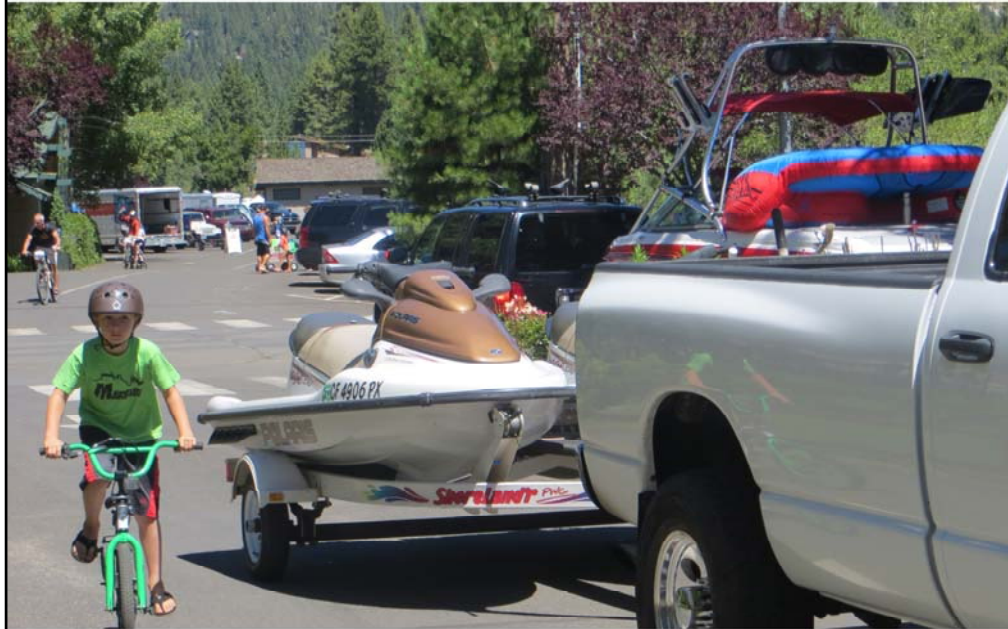
Entry/Circulation/Parking: Shared pedestrian/vehicle circulation

- Guest arriving on foot or by bike, are required to share the primary circulation route with vehicular traffic.
- Separating pedestrian and vehicular traffic presents an opportunity to improve the arrival and circulation for guests.

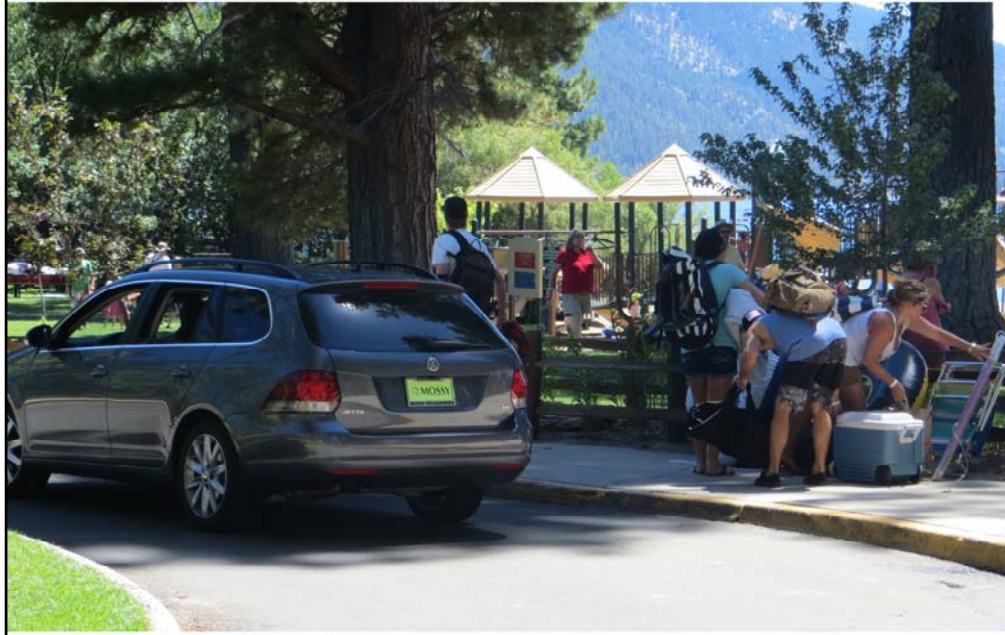
Entry/Circulation/Parking: Drop-off zone

- Most convenient aspect of the current circulation system is the drop-off zone because it allows guests to unload beach gear and passengers, particularly when parking lot is full.
- The design for the drop-off could be improved by widening the drop-off lane to allow vehicles to bypass other vehicles that require prolonged times to load or unload.

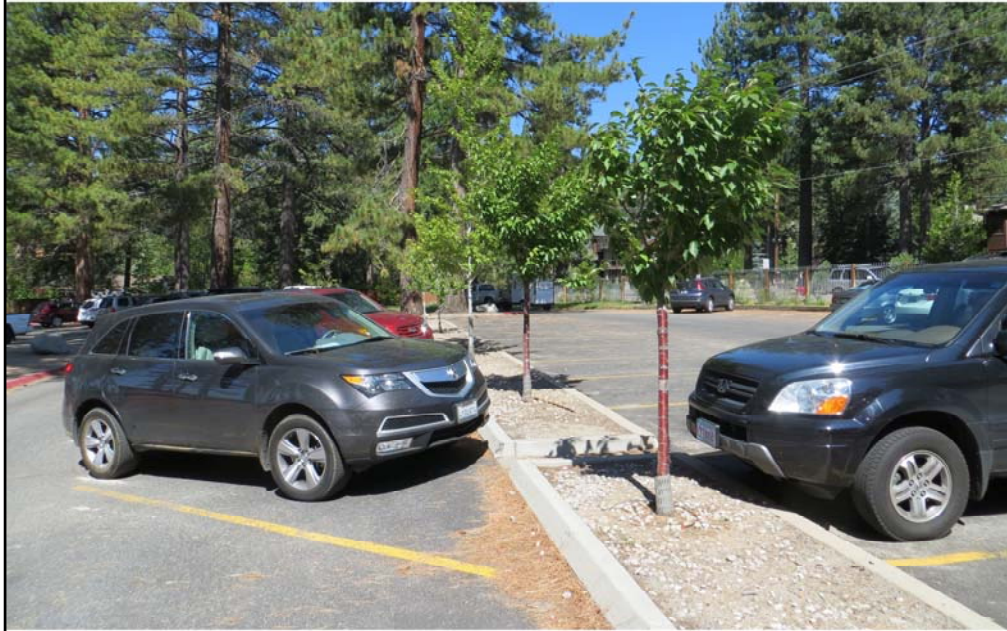
Entry/Circulation/Parking: Parking Lots

- The current parking lot configuration accommodates 91 vehicles, plus 5 ADA spaces. Two offsite lots (Village Green and Overflow) are available across Lakeshore Boulevard which add 54 car and 36 boat trailer spots. There are approximately 15 street parking spots immediately outside the gates of Incline Beach.

- On average the parking lot at Incline Beach fills up by 1:00 pm during the average summer weekday and by 10:00 am on a typical weekend.
- Without dramatically altering the quality of the beach experience, it would be impossible to develop an adequate supply of parking to address the demand on peak days or for peak visitation times.

- On a peak day Incline and Ski Beach might have 1,500 guests. If you assume 3 guests per vehicle, that is 500 parking spots required. Assume 100-parking spots per acre... an additional 3 to 4-acres of land would need to be allocated to parking.

- Other parking strategies might need to be considered in the future.

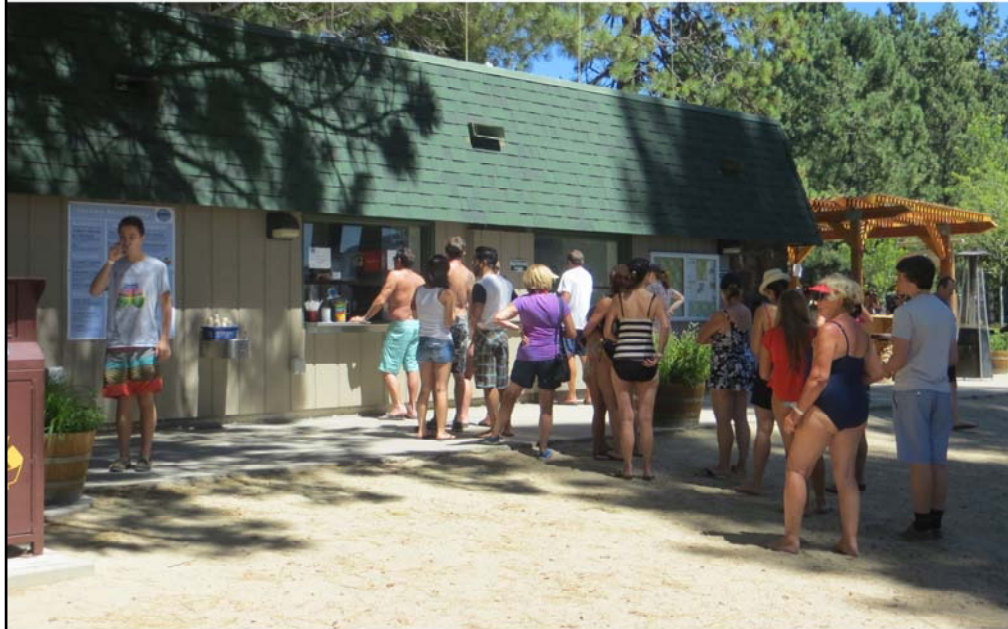
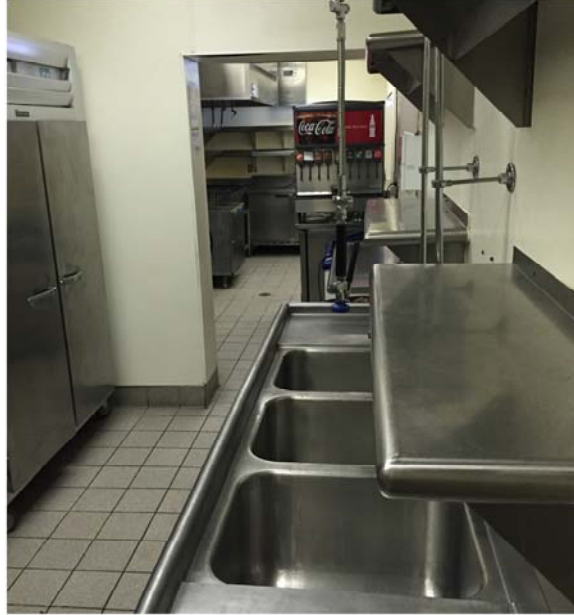
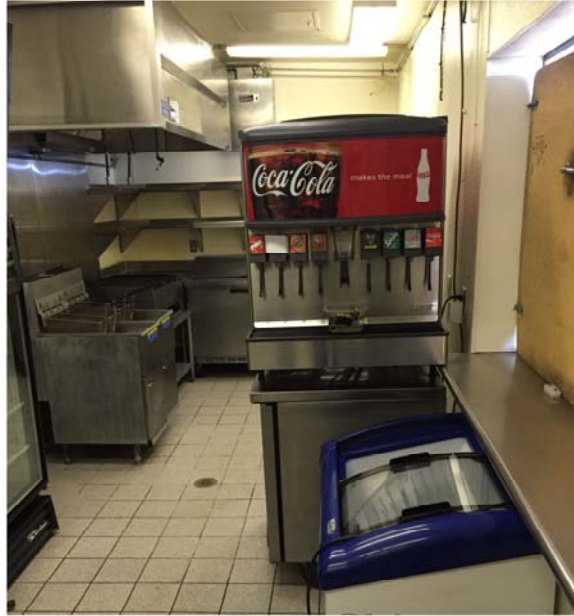
Buildings and Structures: Food Concessions

- The building was constructed in the 70's and is presently largely identical to the original design.
- Concessionaire facility is ideally situated near the entrance and within equidistance of Incline Beach and Ski Beach
- Entire building comprises approximately 1250 sqft, only 370 sqft is allocated to concessionaire operations.
- Allocation of concessionaire space is inadequate based on current needs
- Design of the facility could also be improved to offer a contemporary food/beverage experience
- Contemporary concession facilities have moved away from lining up their guests in favor of an indoor "scramble" system where guests can survey multiple food options, including ready-made items

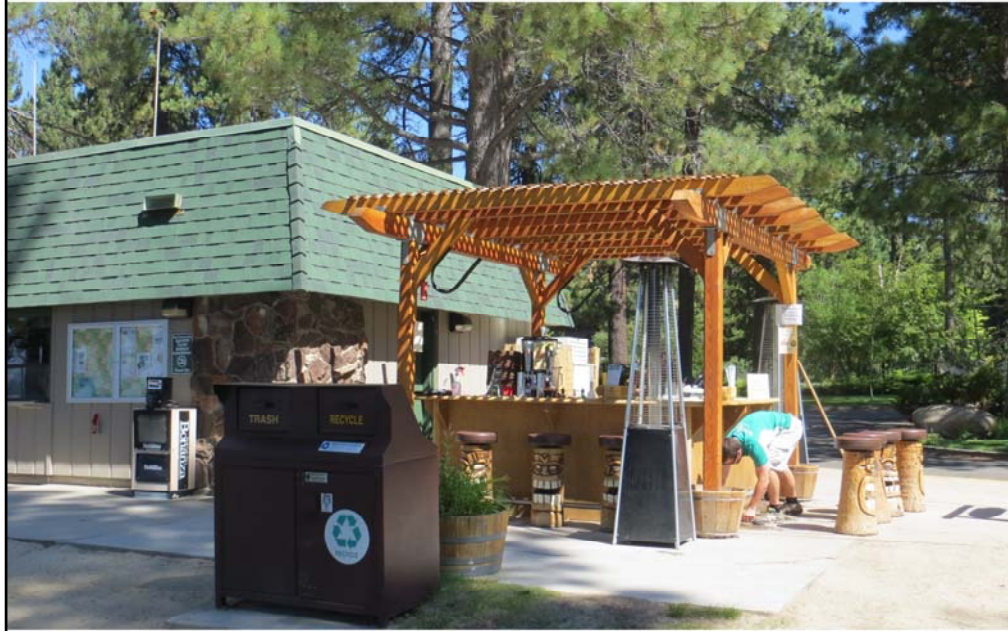
Buildings and Structures: Bar Concessions

- Current bar location is limited because it relies on the power, water and storage from the adjacent snack bar.
- Makes good sense to have the food and beverage services adjacent to one another because of their compatible service requirements
- In addition to dedicated utilities and storage space, future designs for the bar could be better oriented to capture views towards the lake.

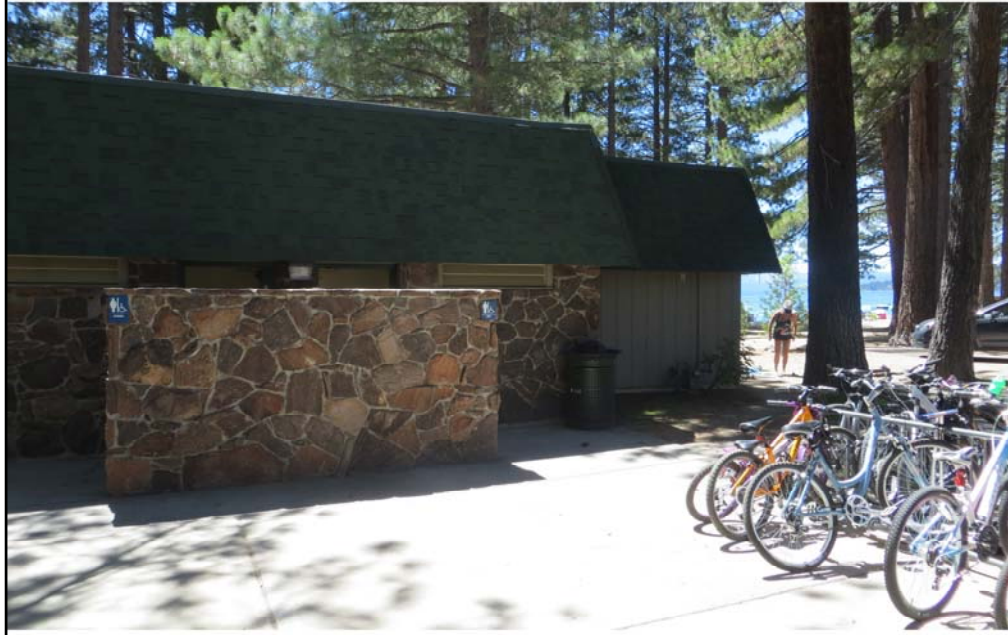
Buildings and Structures: Incline Beach restroom facilities

- Building Constructed in the 70s and Restrooms were remodeled in the 90s.
- The restrooms are well located on the site to service the entire beach from a central location
- Contemporary public restroom design has evolved away from the current shared layout to include individual or family style facilities for both safety and maintenance reasons.

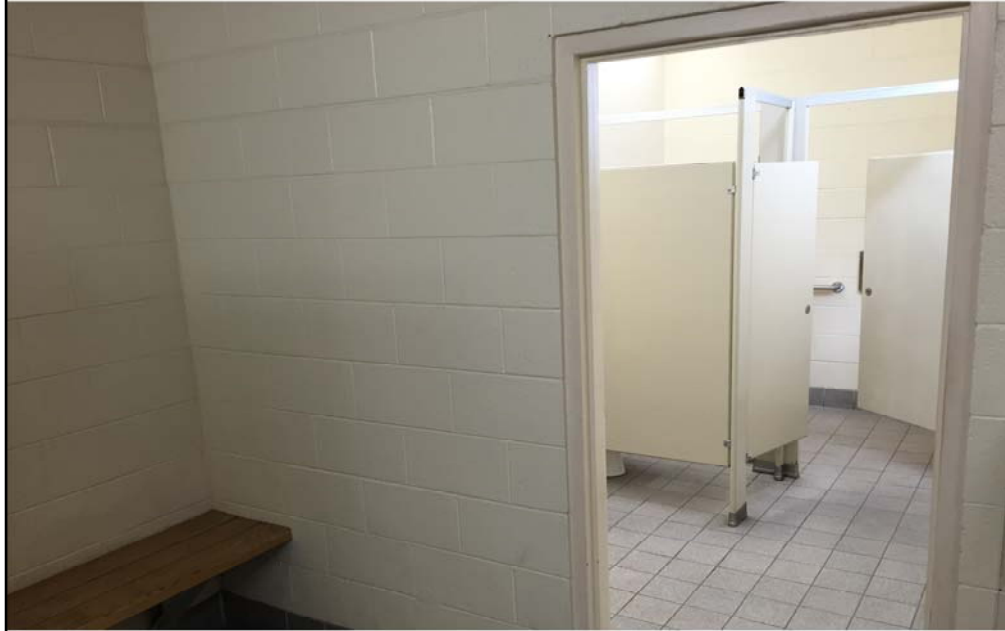
Buildings and Structures: Incline Beach restroom facilities

- Based on current standards, the facilities provide an insufficient number of restroom fixtures and offer an uninviting experience.
- Using the current standards based on the “average daily use during peak periods of use” you might expect to have between 12-14 restroom stalls at Incline Beach vs. the 8 fixtures that currently exist.
- Restroom figures exclude the 4th of July visitation from the calculation so that the numbers are not skewed.

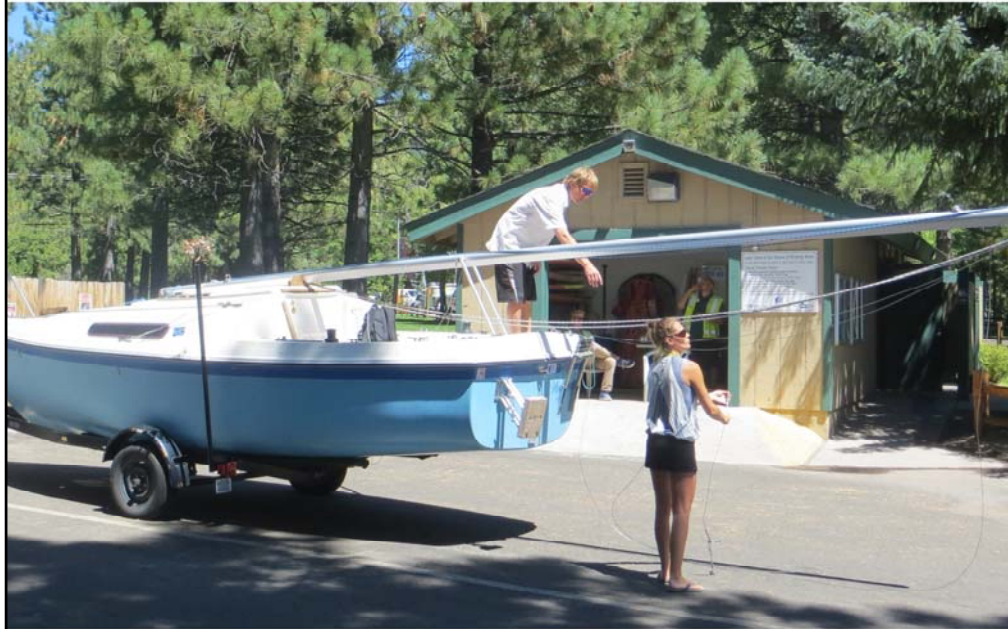
Buildings and Structures: Ski Beach restroom and storage facilities

- Conveniently located adjacent to the boat launch the Ski Beach restroom provides a combined storage/bathroom facility.
- The building is presently being replaced with a new facility with heated stalls so that the facility can be open to guests year-round.
- New facility to have 4 restroom stalls which is consistent with current standards.

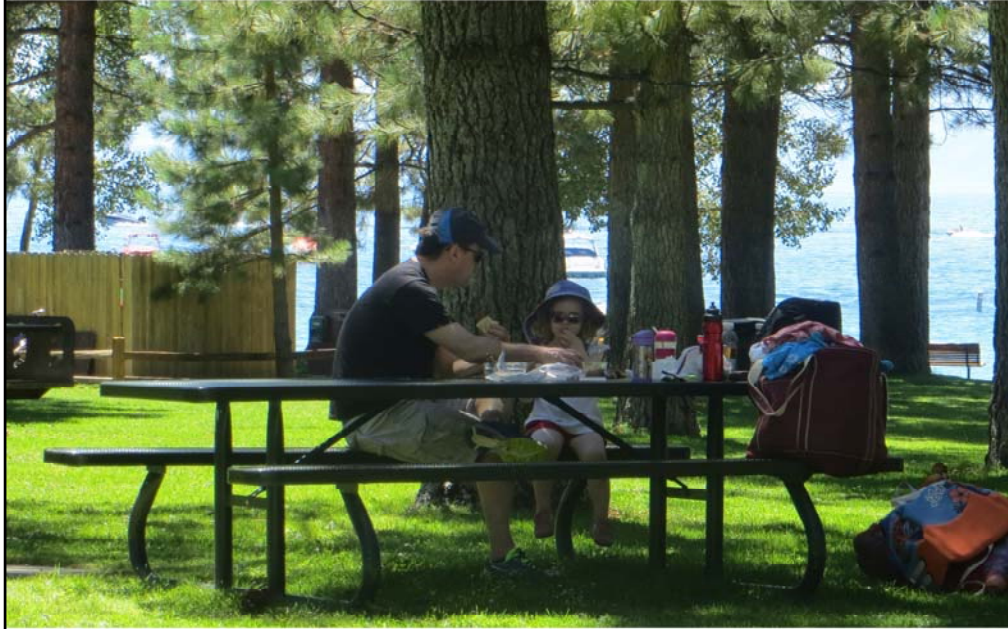
Recreation Areas: Group and individual picnic areas

- Recreation amenities have been dispersed to provide a range of experiences, some in the sun, others in the shade. Some for large groups, others for families.
- Picnic tables and grills are in good condition.

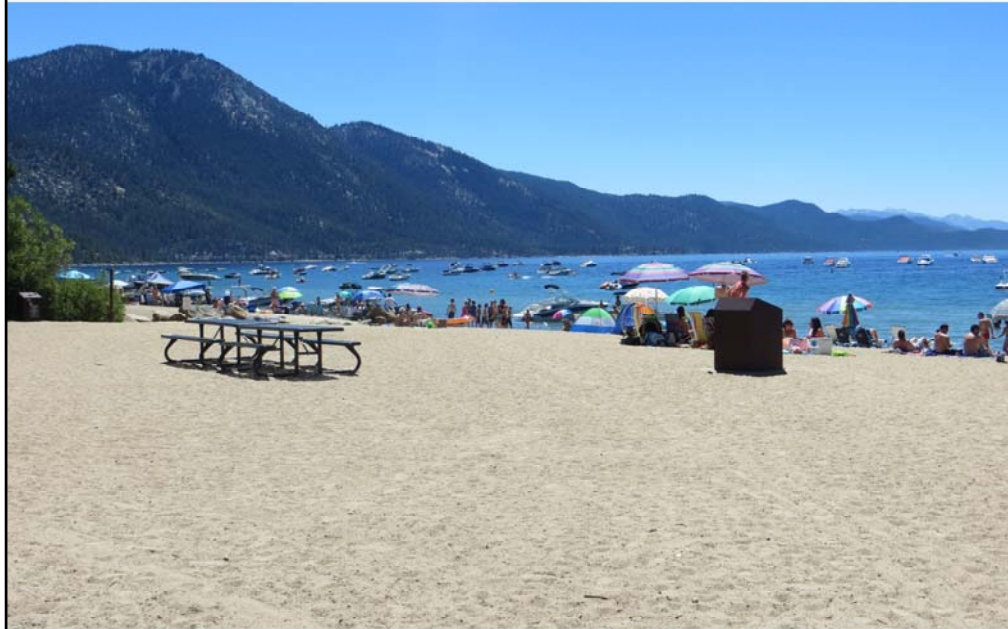
Recreation Areas: Beach zones managed to accommodate a variety of uses

- Incline Beach, Ski Beach and Hermit Beach are each managed differently to accommodate a variety of users.
- Incline Beach offers over 600 linear feet of beach frontage and a protected swim zone.
- Ski Beach allows motor boats to utilize the beach for loading, unloading, and relaxing.
- Hermit Beach offers guests a launch zone for non-motorized watercraft.
- The division of use is clearly delineated by the creeks that bisect the property.
- One area where the beach zone could be improved is through the placement of trash receptacles.
- Although conveniently placed, the trash receptacles location could be improved on the beach as they detract from the scenic quality and create an undesirable zone for beach use.

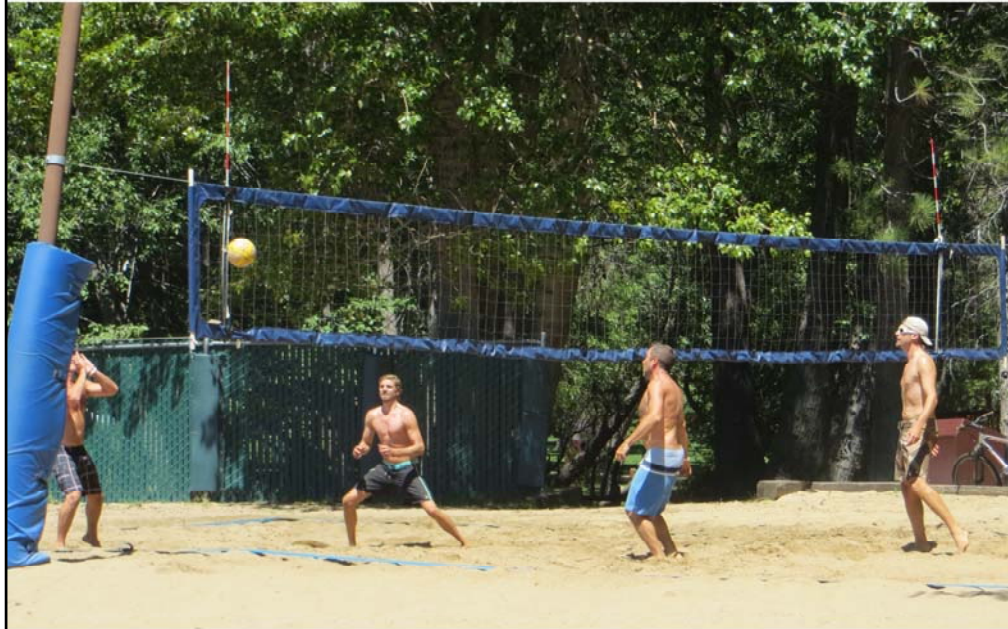
Recreation Areas: Volleyball and active recreation

- On a typical weekend day the volleyball courts are used for competitive games.
- The beach area is a good location for volleyball and active recreation
- Noise from the lake and boats reinforces why active recreation within the beach zone is appropriately located.

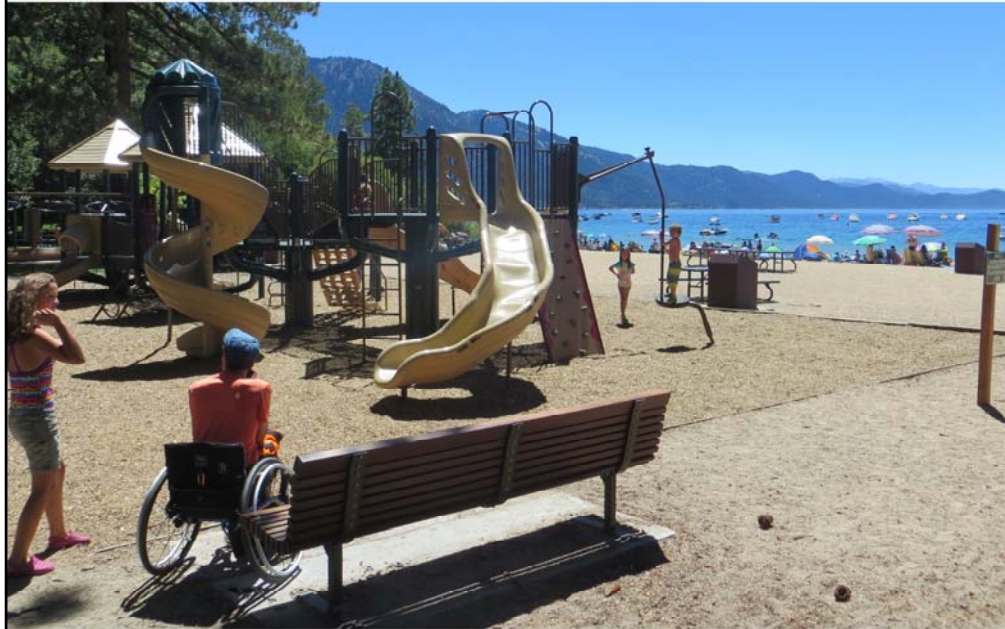
Recreation Areas: Playground

- The playground is located within close proximity to both the restrooms and the beach making it convenient for families.
- Kids love the playground.
- The number and placement of benches around the playground provide popular seating locations for parents and families while watching their kids
- Future improvements to the playground might include enhancements of the accessible route of travel and installation of fully accessible play features.

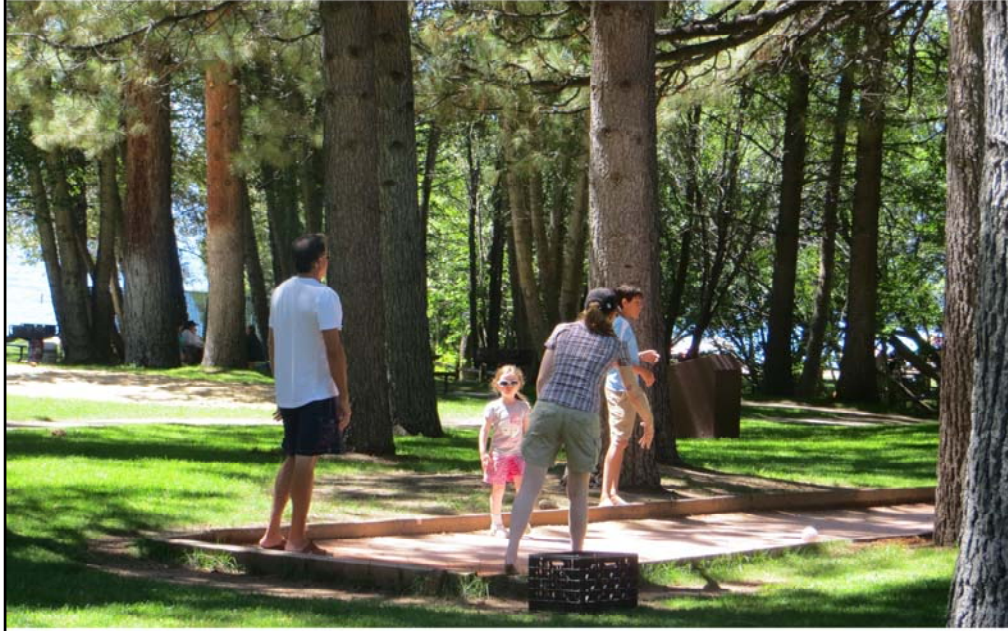
Recreation Areas: Quiet games located in the forest

- Quieter forms of recreation and relaxation are situated away from the beach to take advantage of the shade and secluded atmosphere.
- Massage tent is another example of a use that benefits from being located away from the highest intensity areas.

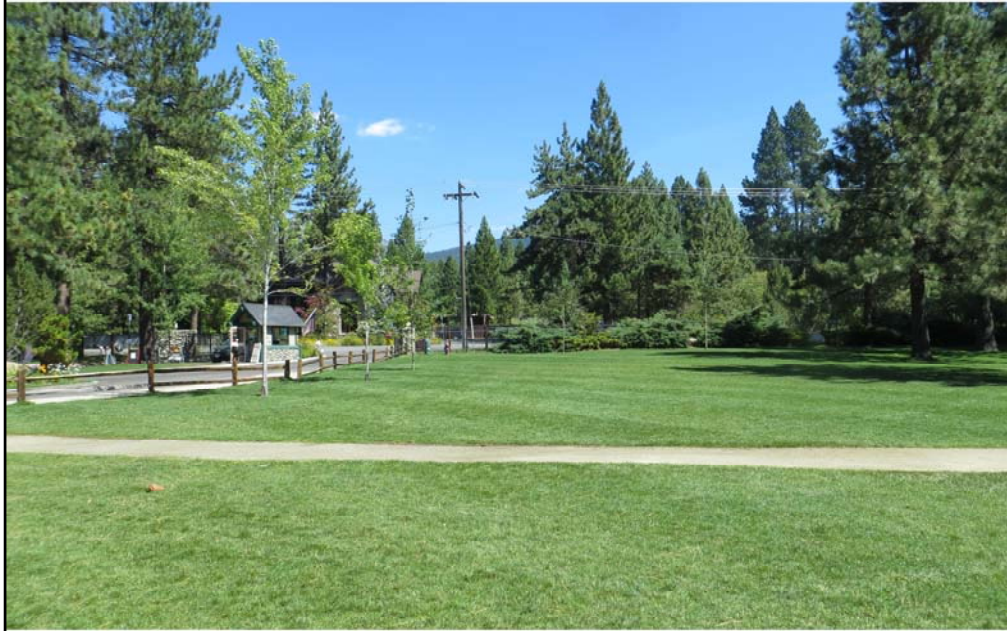
Recreation Areas: Flexible lawn space

- Turf space at the entry to Incline Beach, is used for lawn games and overflow during heavy visitation.
- Ideally located to accommodate temporary events and activities because of its highly visible location.
- From an experiential standpoint it is nice that the lawn area is open, it allows the site to breath and feel large even on days with heavy visitation.

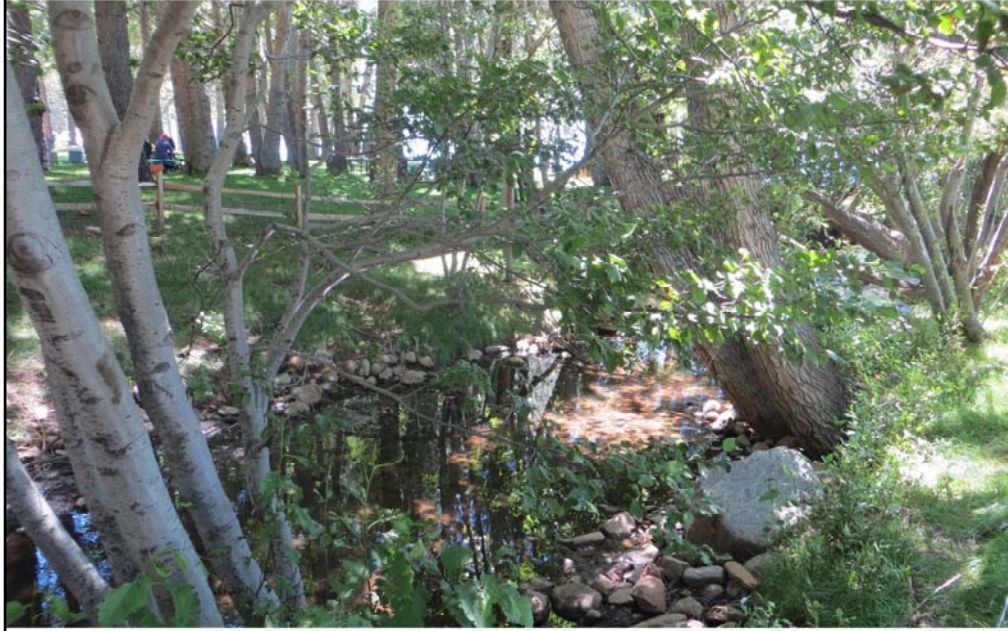
Undeveloped Areas: Creek corridors

- The remaining areas of Incline Beach and Ski Beach can be collectively grouped together as undeveloped or unprogrammed space.
- Creek areas provide natural green space and enhance the setting
- Help to separate the various activity areas and diversify the experiences available at the beach.

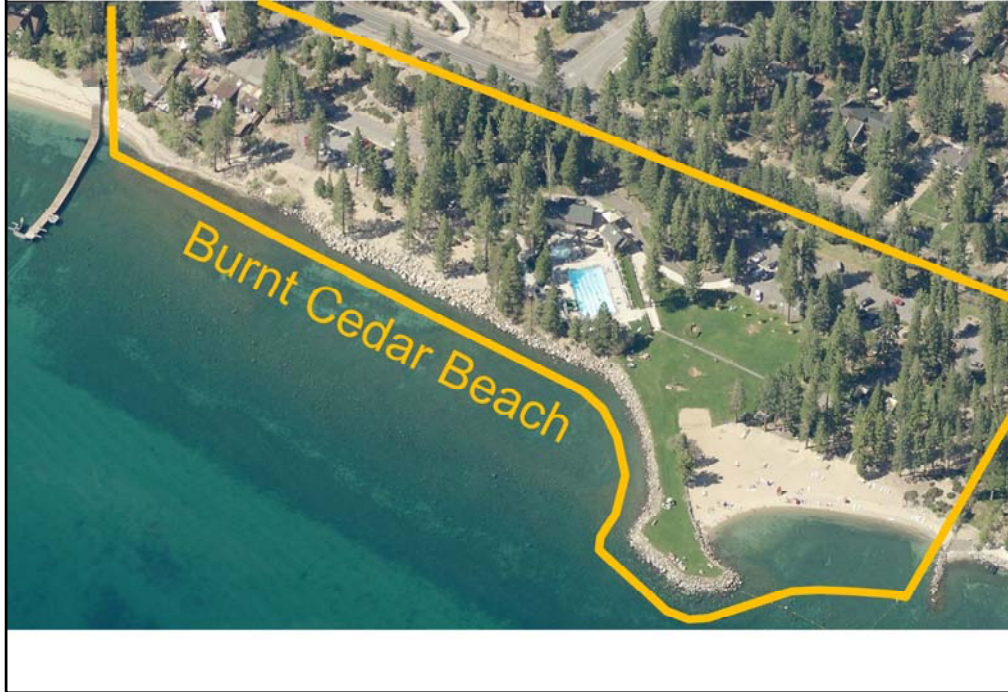
- Burnt Cedar Beach is comprised of approximately 10 acres
- Portion of the area is dedicated to the IVGID water system infrastructure.
- The beach is surrounded entirely by residential uses
- Unlike at Incline and Ski beach where a sandy shoreline extends for the entire length of the lake, Burnt Cedar's beach is limited to a much smaller area protected by the jetty.
- The protected nature and shallow waters make it an ideal spot for kids.
- Besides the lake, the primary attraction at Burnt Cedar Beach is the pool complex.
- Similar to the analysis for Incline Beach and Burnt Cedar Beach, the primary uses can be lumped together in four distinct categories.
 1. Entry/Circulation/Parking
 2. Buildings and Structures
 3. Recreation Areas
 4. Undeveloped Areas

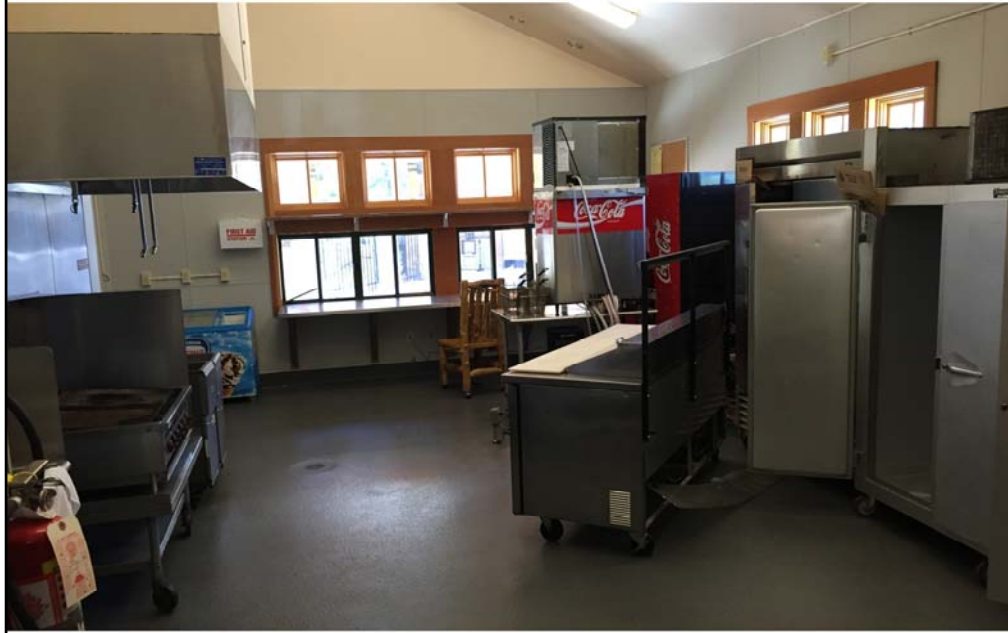
Buildings and Structures: Food Concessions

- The kitchen layout is both inefficient and outdated.
- Too many items line the perimeter walls with the middle left wide open.
- Cold and dry storage is a bare minimum and not optimally laid out for either delivery or food preparation.
- An efficiently design “back-of-house” could significantly improve service.
- High volume of the kitchen is going to waste and with a modest expansion it could provide the room required for a modern scramble food service design.

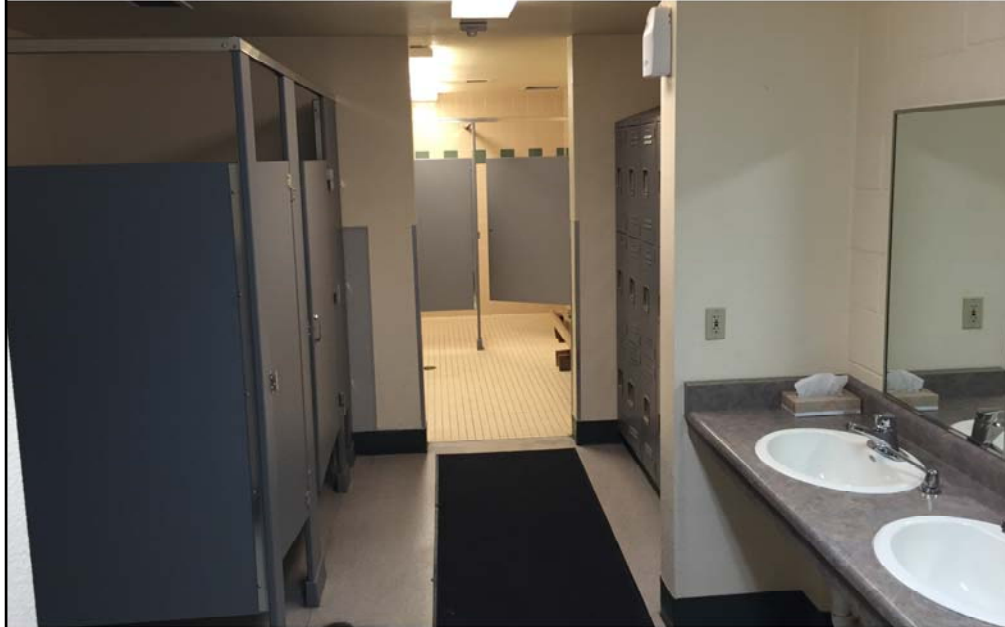
Buildings and Structures: Lockers, showers and restrooms

- The facility's locker, shower and restroom facilities are laid out in a linear, shotgun fashion intermingling clean, wet, dry and dirty areas.
- It also appears the shower and locker space is underutilized, particularly as there is an available outdoor shower.

- In the current Burnt Cedar configuration, guests who simply want to change must walk through the "dirty" restroom area and into the "wet" shower area.

- The lockers and changing areas are also directly adjacent to the shower which creates the potential of tracking water throughout the entire facility.

- Contemporary facilities that are predominately designed for resort style use vs. recreation uses, typically are designed to separate clean, dirty, wet, and dry areas.

- Dry locker areas should be easy to access but somewhat private so guests do not feel exposed while changing.
- It is ideal to have a locker room layout where the wet and dry vanities, as well as the showers are in a central location so the travel from wet to dry areas is somewhat close.

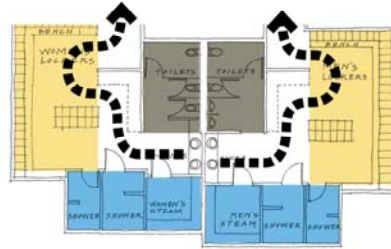
- Wet (showers)
- Dry (changing areas)
- Dirty (toilets/lavatories)

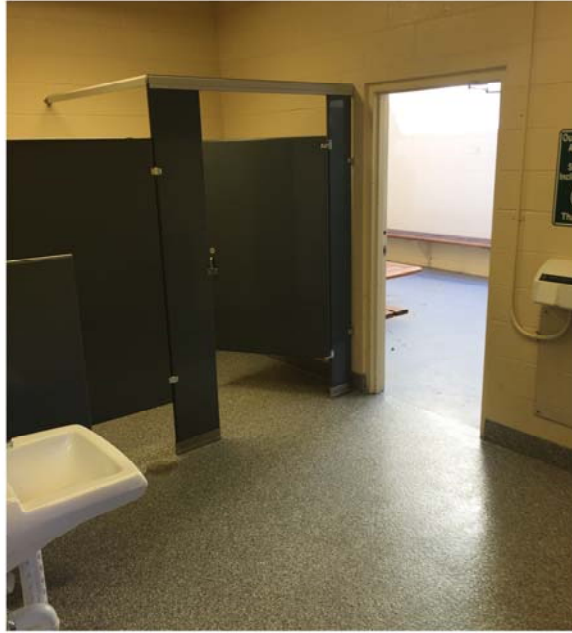
Buildings and Structures: Remote restrooms

- At about 1250 square feet, the building is also quite small, particularly given the number of uses within (restrooms = 440 sqft changing area = 440 sqft, and storage = 370 sqft)

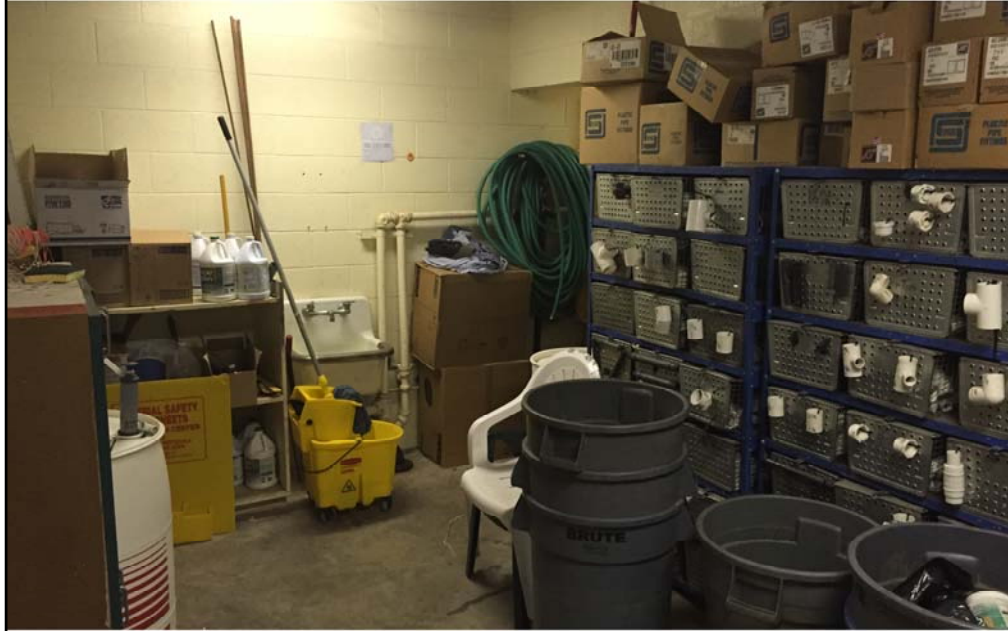
Buildings and Structures: Remote restrooms

- Space presently allocated to storage, while necessary for operations, is in a location that is better suited for potential additional concessionaire space.

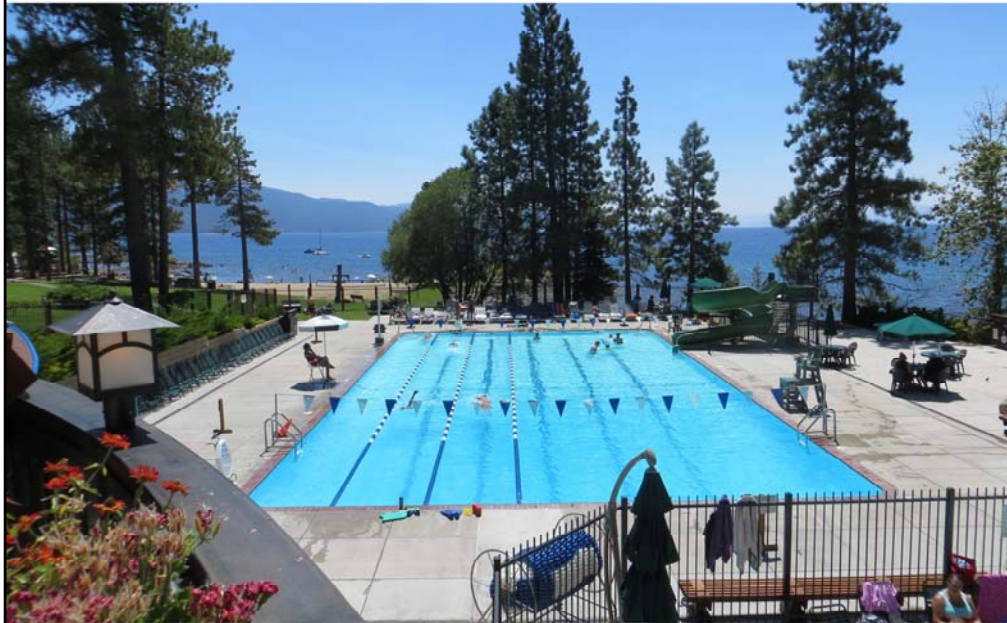
Recreation Areas: Pool

- The pool is the defining characteristic of Burnt Cedar offering guests the opportunity to swim and sunbathe at the beach without actually needing to go into Lake Tahoe.

- Pool dates to the 1960s and the mechanical design dates to the early 1980s with limited equipment upgrades/replacement over time.
- Pool/mechanical enhancements were not a component of the 1999 Pool House replacement project.

- Dated mechanical design lead to closures during periods of peak use due to cloudy water from sunscreen use.
- Improvements in pool chemical technology has helped mitigate some of the water visibility issues.

- The design, again dating to the 1960s, is arranged with the adult lap swimmer in mind with the exception of the recently added waterslide.
- Diving well/deep end is underutilized... too shallow to allow a diving board but too deep for casual swim.

- Because of that, the waterslide, which is enjoyed by many, impacts the use of the available shallow pool because the slide requires a roped off safety zone.

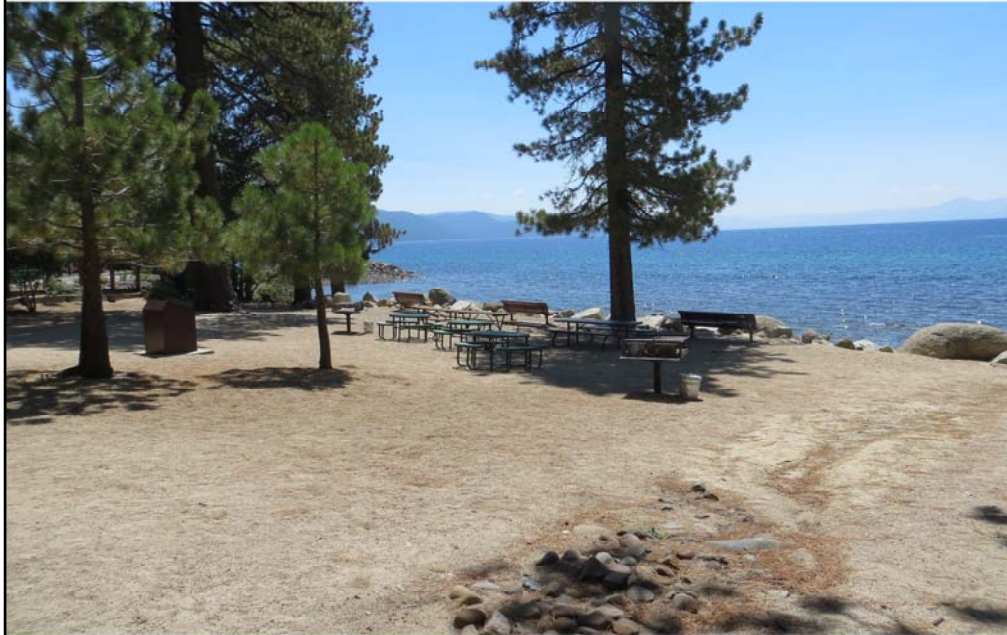
Recreation Areas: Group and individual picnic areas

- Picnic areas are distributed throughout the site with some attracting heavier use than others.
- The picnic sites closest to the beach on the east side of the pool seem to be the most popular.
- The sites on the west and the sites at the edge of the parking lot are the least popular.
- Landscape improvements may serve to help improve the experience for those picnicking in these areas.
- A greater connection to the rest of the site, while challenging, could enhance use.

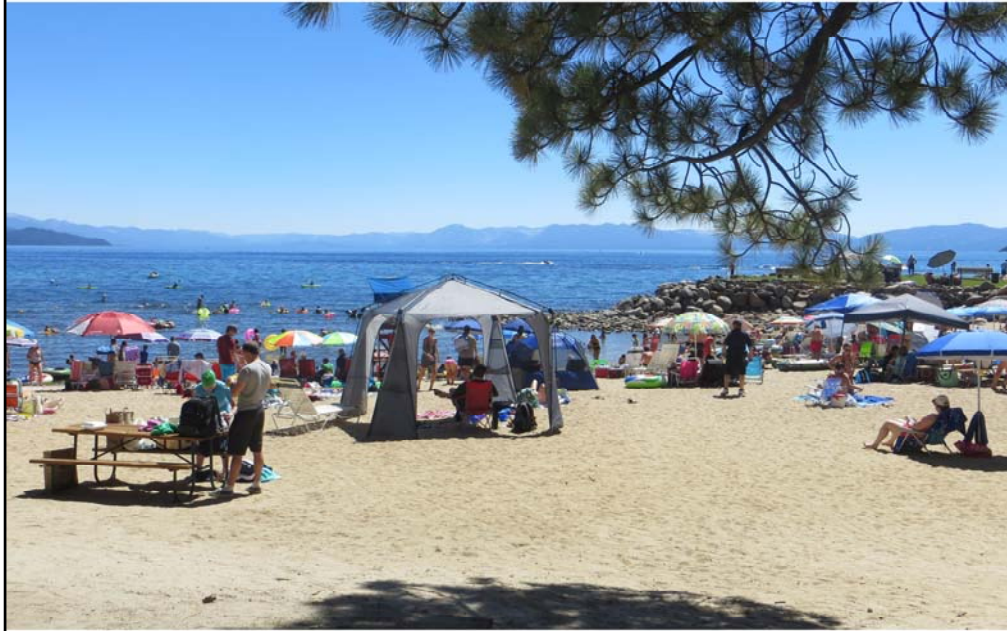
Recreation Areas: Beach zone

- Burnt Cedar is managed to allow for swimming.
- Beach is protected by the jetty, the waters are shallow, and visibility of the water from the beach is good which might be one of the reasons that Burnt Cedar is a popular beach for families and kids.

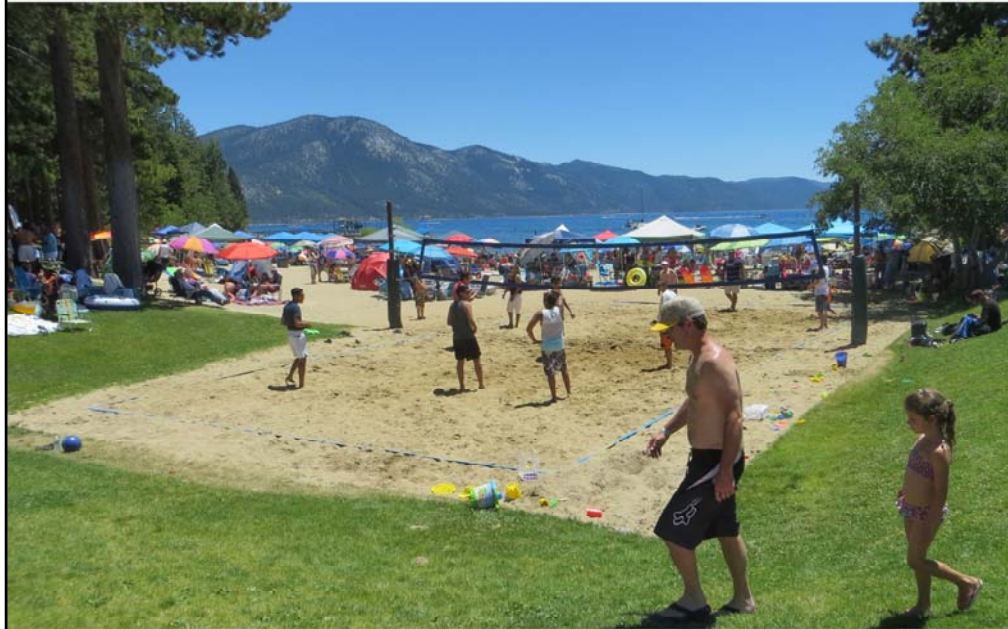
Recreation Areas: Volleyball

- Compared to the competitive volleyball courts at Ski Beach, the court at Burnt Cedar attracts families and groups interested in leisurely play.

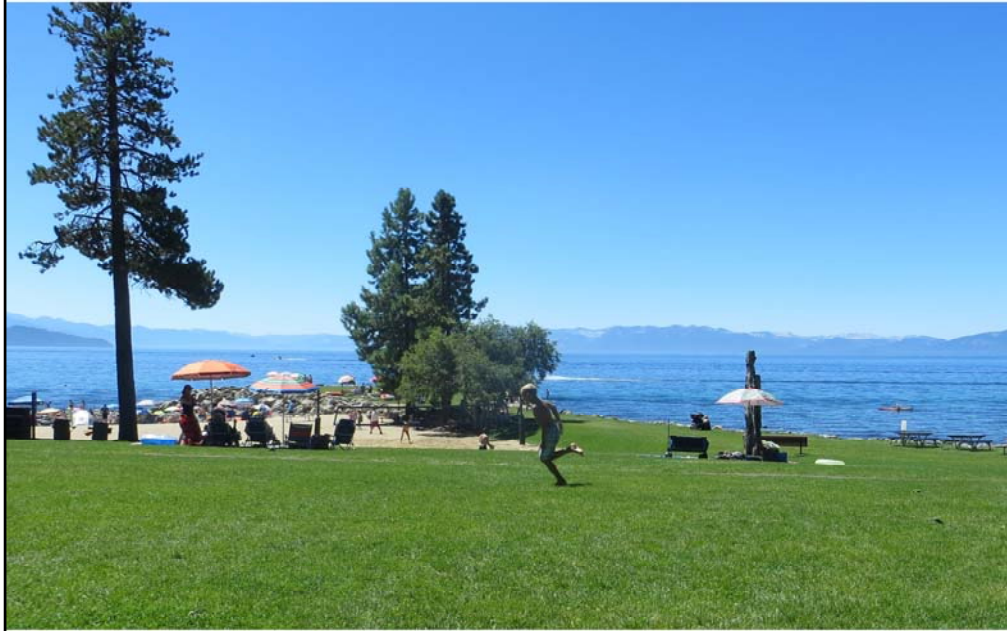
Recreation Areas: Flexible lawn space

- Despite its sloping nature, the large lawn area between the parking lot and the beach is popular for throwing the Frisbee and ball games.
- Because it is equidistance between the beach and the pool it seems to attract more spontaneous activity than the lawn area at Incline beach.

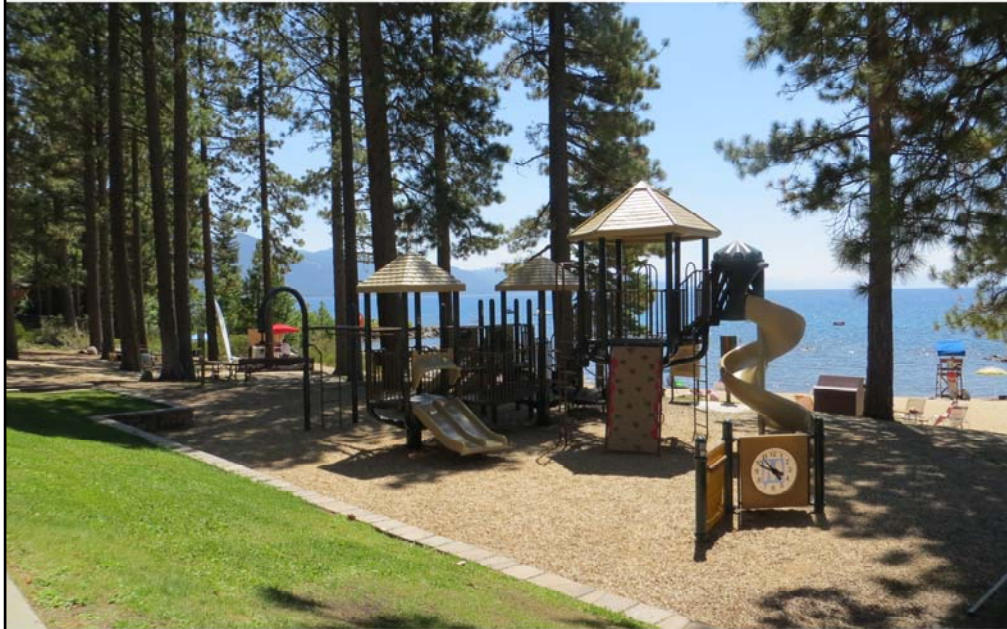
Recreation Areas: Playground

- Positioned on a terrace overlooking the beach
- Has the added benefit of a shady location and proximity to the restrooms.
- The experience for adults could be improved by providing additional seating opportunities that offer views of the lake and the play area.
- Despite Burnt Cedar having the family reputation, the playground is smaller than the one at Incline Beach.
