Incline Village Beaches Site Analysis

Incline Village Beaches Site Analysis – Existing Conditions

Existing Conditions Analysis-Incline and Ski Beach
(includes Hermit Beach)

Existing Conditions Analysis-Burnt Cedar Beach

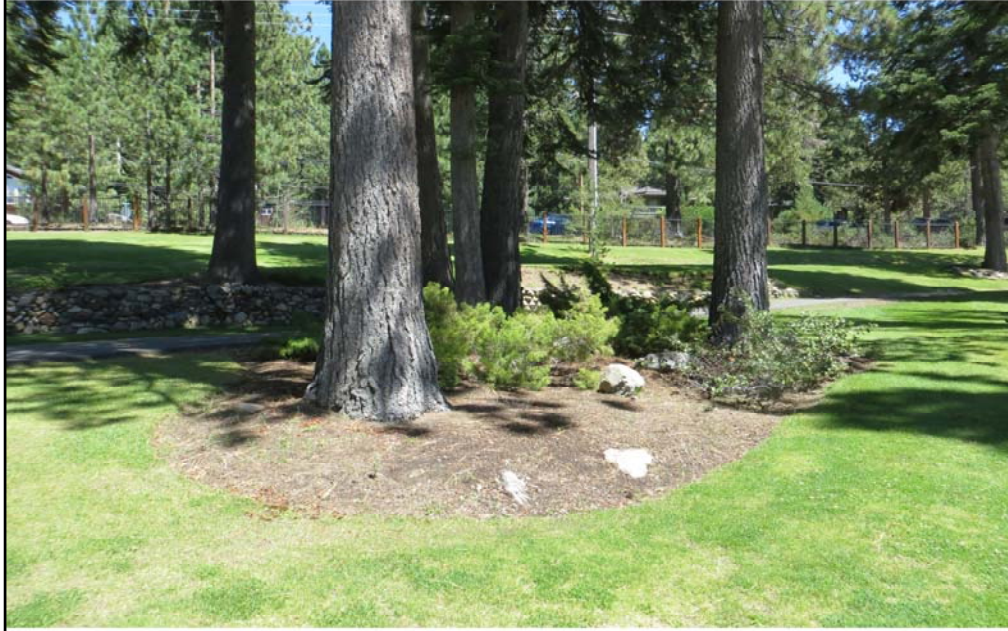
Undeveloped Areas: Landscape buffer

- One of the nicest aspects of the site is that the entire area has not been programmed with buildings or activities.
- Along the northern property boundary is a nicely landscaped buffer helps to screen the facility from the surrounding residential uses
- Maintaining and potentially enhancing this buffer to visually screen the parking lots is a good use for this space.
