**TWSA BOARD MEETING
PACKET
For 3/6/2019**

Aquatic Invasive Plant Control Pilot Project Final Monitoring Report Species (Tahoe RCD)	16-116
Scoping Notice for Lakewide AIS Controls (mechanical methods)	117-120
South Tahoe Area PCE - Reference Information	121-124
IVGID 2017 Public Works Sustainability Report	125-185

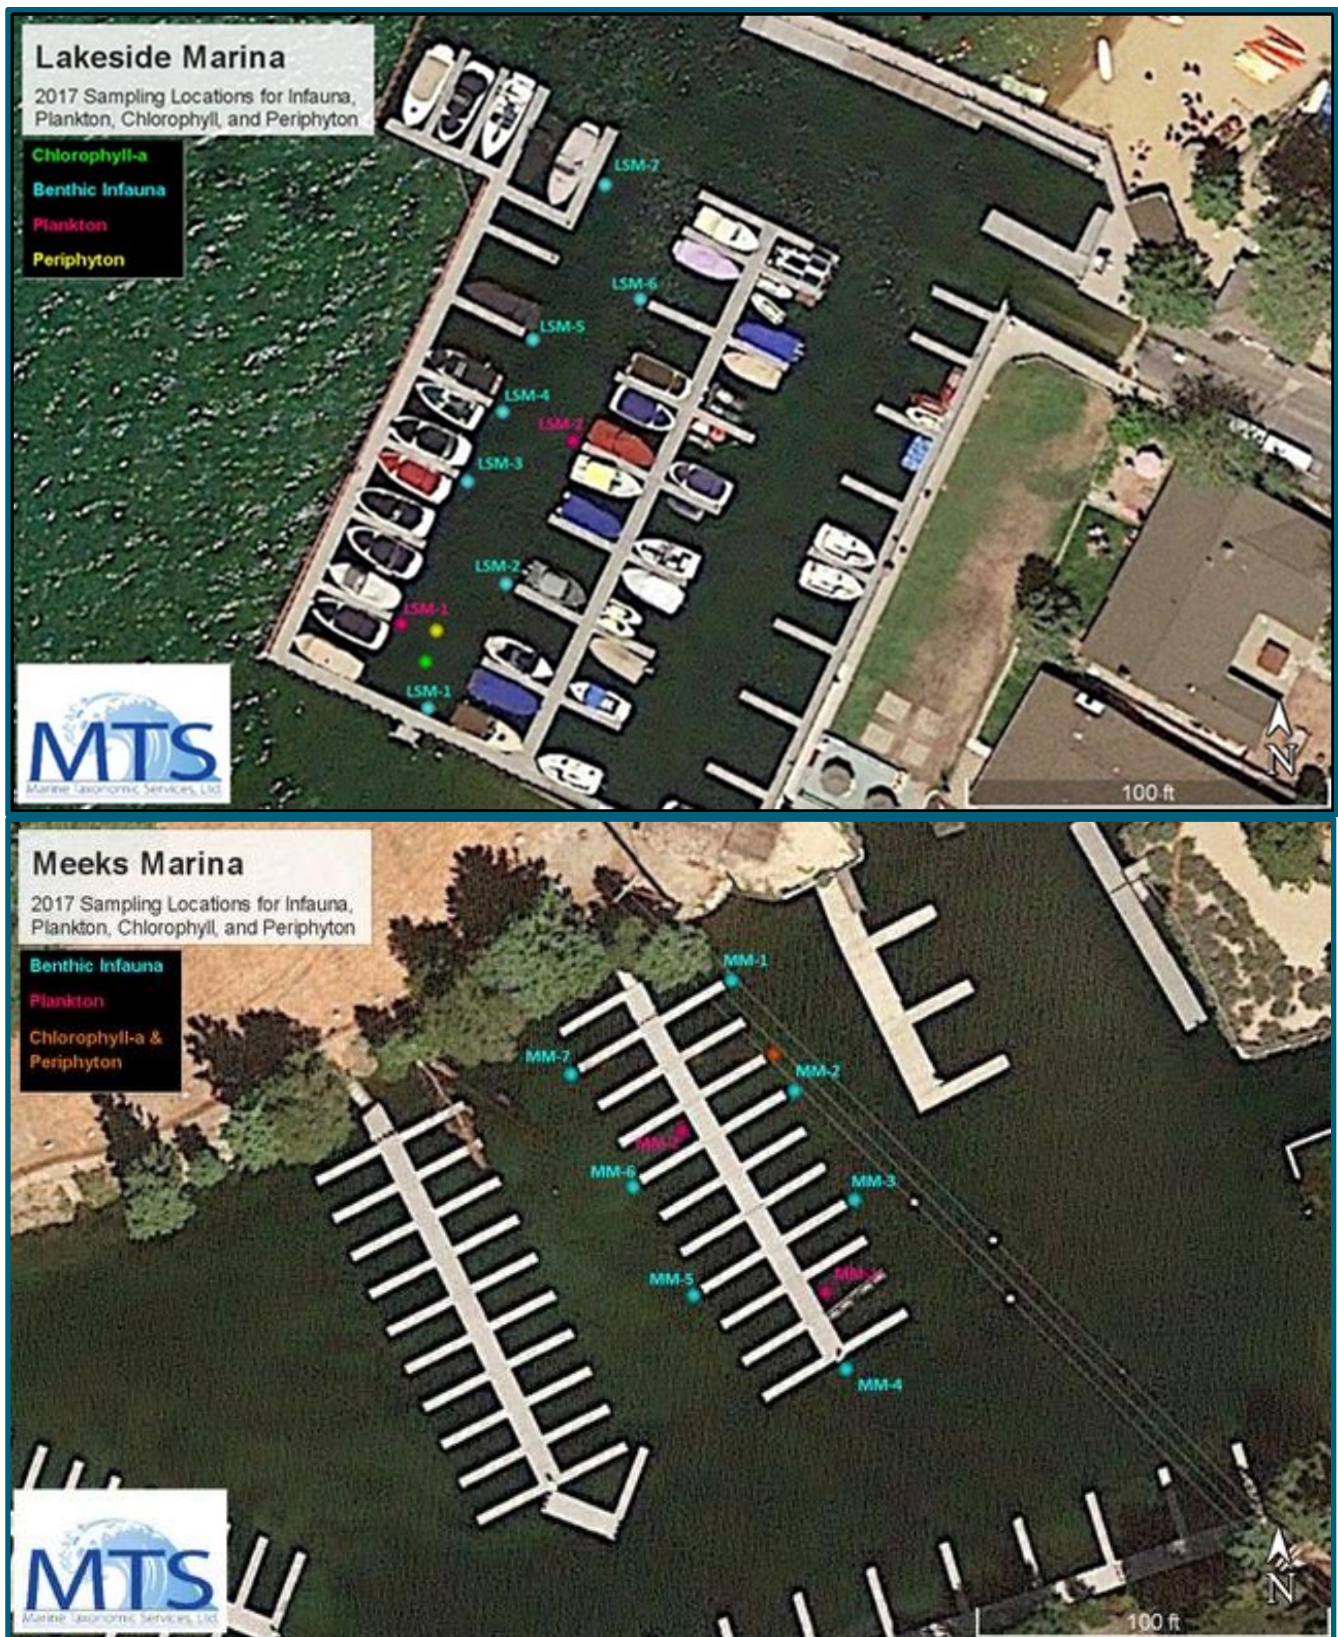
Figure 3. LSM (treatment site) and MM (control site) biomonitoring sample locations

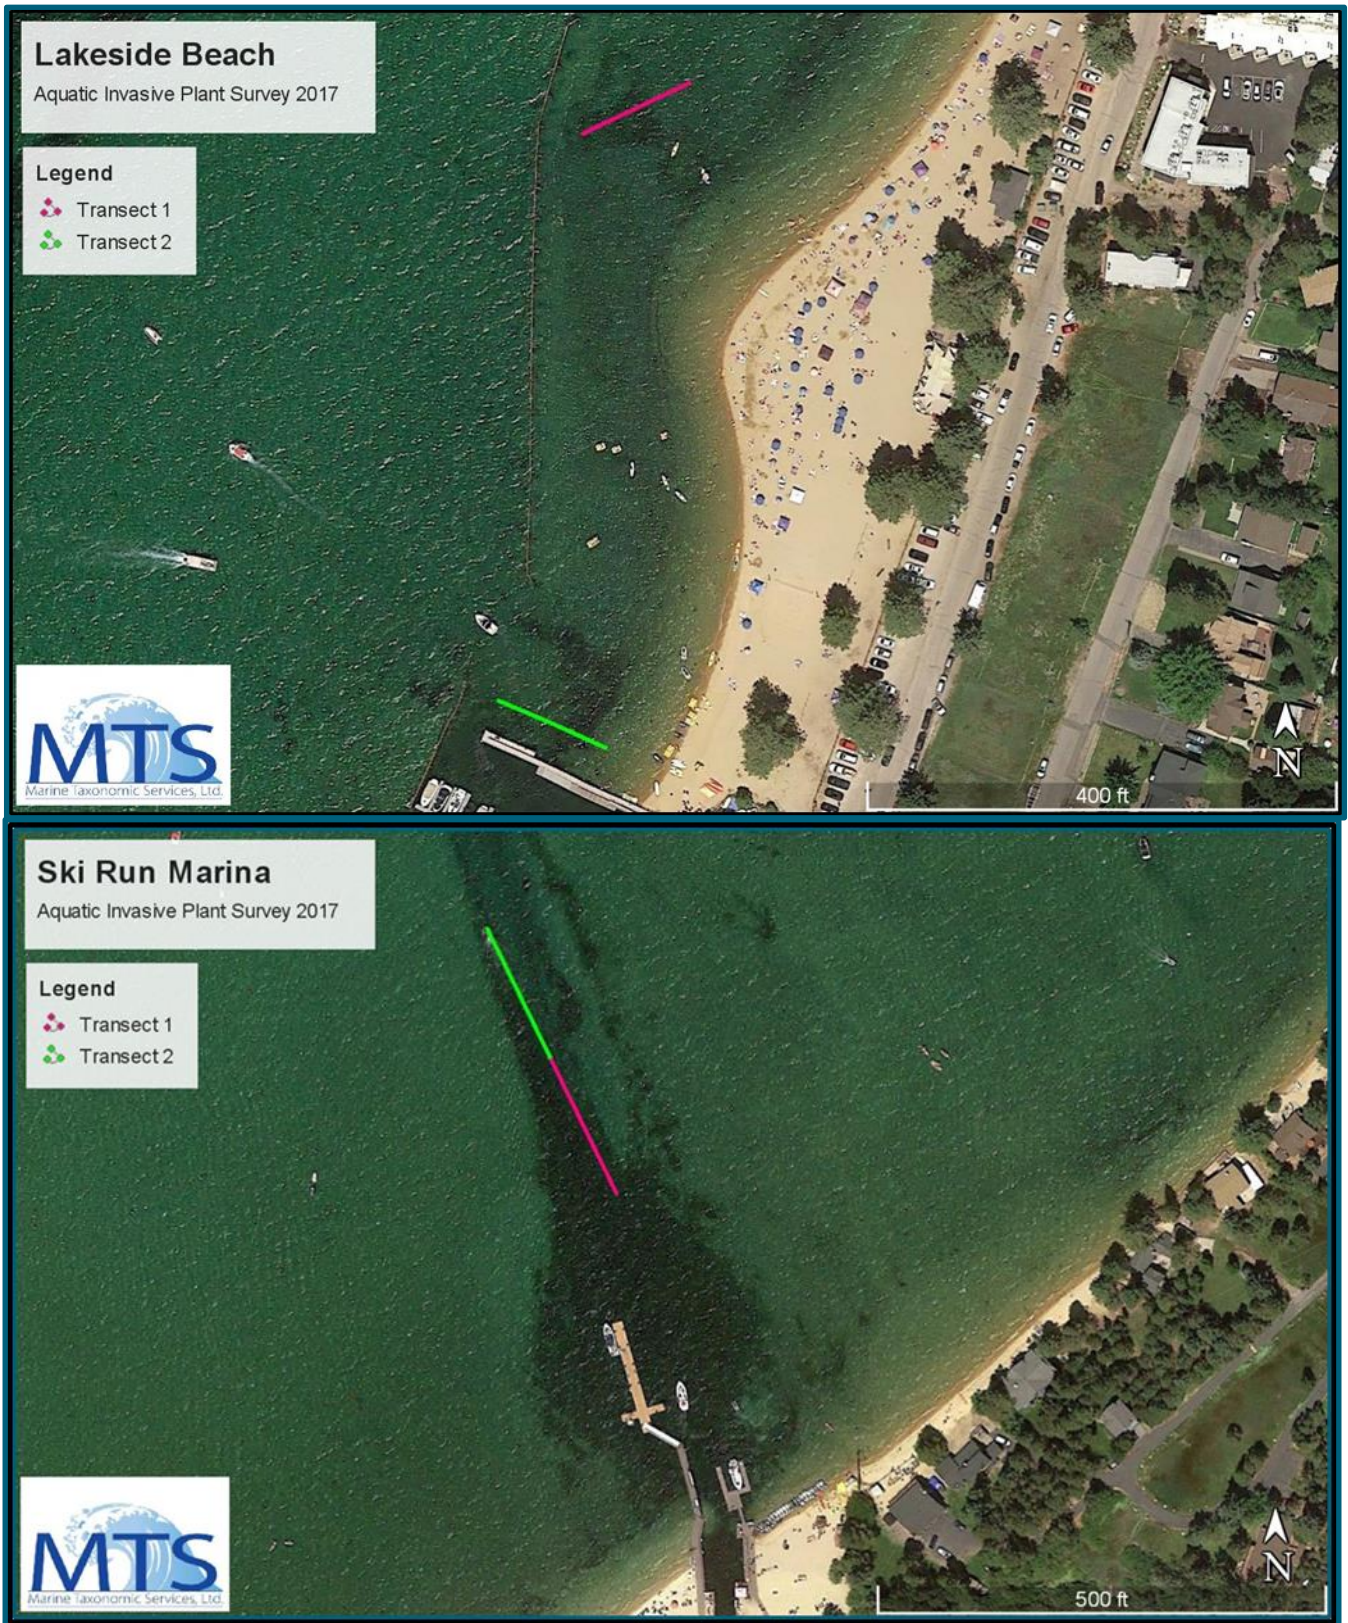
Figure 4. LSB (treatment site), the LSB-Taxi transect is green and the LSB-Swim transect is pink, and SR (control site) macrophyte transect locations

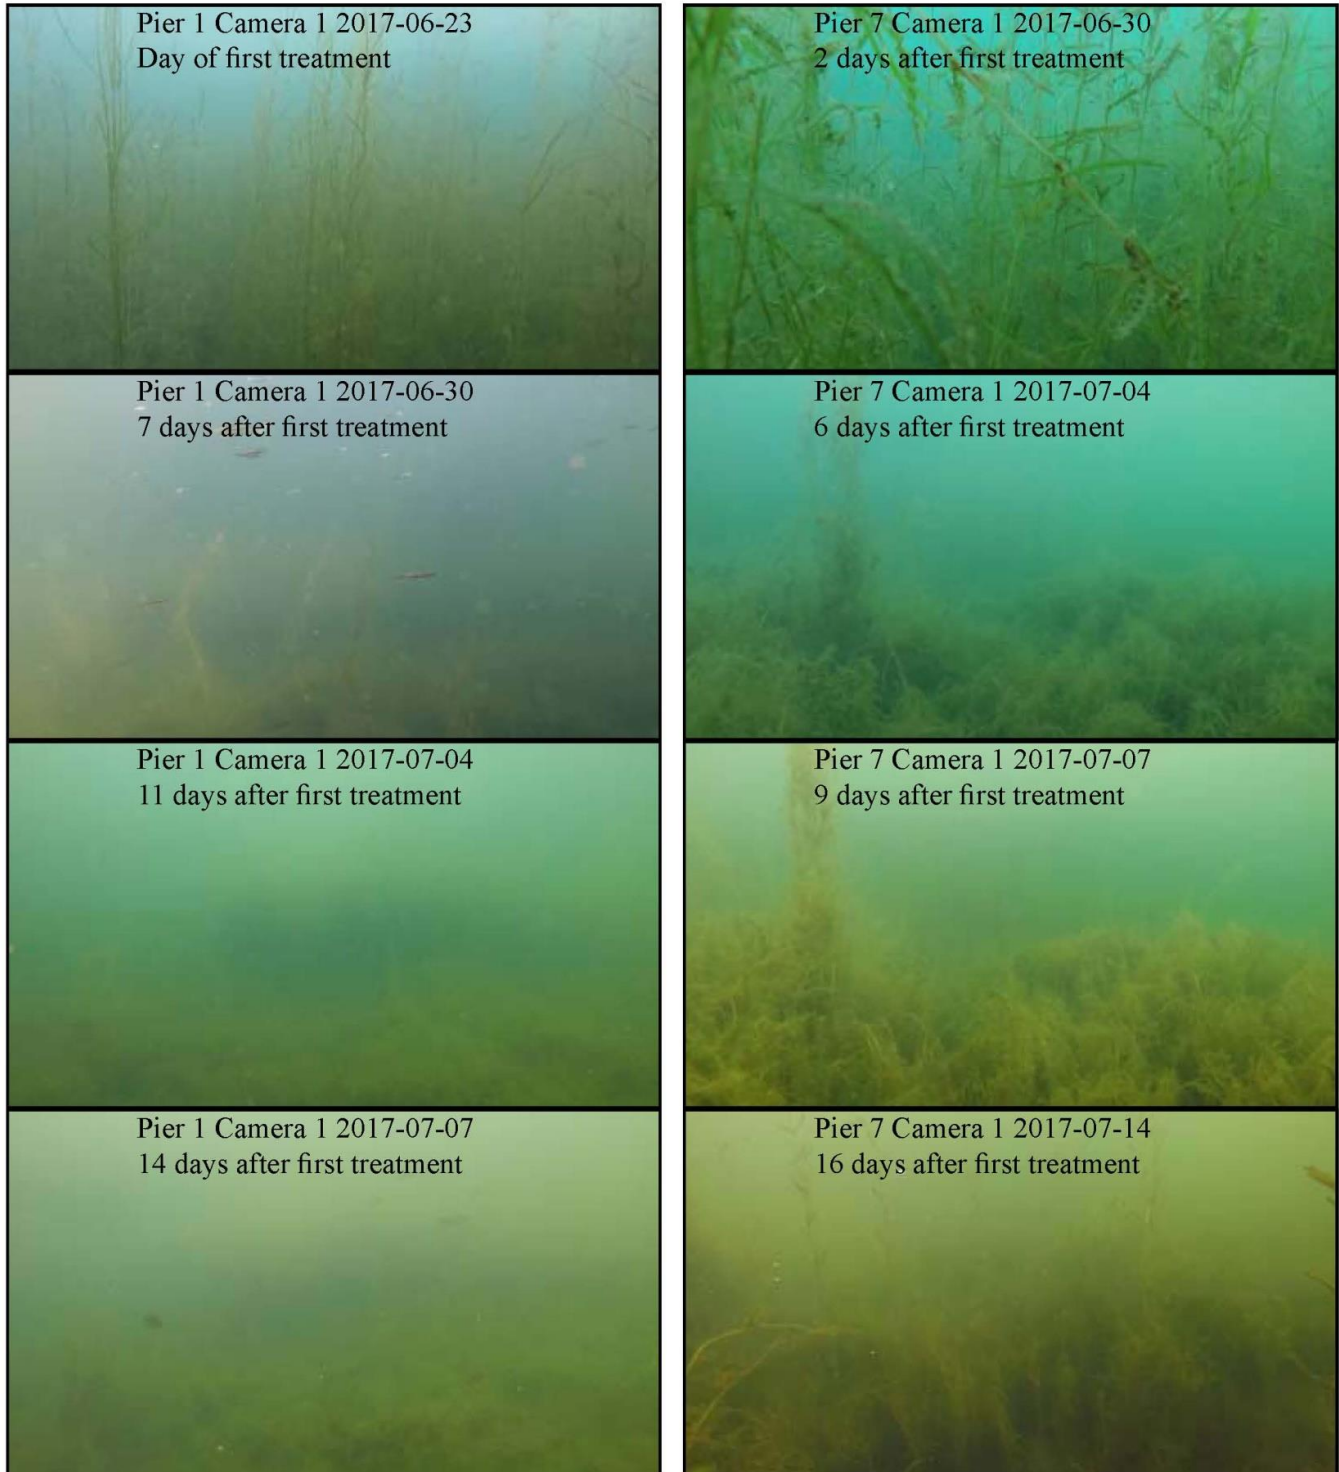
Photo 3. Photo documentation over a 16-day period following UV-C light treatment in the LSM, June 23, 2017 through July 14, 2017

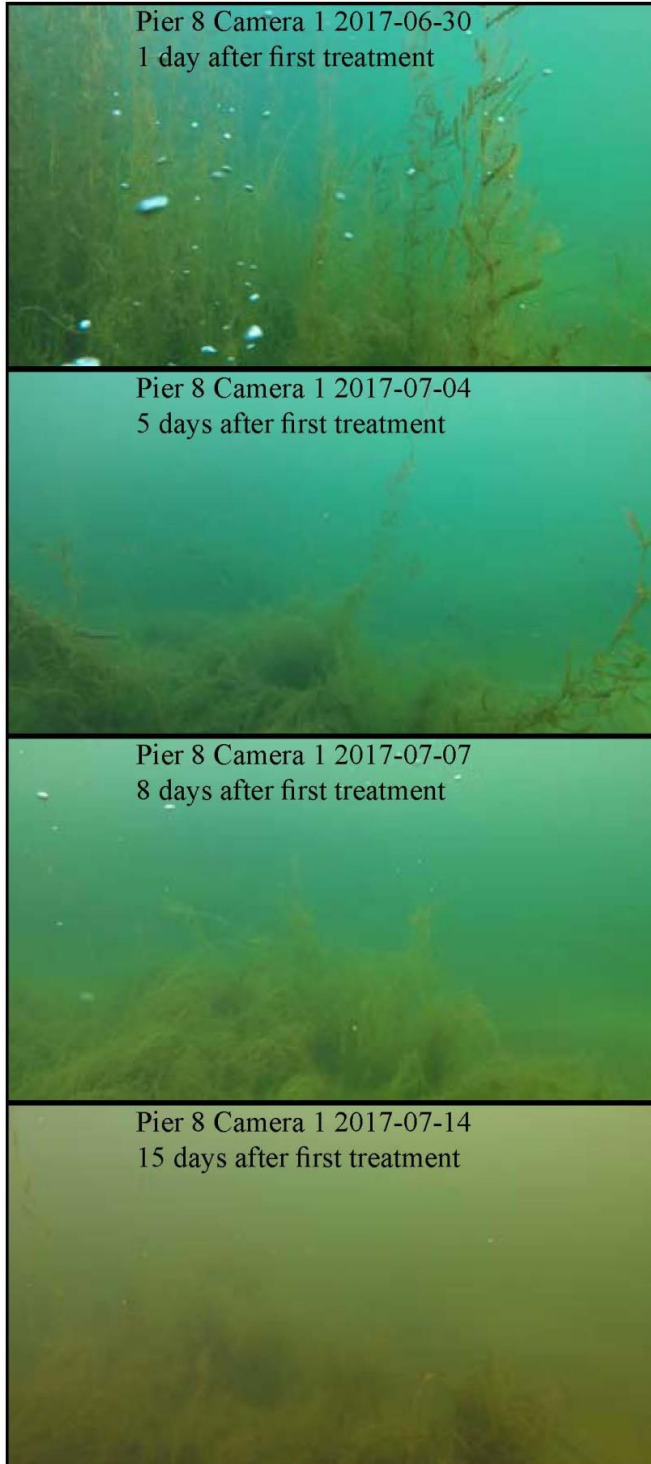
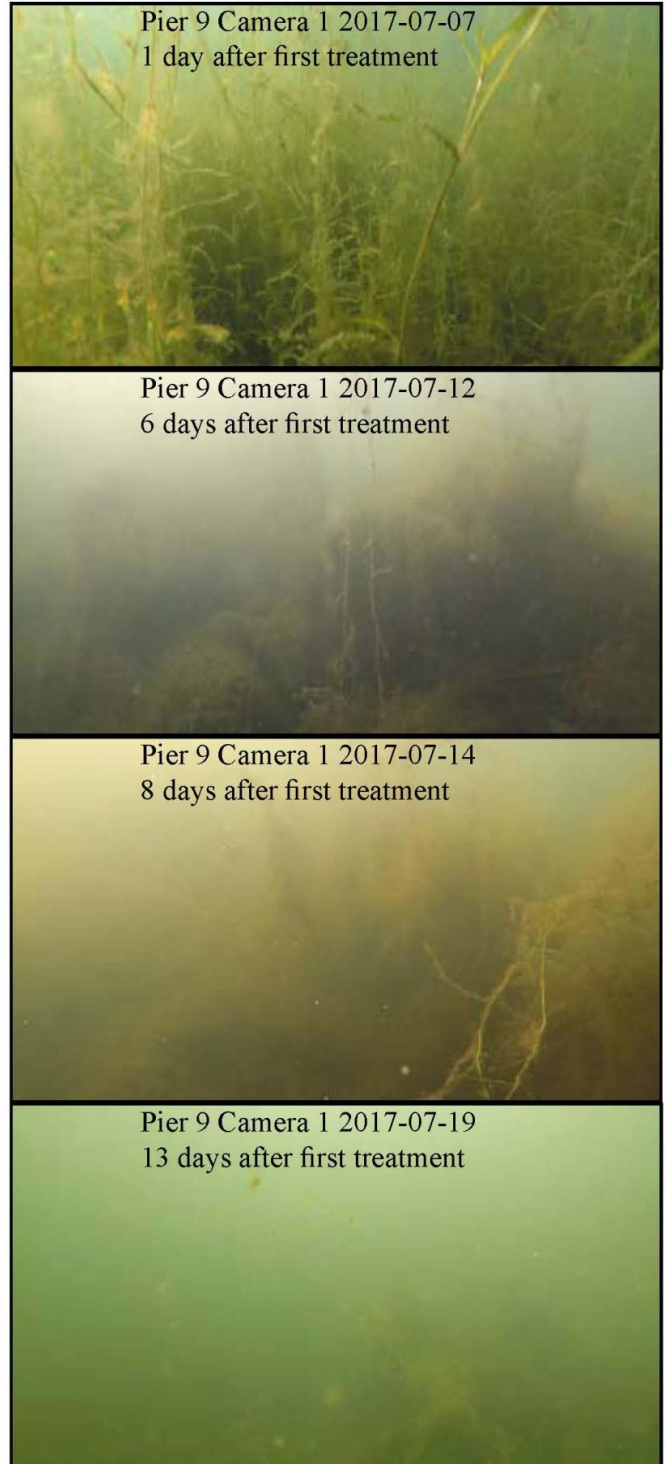
Photo 4. Photo documentation over a 16-day period following UV-C light treatment in the LSM, June 30, 2017 through July 19, 2017

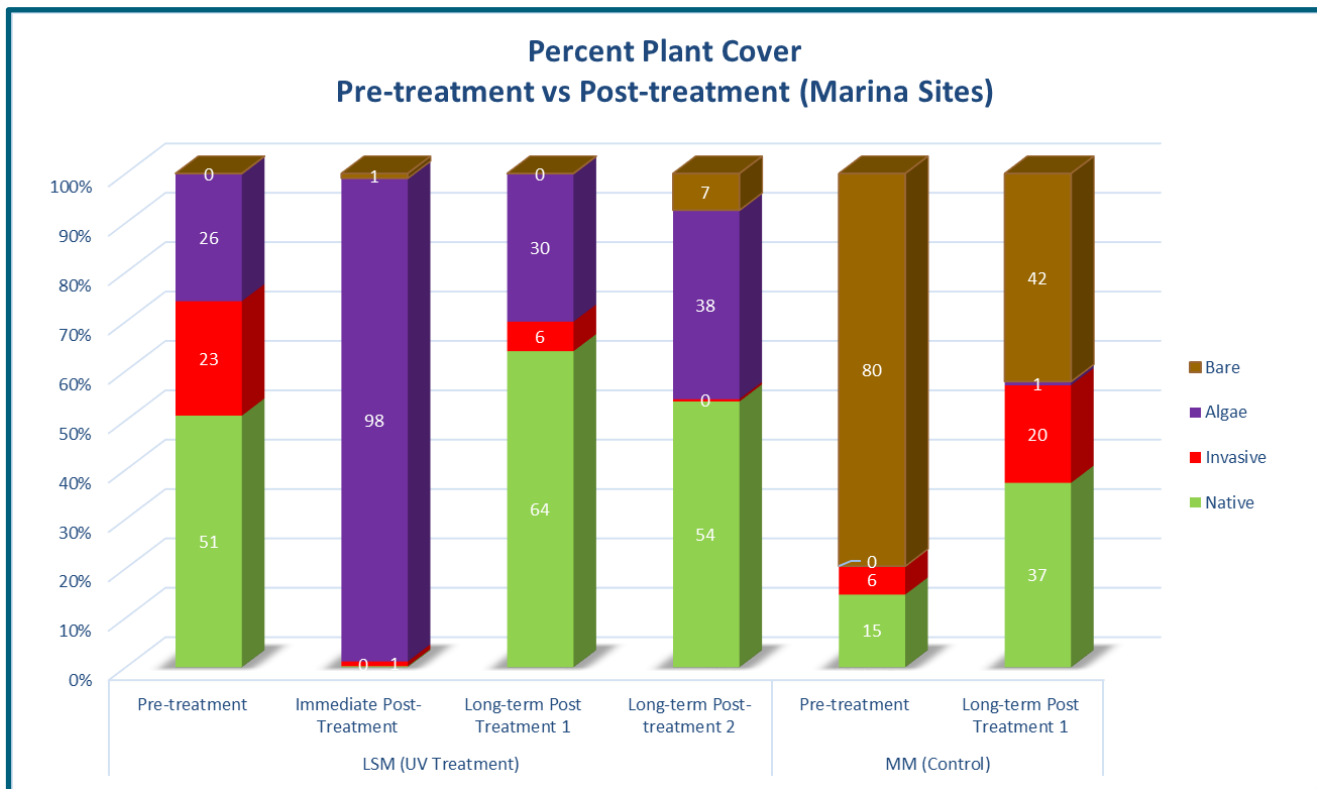
Considering the MM control site, little to no Algae cover was measured pre-treatment or post-treatment. In the absence of UV-C light treatment, percent cover by both Natives and Invasives at MM increased between 2017 and 2018 surveys.

Figure 10. Stacked composite bar graph presented percent plant cover measured at marina sites for comparison of pre-treatment to post-treatment conditions

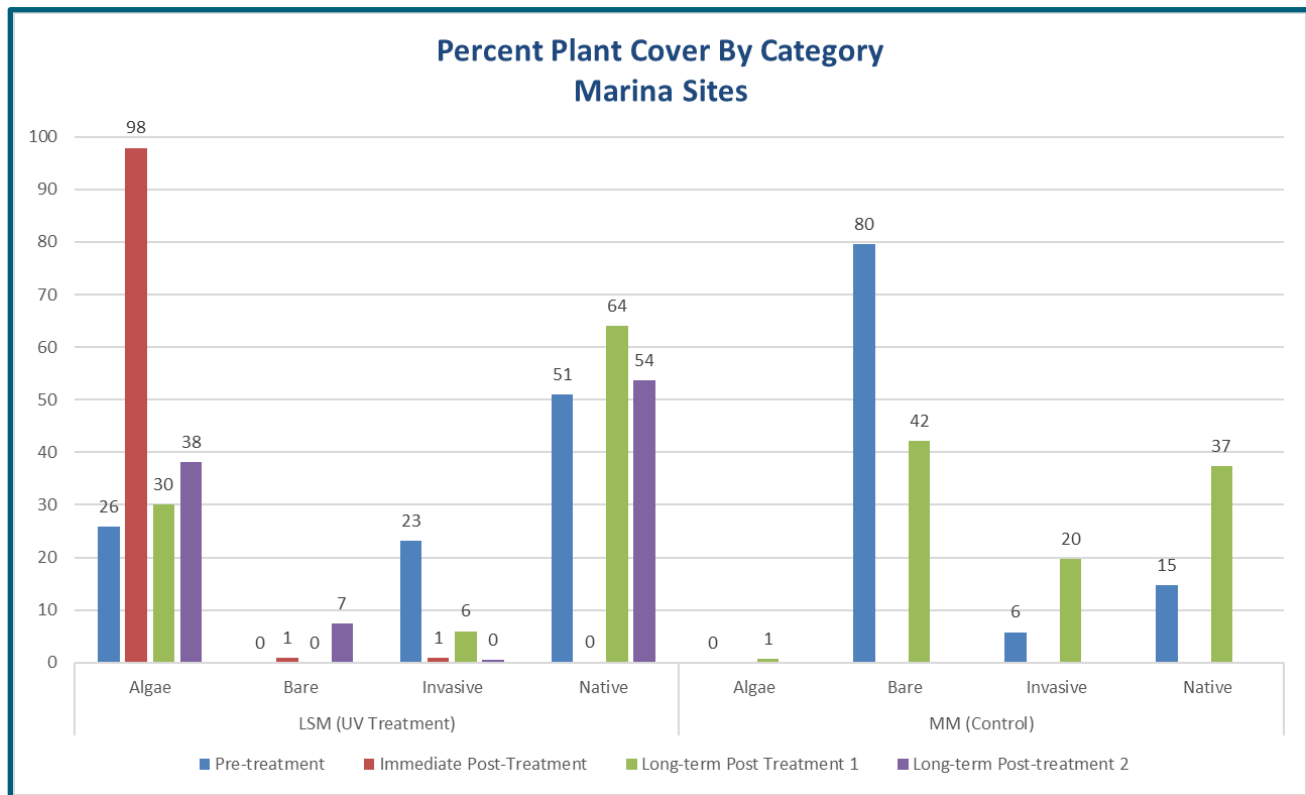
Figure 11 presents the same percent cover results for the marina sites by Plant Category for comparison of pre-treatment to post-treatment measurements.

Figure 11. Mean percent cover measured at marina sites, as presented by Category

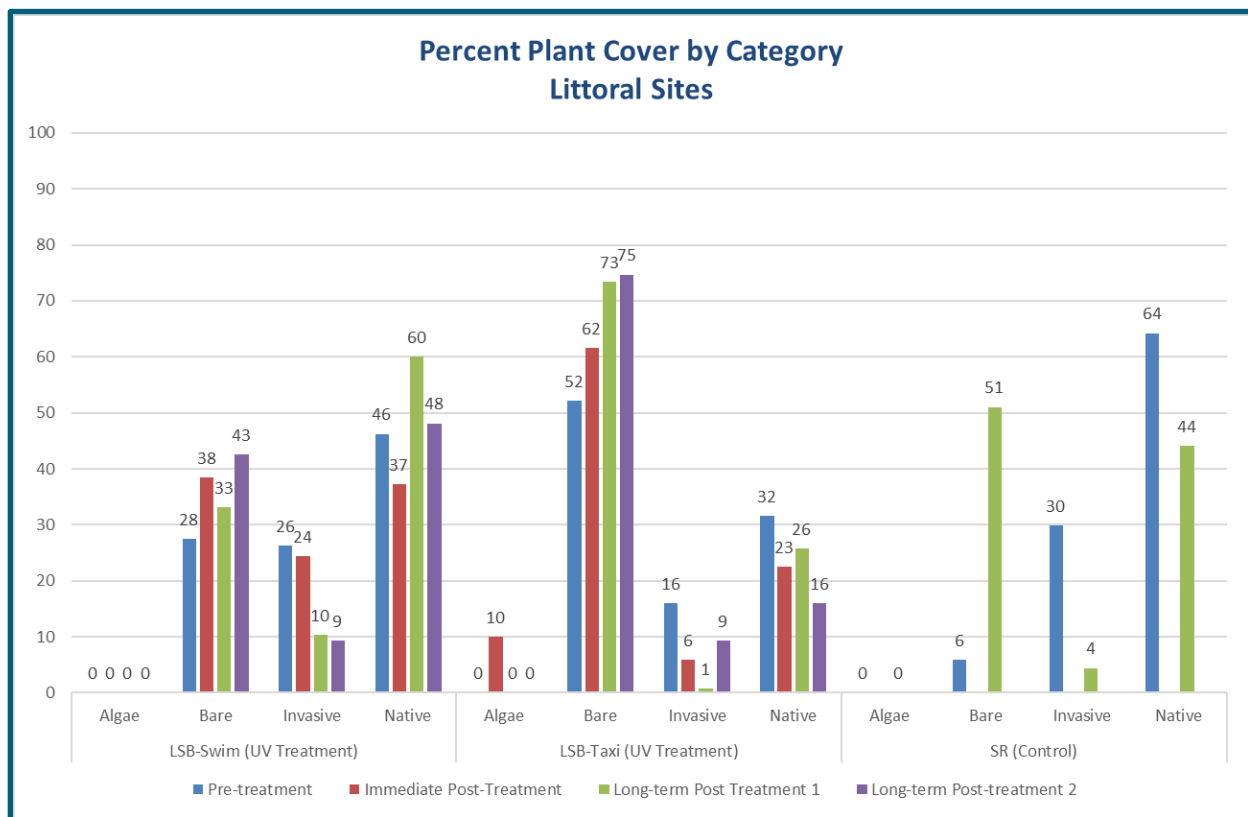
Considering the SR control site, in the absence of UV-C light treatment, percent cover by both Natives and Invasives onsite decreased between July 2017 and July 2018. The SR control site is located in an area of high boat traffic so plant populations could be impacted by scouring and effectively mowing by propellers. **Figure 15** presents the same percent cover results for the littoral sites by Category for comparison of pre-treatment to post-treatment measurements and appears to show a similar trend for LSB-Taxi and the SR control site. Treatment response at LSB-Swim is similar but muted and is possible due to this treatment site being more protected from boat traffic.

Figure 15. Mean percent cover measured at littoral sites, as presented by Category

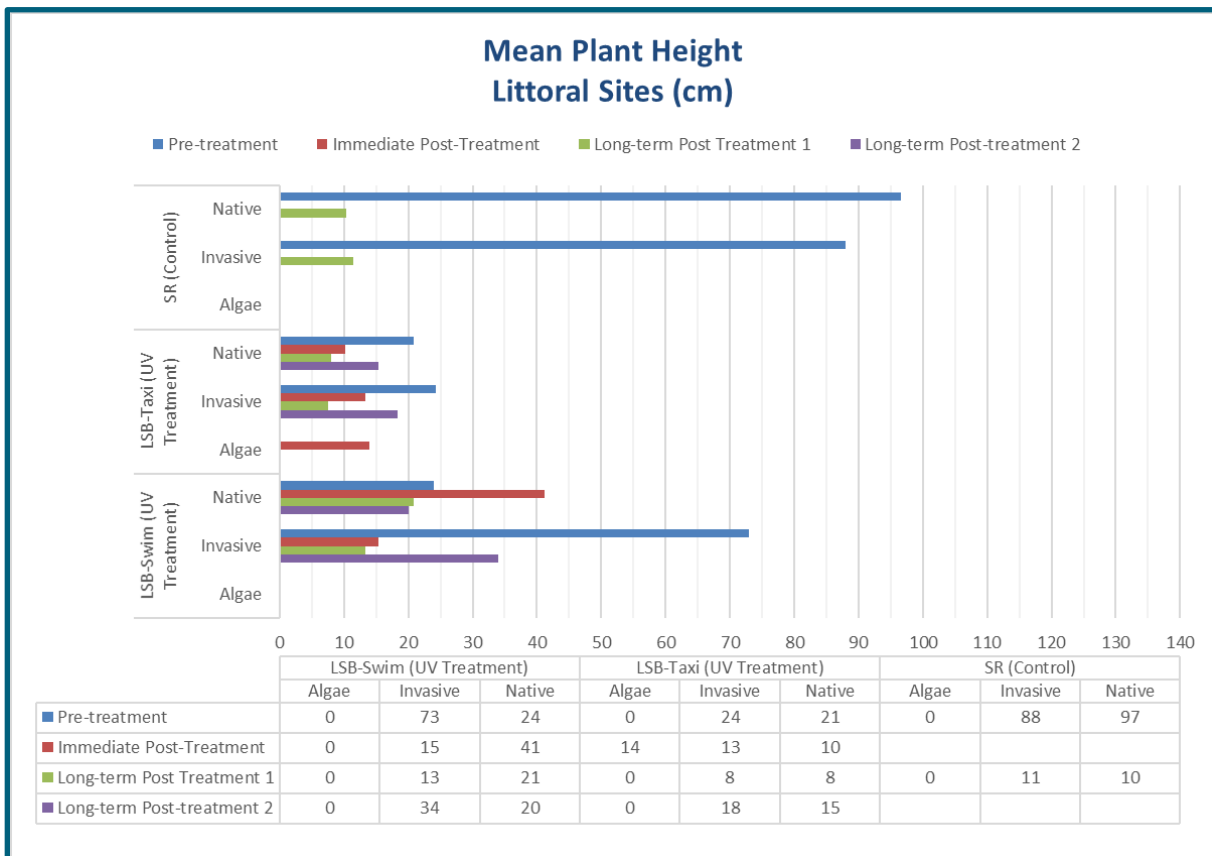
As depicted in **Figure 16**, Invasive and Native mean plant height decreased from 88 cm and 97 cm as measured in June 2017 to 11 cm and 10 cm, respectively, as measured in June 2018.

Figure 16. Mean plant height in centimeters measured at littoral sites, by Category

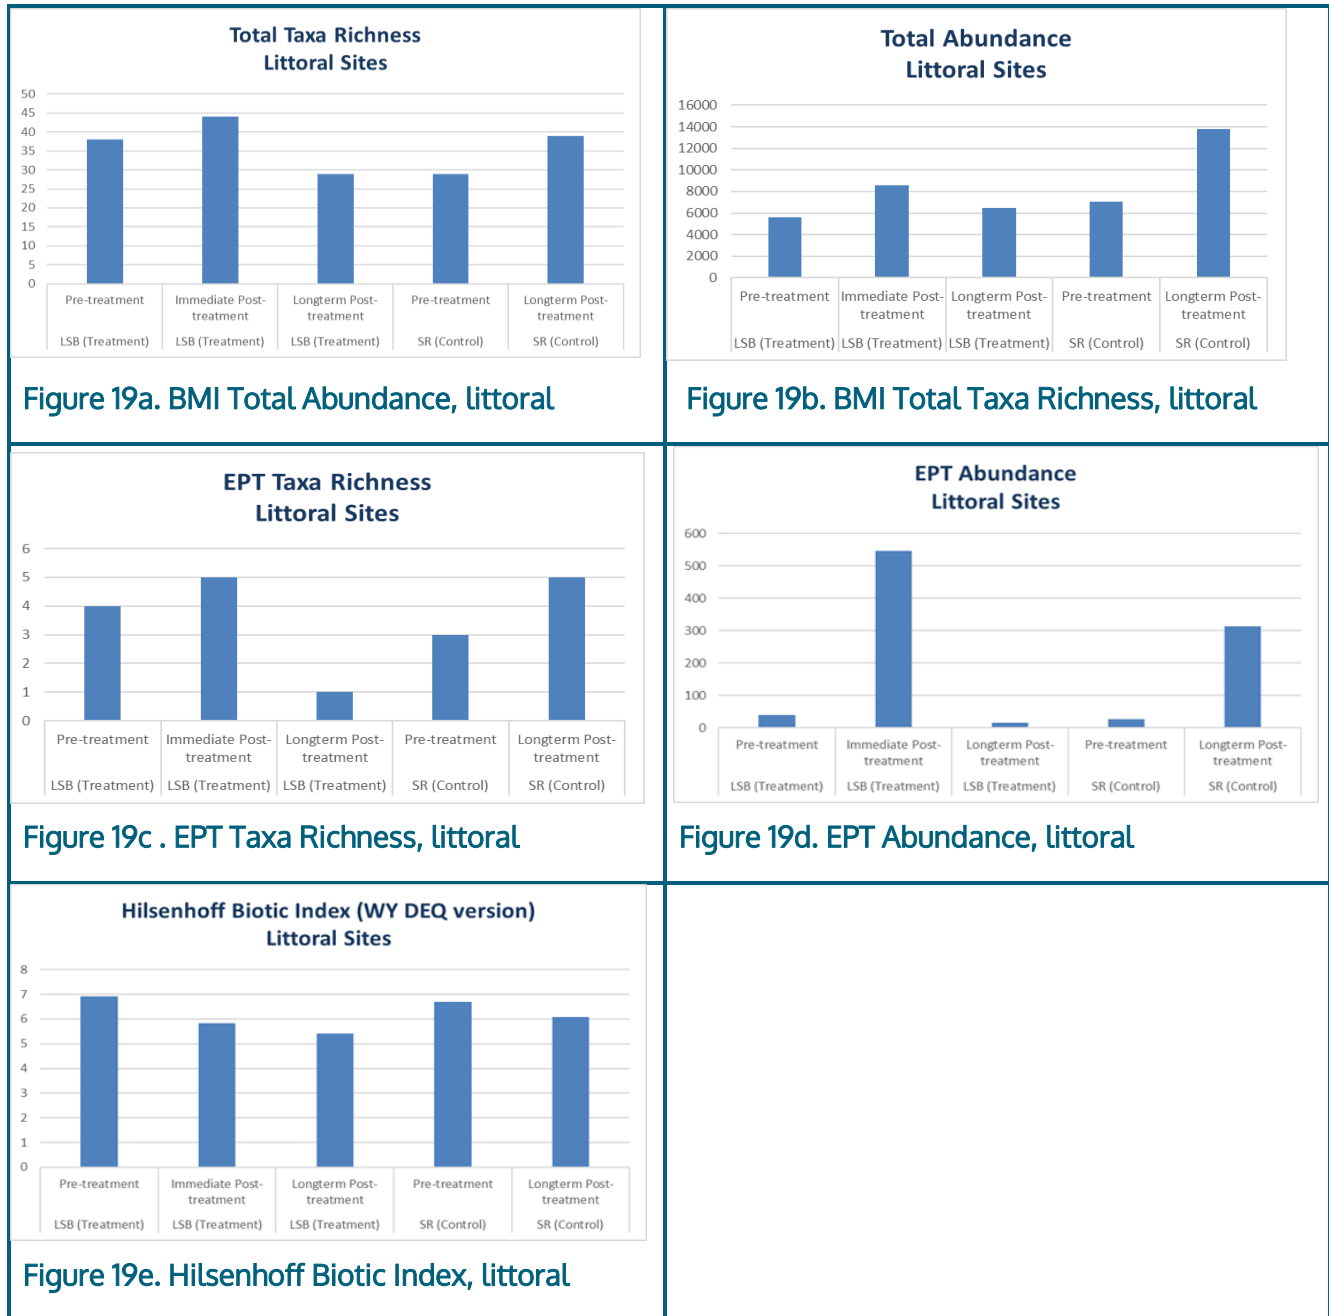
Figure 19 presents a compilation of BMI results, as titled for 19a through 19e, that were reported for littoral sites for a general comparison of pre-treatment conditions to post-treatment conditions. At LSB total taxa richness, total abundance, total EPT richness and EPT abundance increased immediately following UV-C light treatment, but one (1) year later these metrics measured below pre-treatment level. This possible trend for the open water littoral sites is not the same as potential trends graphed for LSM, an enclosed water system. The HBI response at the LSB littoral sites indicates a less tolerant BMI community immediately following UV-C light treatment with long term post-treatment results also reporting a less tolerant BMI community composition. Comparatively, for the SR control site total taxa richness, total abundance, EPT richness and EPT abundance all increased between the 2017 and 2018 growing seasons. HBI decreased slightly between 2017 and 2018 indicating a shift towards less tolerant BMI community composition.

Figure 19. BMI summary results for littoral sites

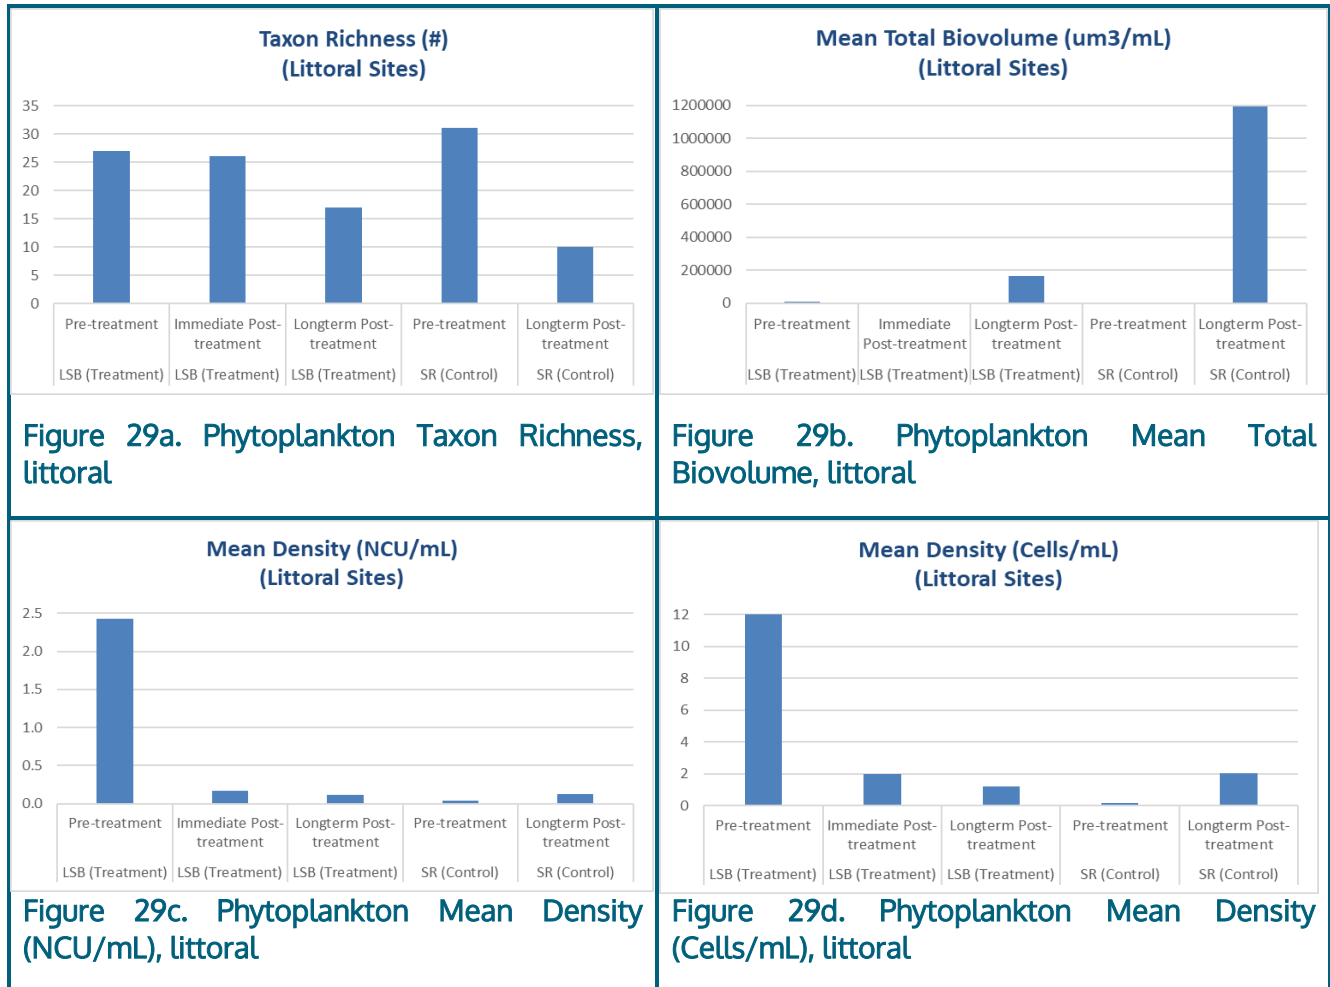
Figure 29 presents the compilation of phytoplankton results, as titled for 29a though 29d, for the littoral sites. Taxon richness and mean density appear to have decreased at LSB following UV-C light treatment, but when compared to the SR control site, uncontrolled physical, chemical or biological inputs may have had influence. No concluding trends are reported for the data set.

Figure 29. Phytoplankton results for taxa richness, mean total biovolume and mean density, littoral sites

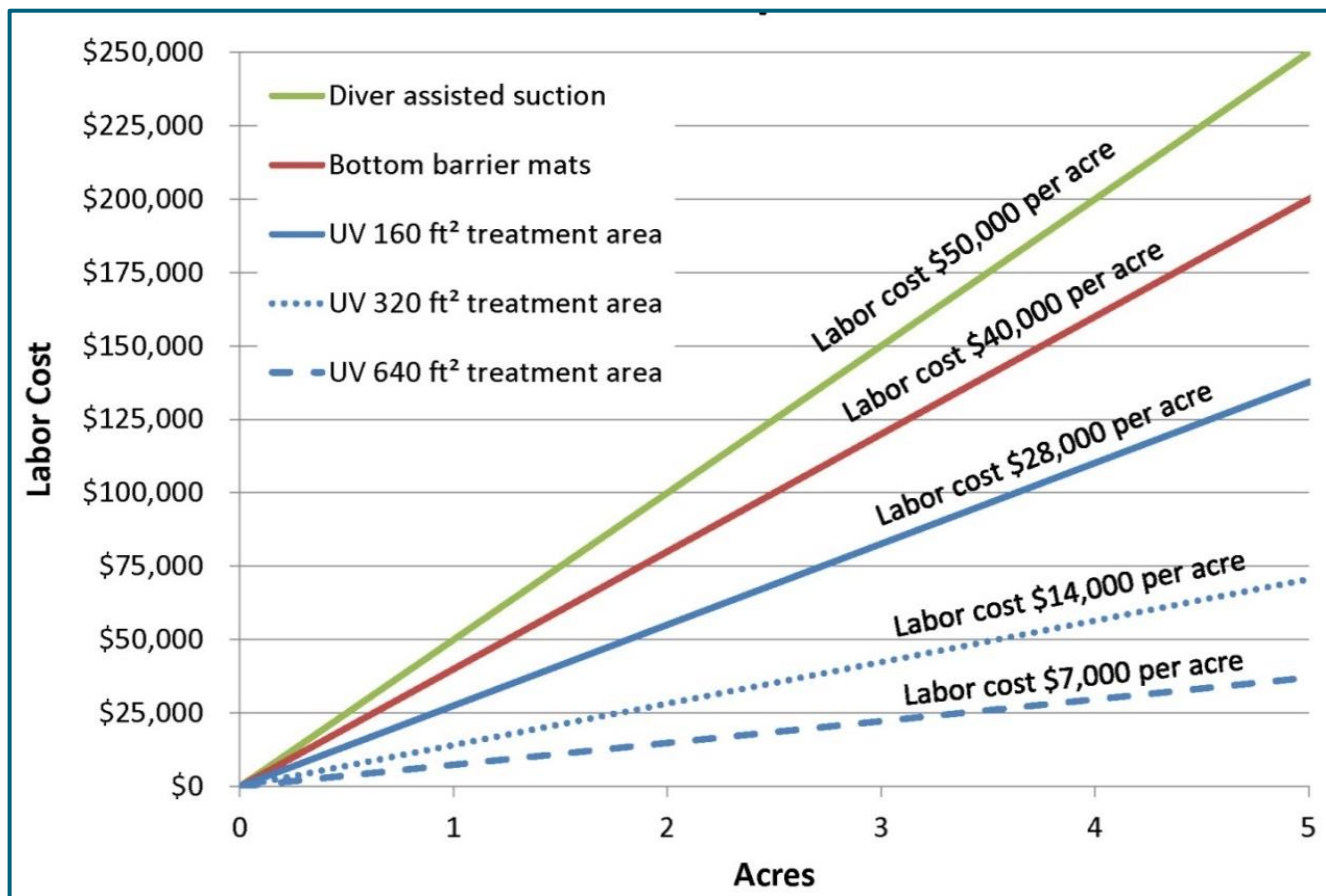
Figure 31 below illustrates labor cost for each of the treatment method options reviewed when client owns the treatment vessel. UV-C treatment method is the least expensive method in terms of labor.

Figure 31. Labor cost comparisons
