**TWSA BOARD MEETING PACKET for 6/7/2023**

**TWSA Board Meeting - Quarter 2**  
**Wed., June 7, 2023 1:00 PM - 4:00 PM (PST)**

## A Lake Tahoe Basin and Truckee Watershed Citizen Monitoring Event (May 21, 2022)

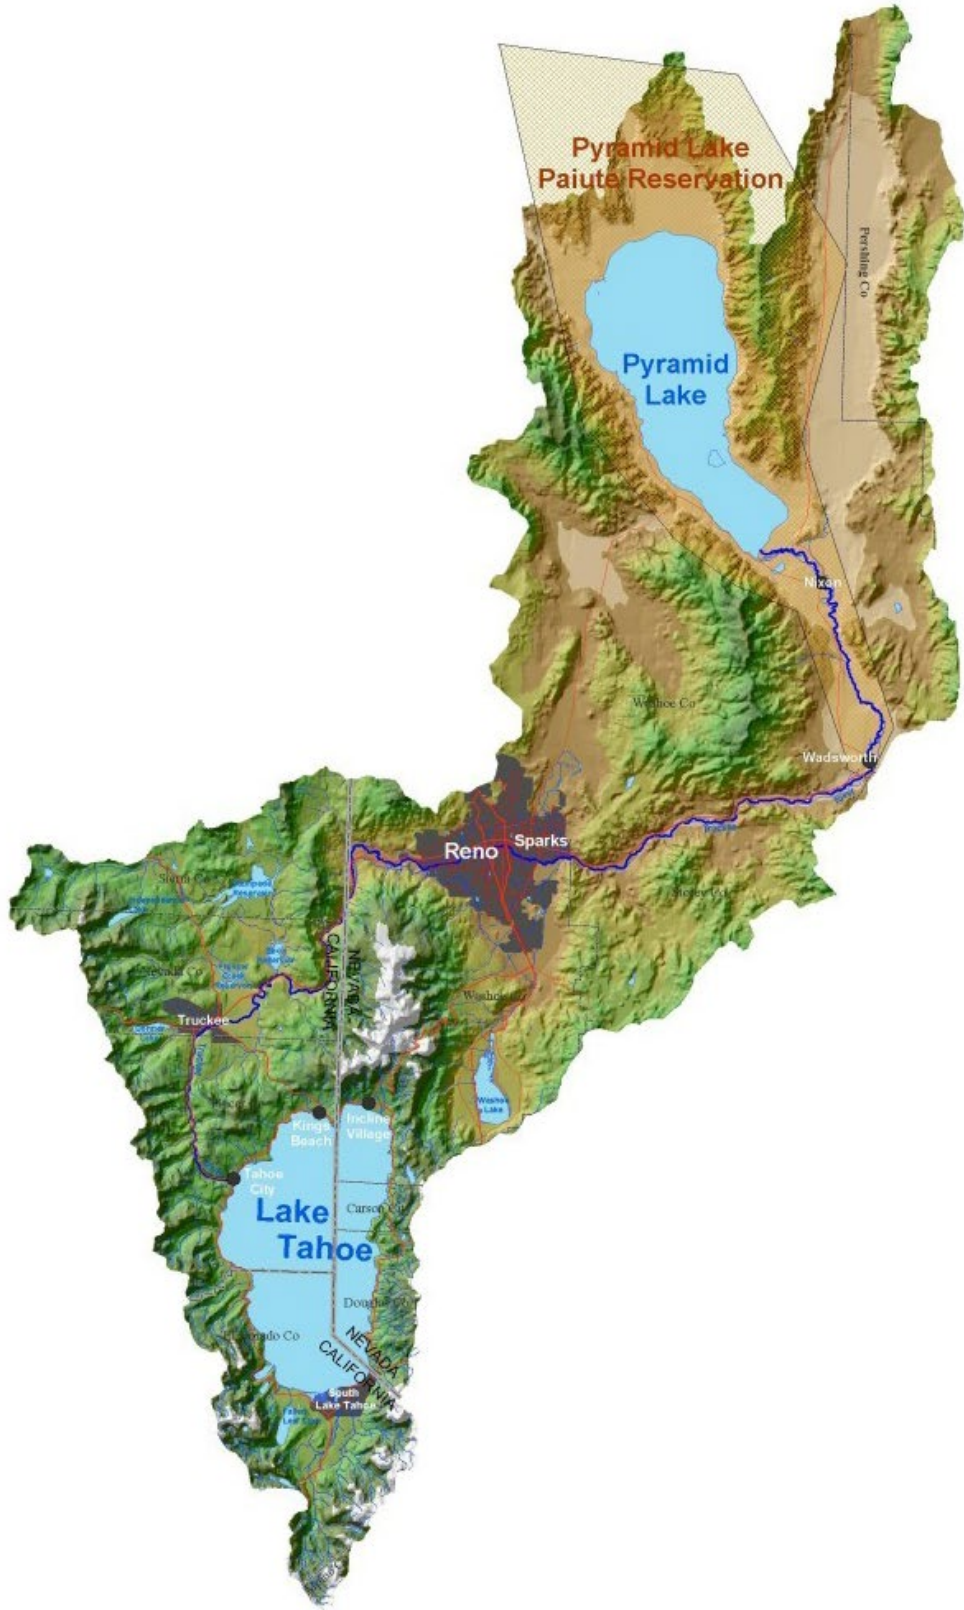
Figure 1: Truckee River Watershed from Lake Tahoe, CA to Pyramid Lake, NV

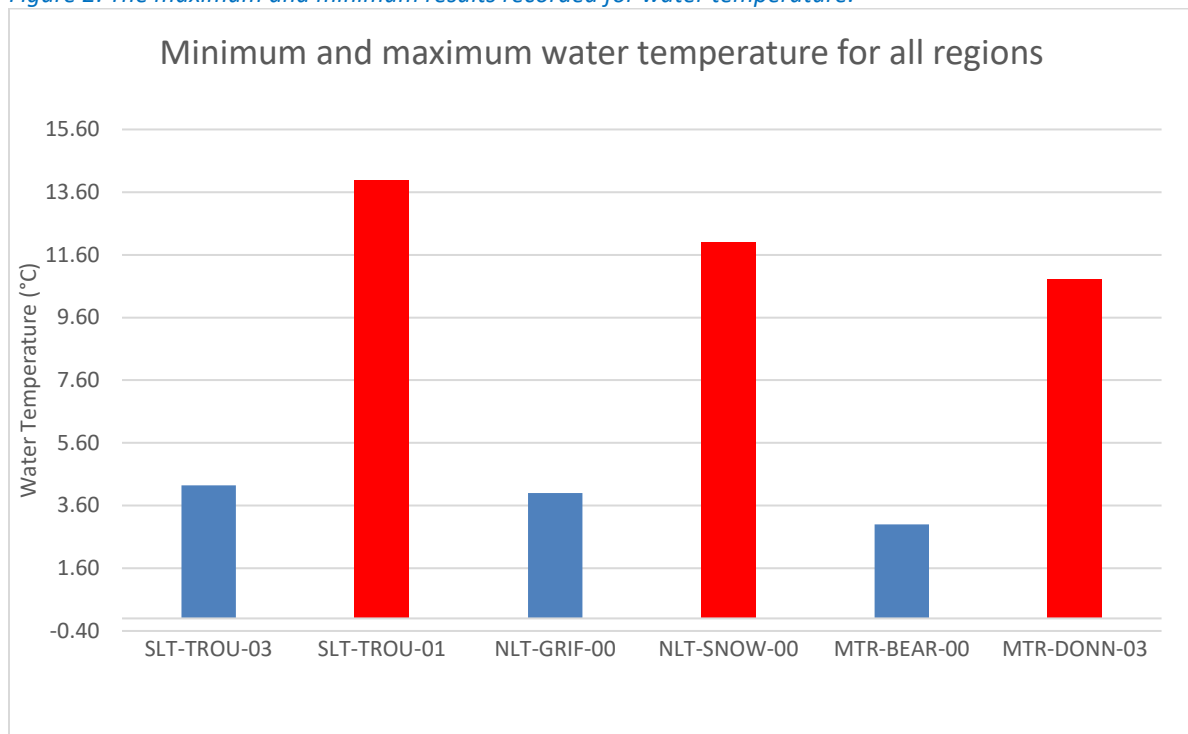
In 2022, 69 sites were sampled for water temperature. The lowest recorded temperature from Snapshot Day 2022 was 3° C at the Bear Creek sampling location in the Middle Truckee watershed. The highest recorded temperature was 14.00° C recorded at Trout Creek at Bellevue Avenue in South Lake Tahoe. Figure 2 below represents the lowest (blue) and highest (red) temperatures for the four regions sampled during the 2022 event. The high temperature noted above was collected from a tributary to Lake Tahoe and did not exceed 15.6° C, the maximum optimal temperature for rainbow trout.

Figure 2: The maximum and minimum results recorded for water temperature.

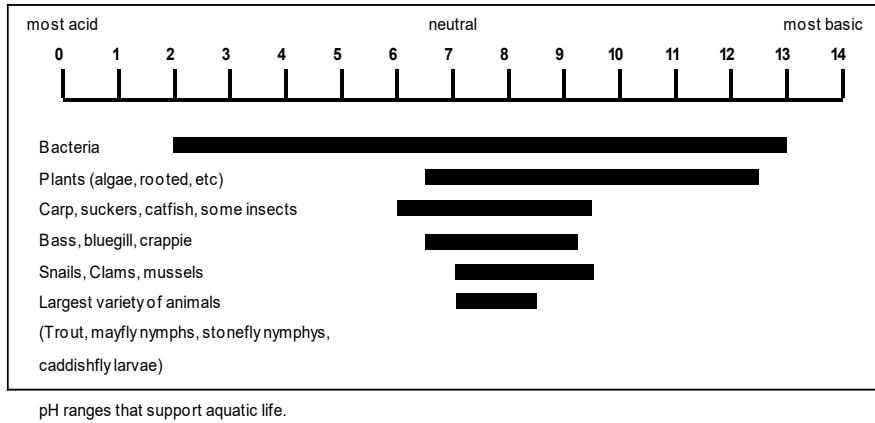
pH is a measurement of the degree to which water is "acidic" or "basic." pH is measured on a scale of 0 (very acidic) to 14 (very basic), with 7 in the middle as "neutral." Most aquatic life prefers a pH close to 7. **Figure 2** displays the pH ranges that support aquatic life.

*Figure 3: pH range that supports aquatic life*

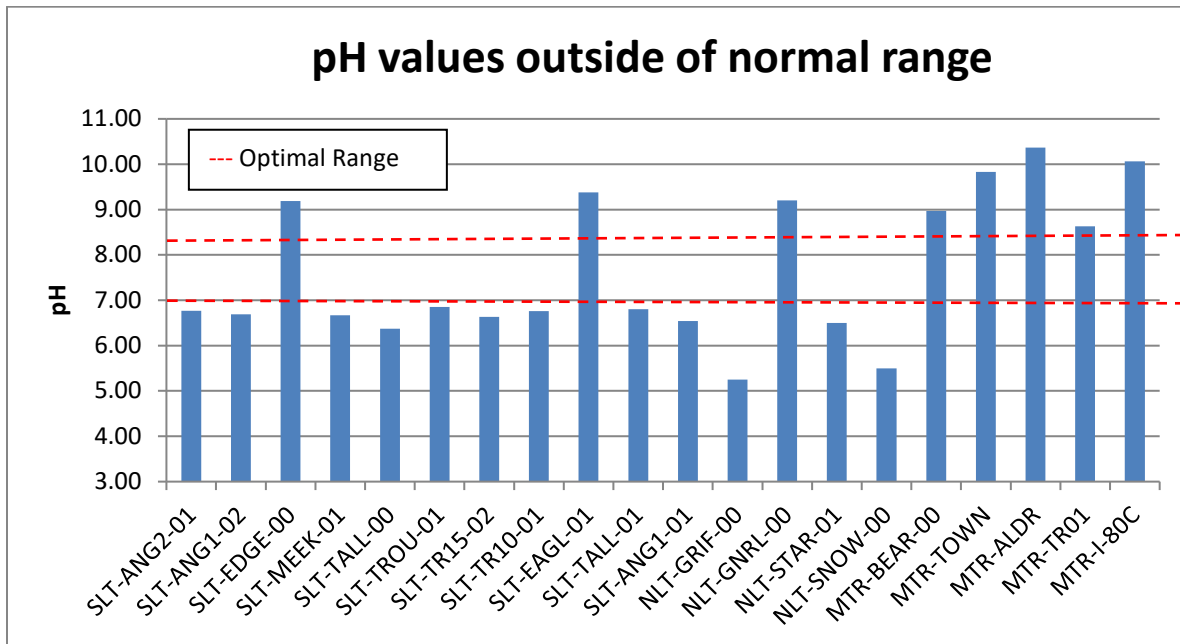
*Figure 4: pH results outside optimal range for aquatic life.*

The lowest pH measurement for Snapshot Day 2022 was 5.25, taken at Griff Creek in North Lake Tahoe. The highest pH measurement was 10.37 at Alder Creek in the Middle Truckee River region. Of the 69 sites that took pH readings, 13 sites had a pH below the optimal range, and 7 sample sites had a pH value above the optimal range.

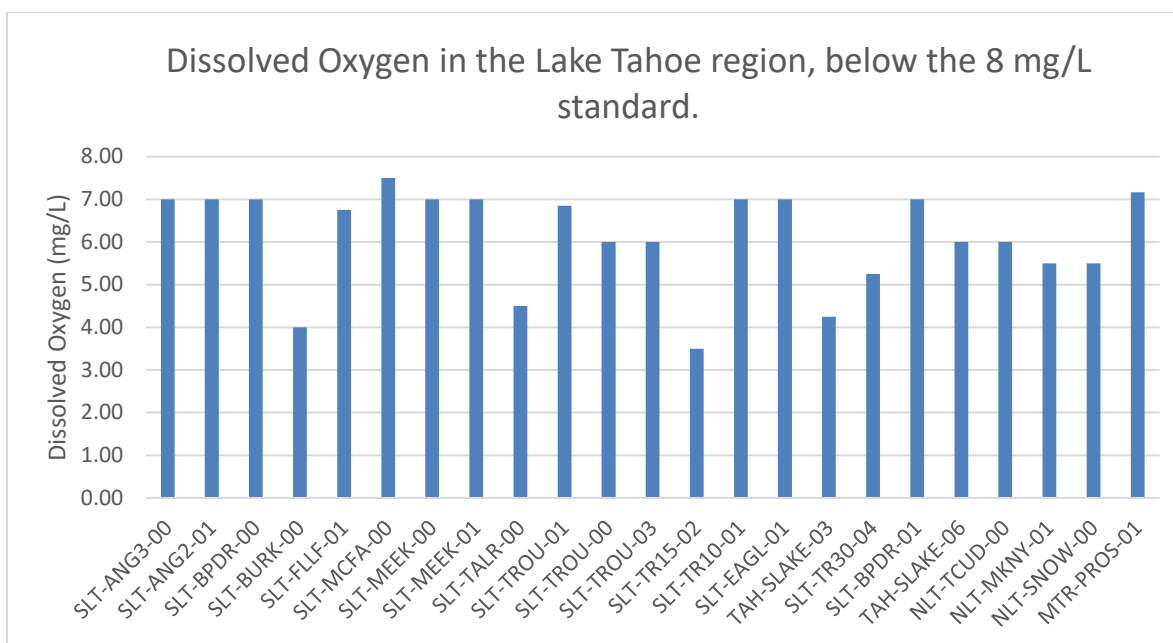
*Figure 5: Dissolved oxygen concentrations that were measured below 8 mg/L.*

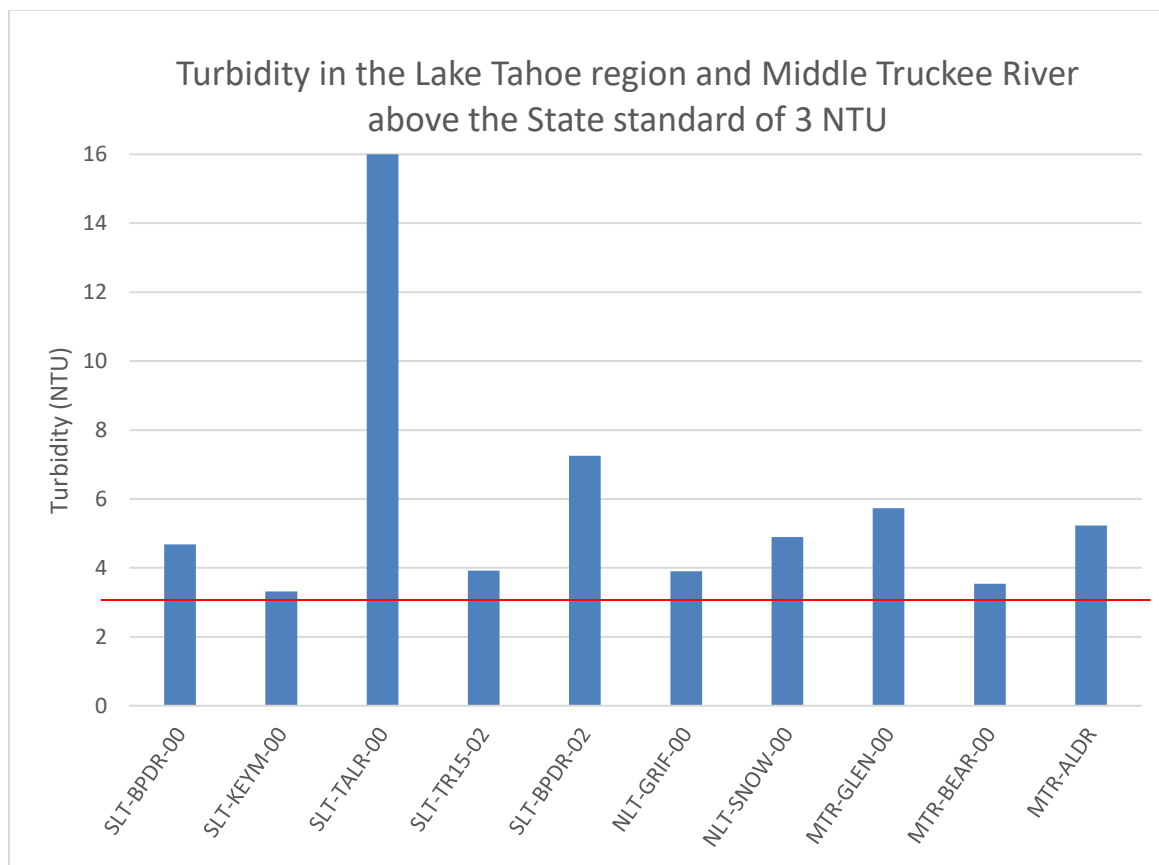
The U.S. EPA's recommended criteria for turbidity in streams in Eco-Region II (forested mountains in the western U.S.) is at or below 1.3 NTU. The California portion of the Truckee River Watershed is located within this Eco-Region; however, the State of Nevada outside of the Tahoe Basin is located right outside this Eco-Region. The TRPA and Lahontan have a nearshore turbidity standard of 1-3 NTUs (measured by monthly means) in Lake Tahoe. The standard for the Lower Truckee River and associated tributaries in Nevada is 10 NTU.

*Figure 6: Turbidity readings that did not meet state or regional NTU standards.*

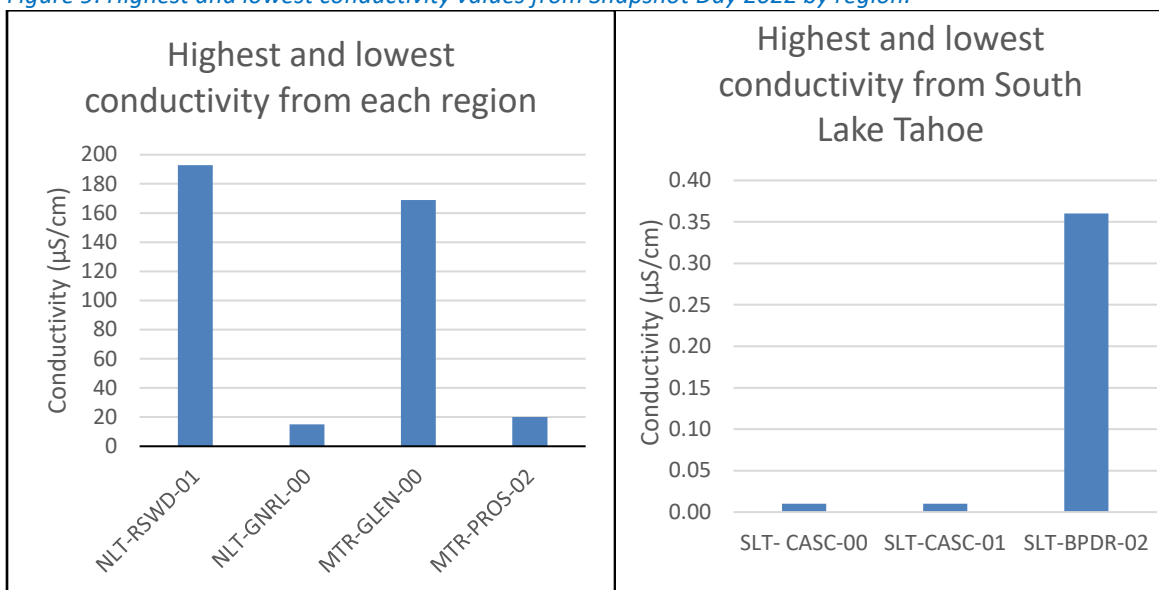
*Figure 9: Highest and lowest conductivity values from Snapshot Day 2022 by region.*

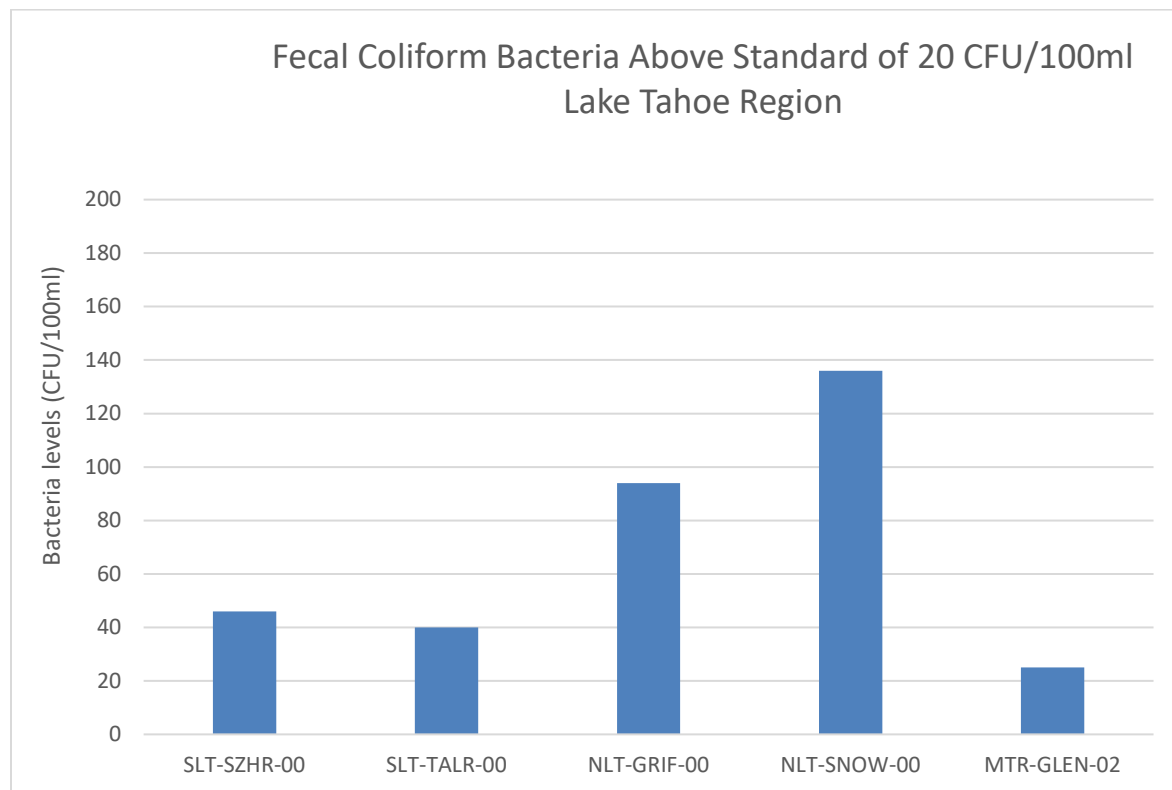
Figure 10: Fecal coliform bacteria counts above 20CFU/100 mL standard – Lake Tahoe Region.

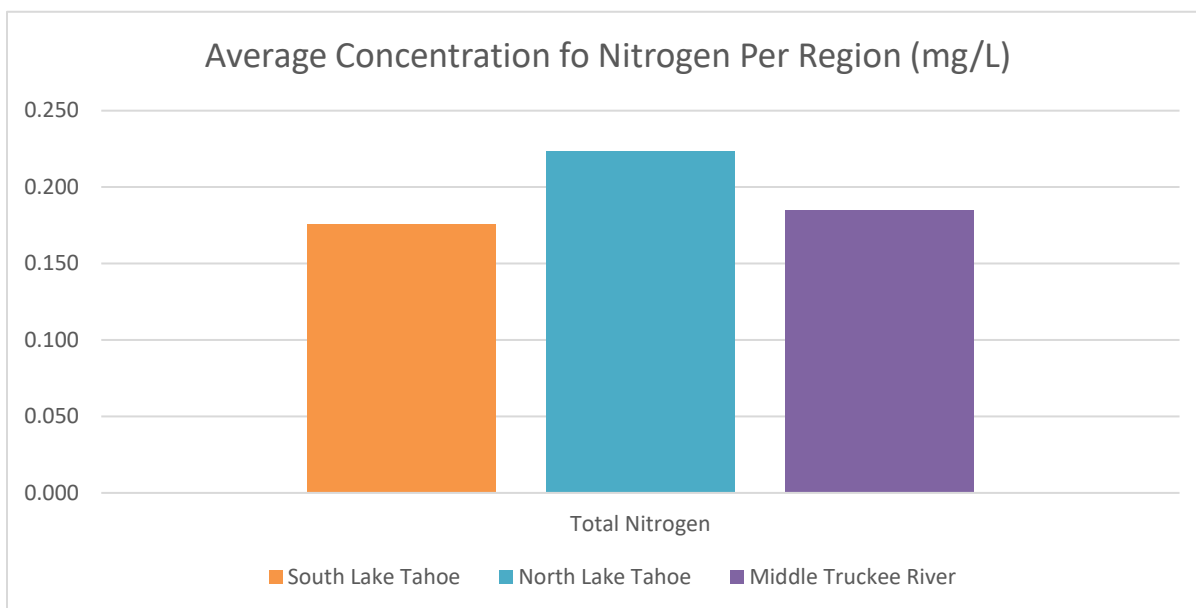
*Figure 11: Total Nitrogen average concentration by region for 2022.*

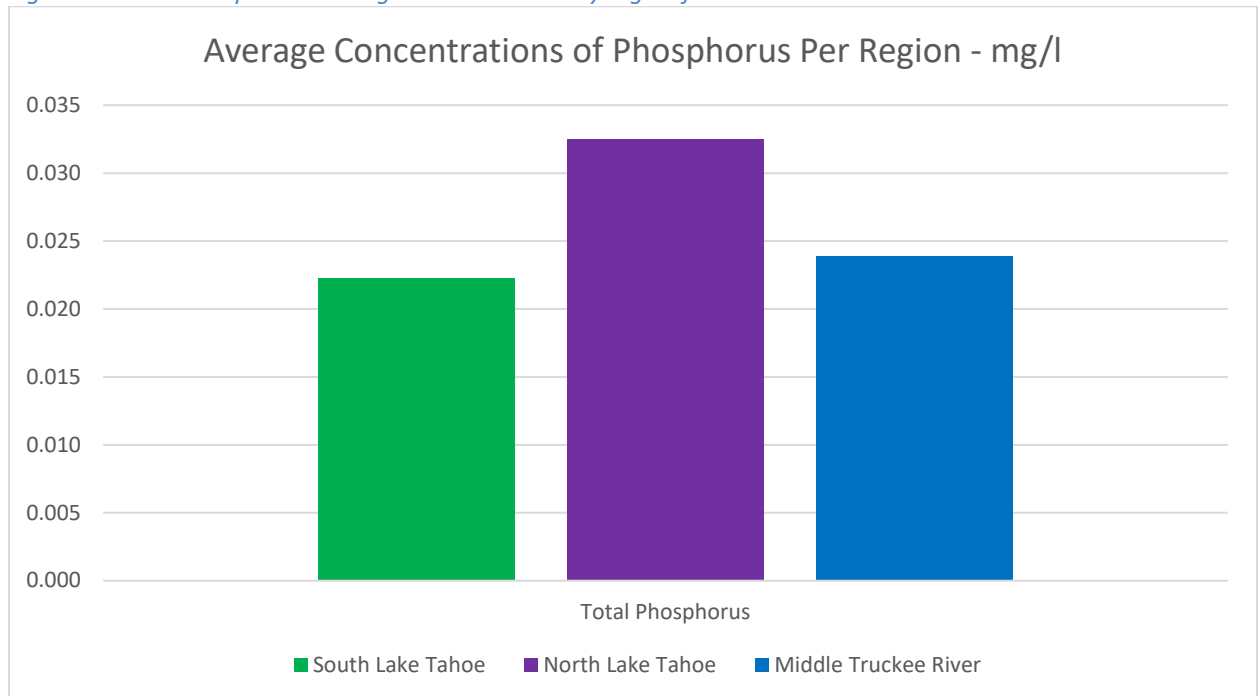
Figure 12: Total Phosphorus average concentrations by region for 2022.

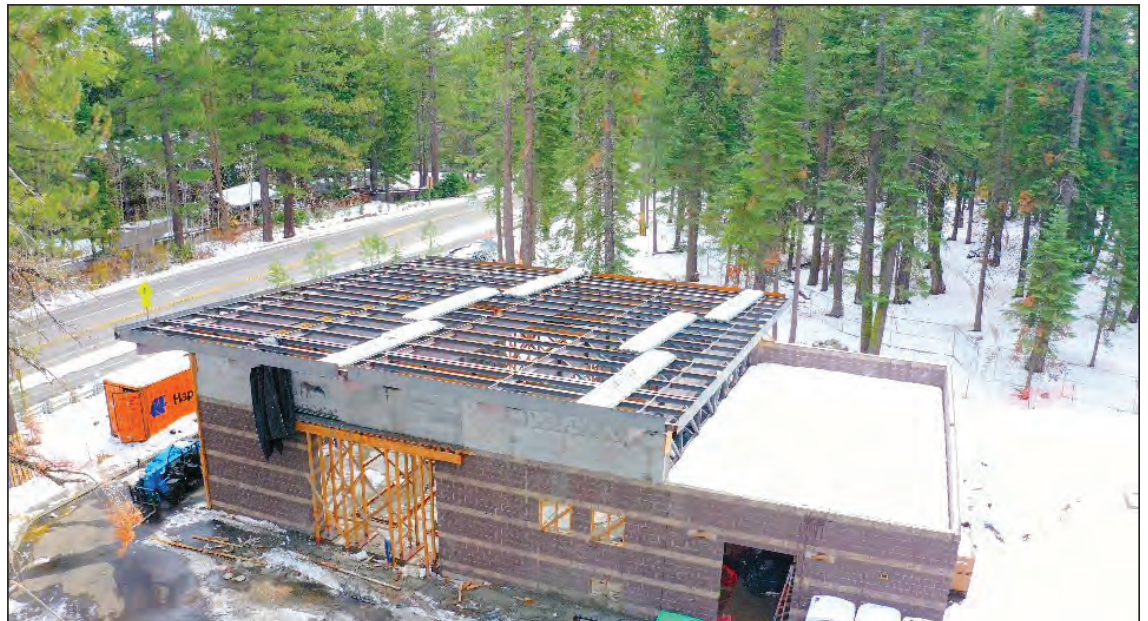
Tahoe City Public Utility District's (TCPUD's) new one million gallon per day (MGD) capacity surface water treatment plant will provide both drinking water and fire protection to the west shore communities of Tahoma and Homewood, California. Photo credit: TCPUD.

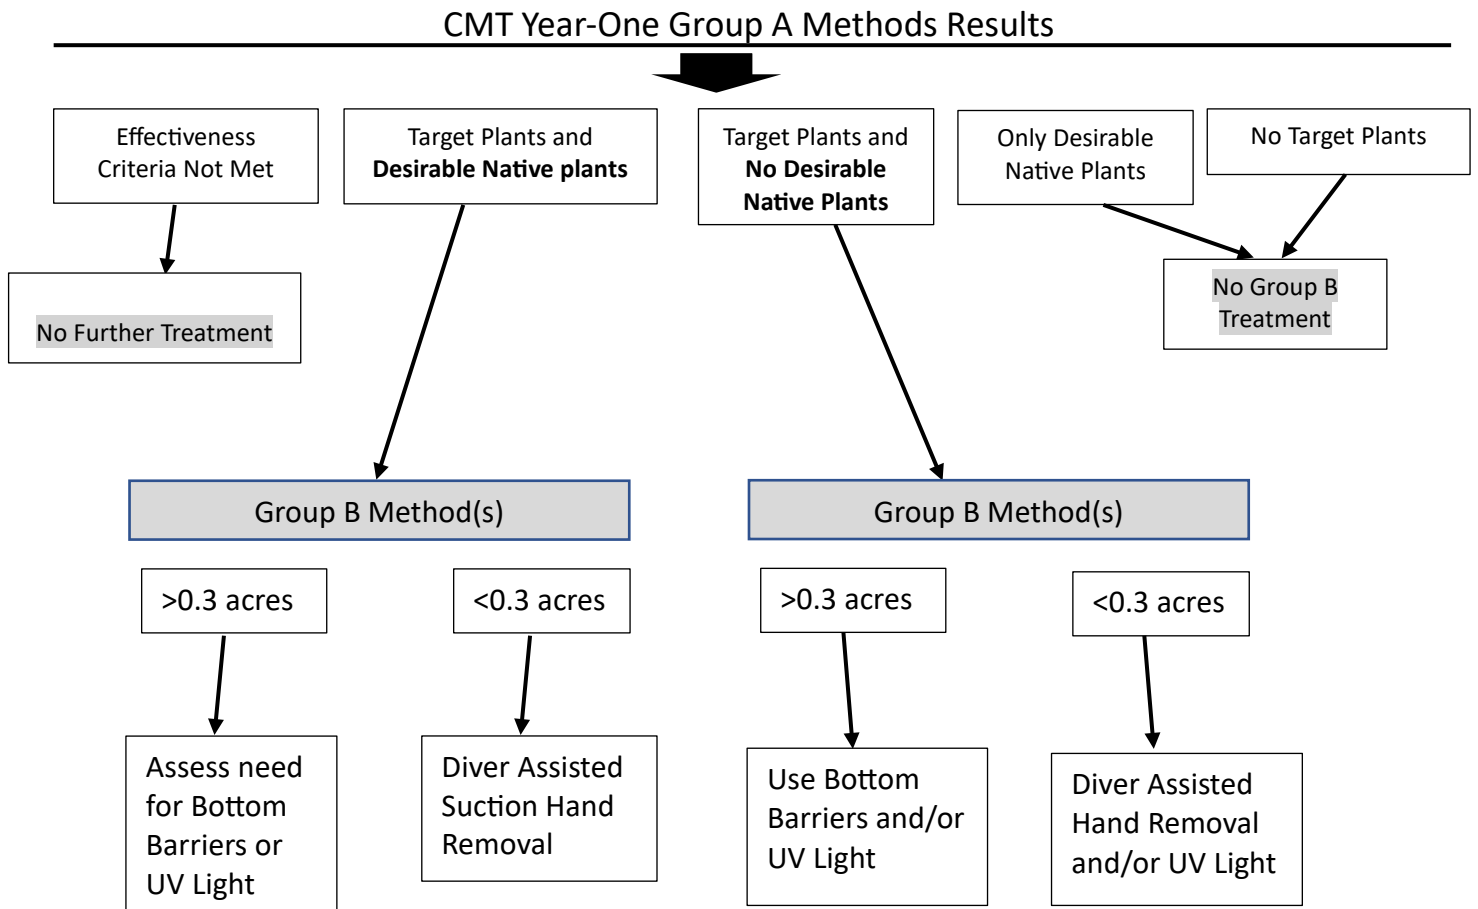
Since the primary objective of the CMT is to develop data for improved management of aquatic weeds in the Keys, the use of Year-Two CMT, “Group B” (non-herbicide) treatments is dependent on meeting three key criteria based on the Year-One “Group A” treatments: 75% reduction in target weed biovolume; achieving a “Vessel Hull Clearance” (for navigation); and enhancing conditions for desirable native plants. These criteria were met in several sites that had received herbicides or UV treatments including Endothall herbicide treatments, UV treatments and selective reduction of Eurasian watermifoil in Triclopyr herbicide treatments. (The criteria were not met in the LFA as this method generally required multiple seasons for effectiveness. Also, sites intended as “Combination Herbicide/UV” were not completed due to lack of access for UV treatments. These sites will receive UV treatments in Year-Two).

Figure 1. Group B Decision Framework.

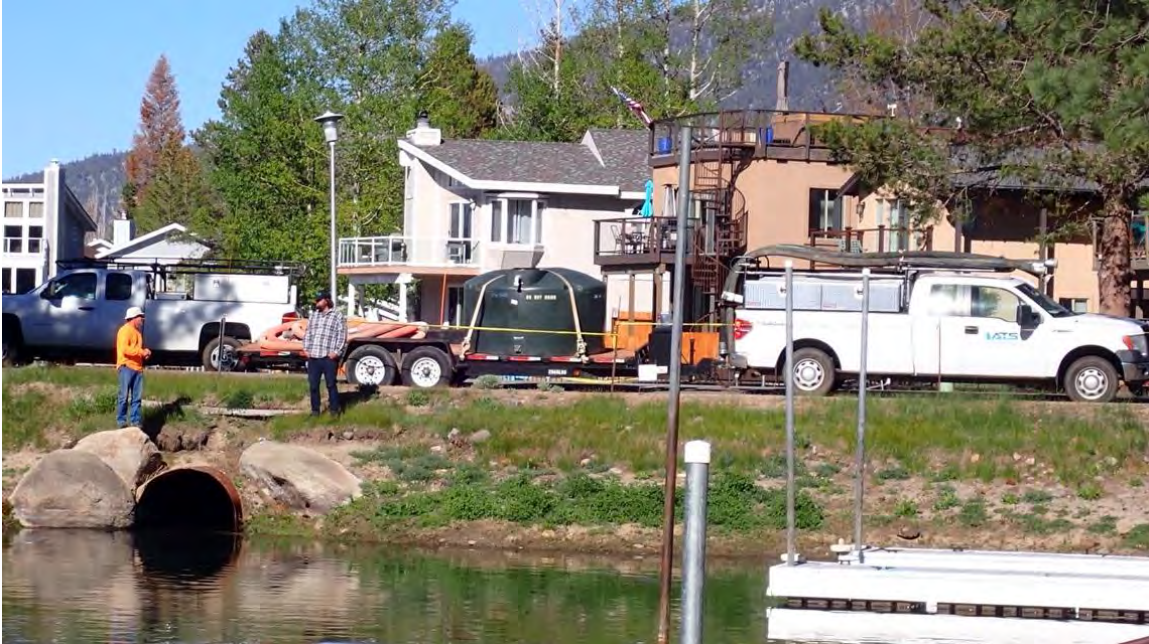
As part of the mitigation and contingency planning, a professional certified hazardous waste removal team was deployed during all applications of herbicides. Preventative protocols are provided in the QAPP (Appendix F). During herbicide applications, the spill contingency team maintained mobile pumping and storage systems adjacent to each treated site until the application was finished. The spill contingency contractor information is provided in Appendix L. As planned, no spills occurred during any of the CMT herbicide applications (see Appendix M). An example of the deployed spill response equipment is shown in Figure 2-2 below. The equipment was moved to each site prior to herbicide application at the site. (Note: storage tank and hoses as well as the black culvert plug at the water's edge.)

**Figure 2-2. Example of Spill Prevention and Contingency Pumping Equipment Deployed During Herbicide Applications**

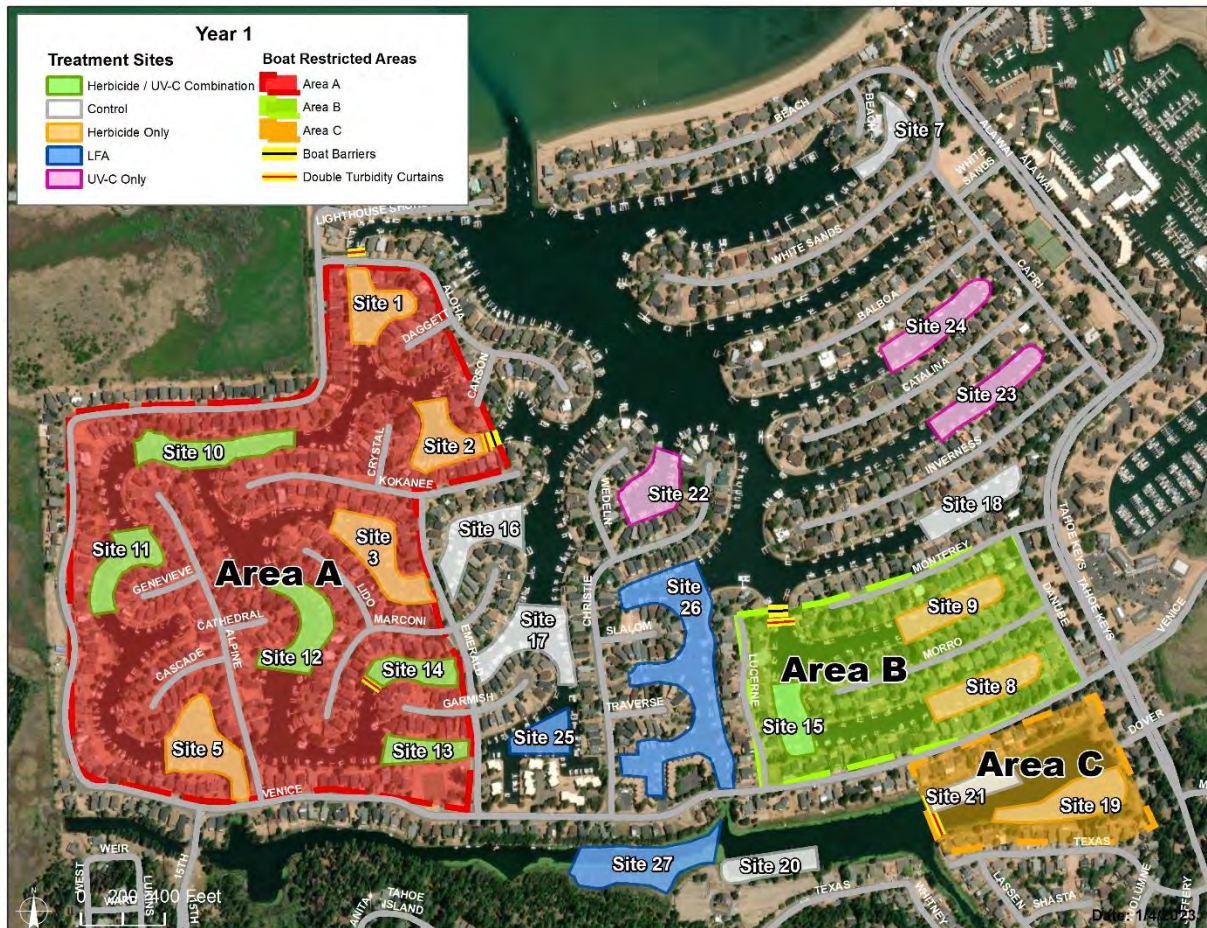
As part of the CMT permit requirements, sites identified for herbicide applications were required to be isolated from the main waterway areas of the West Lagoon and Lake Tahoe. The use of containment curtains effectively isolated three major boating exclusion zones of the CMT sites: Area A (west side of the West Lagoon behind curtains installed at Site 2); Area B (containing sites 8, 9 and 15 in southeast area of the West Lagoon); and Area C (Lake Tallac, all non-motorized boating). Figure 2-3 shows the boating restricted areas (A, B, and C).

**Figure 2-3. Designated Boating Restricted Areas (A, B, C) Separated by Double Turbidity Curtains and Barriers**

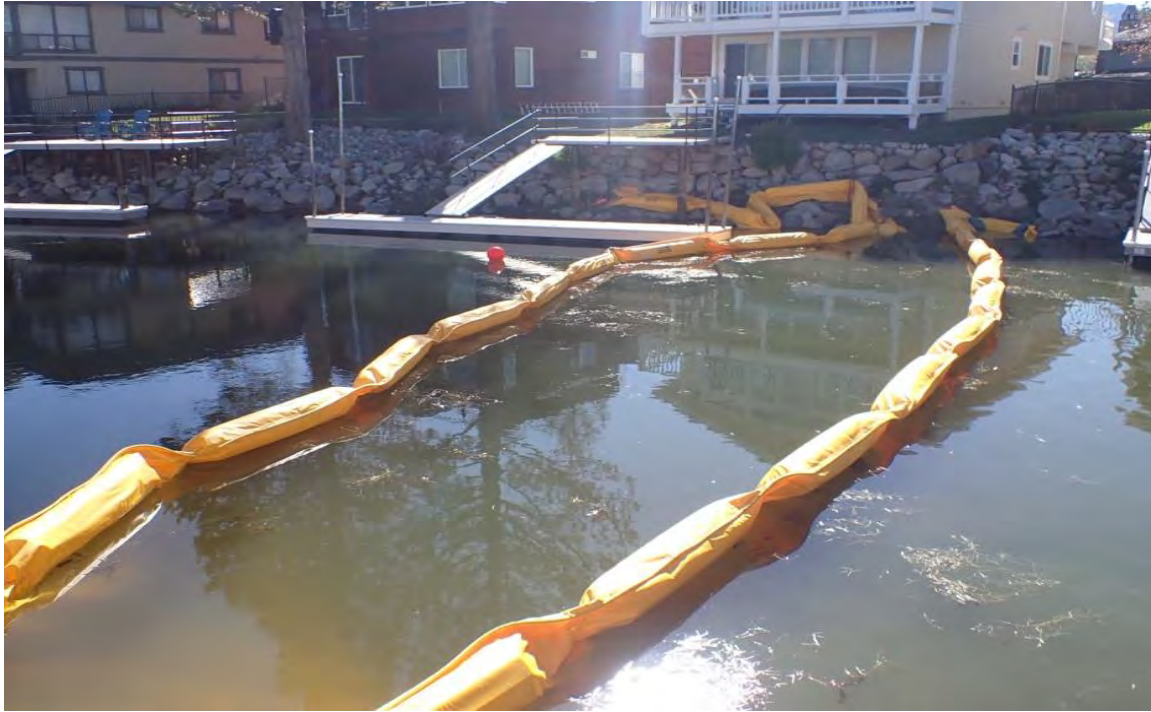
To protect the integrity of the curtains, and to prevent boats from breaching the curtains, physical metal barriers (pilings) and plastic fencing were installed outside the curtains for Areas A and B. Figures 1-1 and 2-3 show where the curtains were installed prior to applications of herbicides. During installation and removal of curtains, turbidity was monitored to ensure disturbance was minimized (Appendix R). Examples of the double turbidity curtain installations are shown in Figures 2-4 and 2-5.

**Figure 2-4. Double Curtain in the West Lagoon**

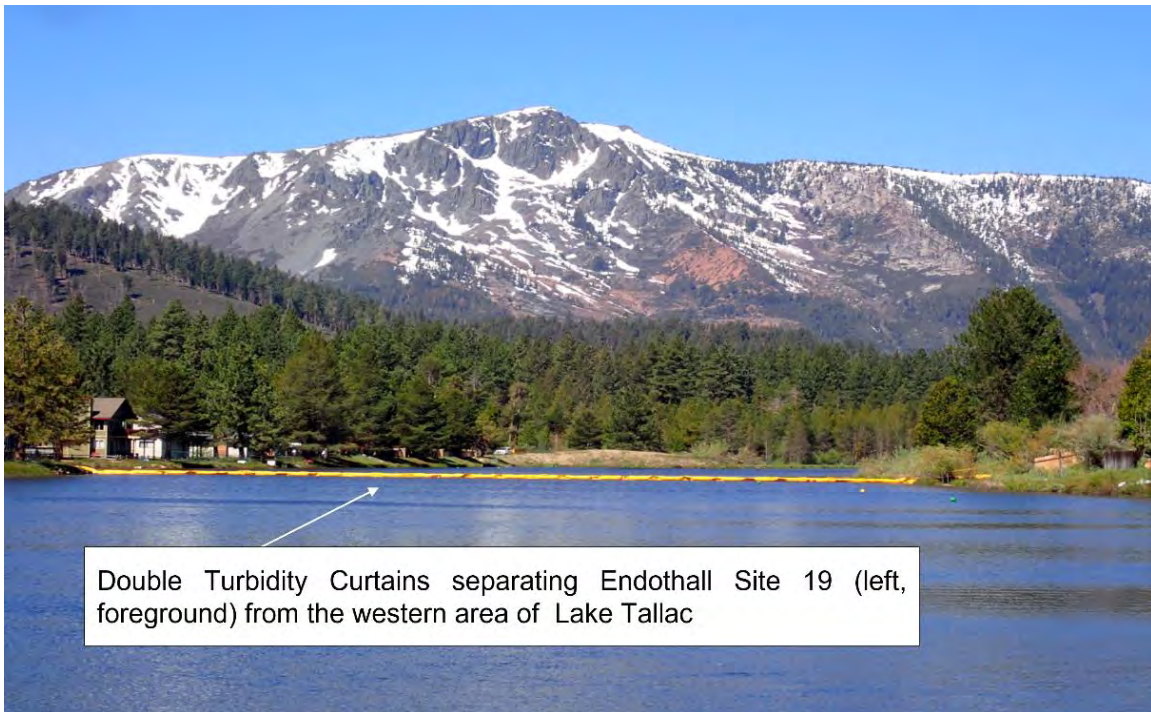
**Figure 2-5. Double Curtain Installed in Lake Tallac**

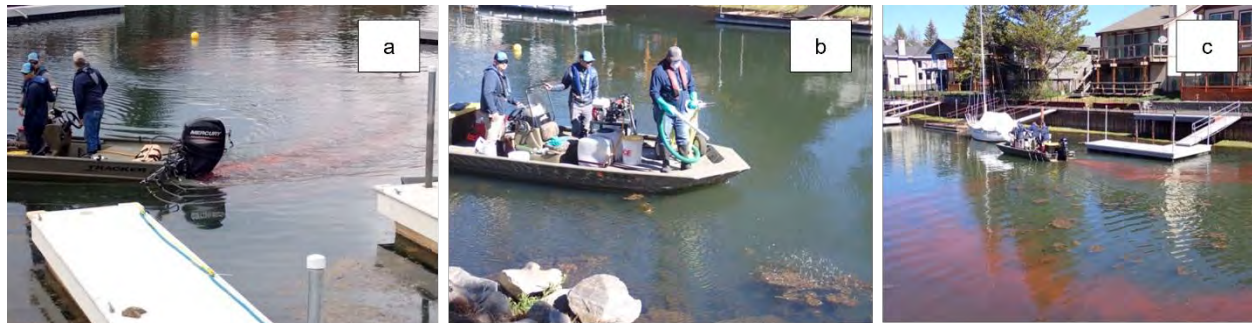
\*Note: All applications were done in concert with the injection of RWT dye (<10 ppb) which was monitored using a flow-through fluorometer to assess movement of herbicides post-application.

**Figure 3-1. Examples of the Herbicide and RWT Applications**
