MASTER PLAN - 2001

# The Golf Courses at Incline Village Championship Course

KYLE PHILLIPS GOLF COURSE DESIGN SEPTEMBER 2001

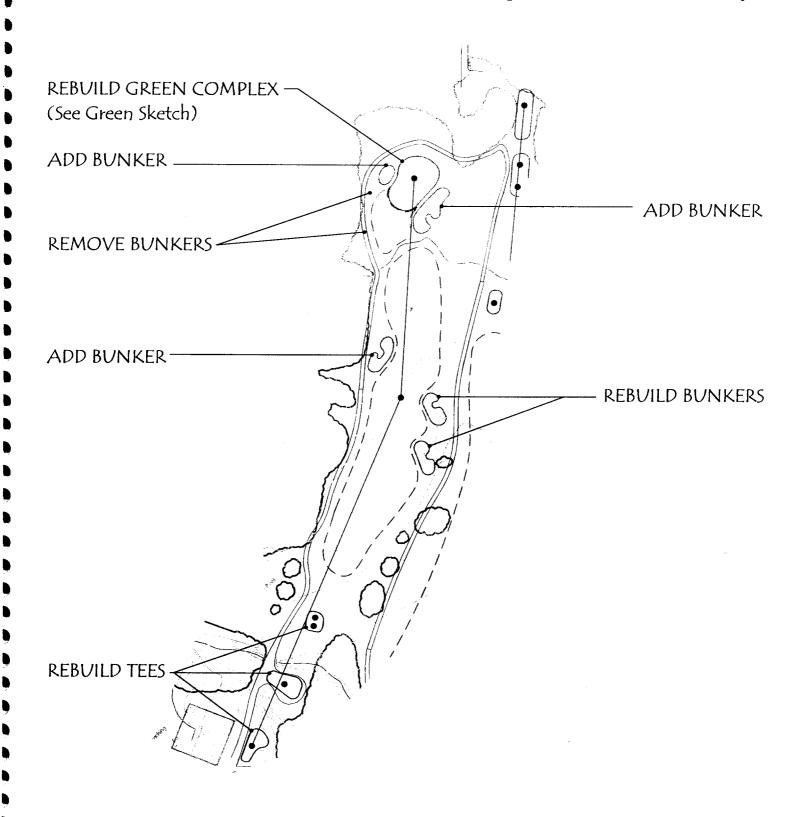
Current: Hole #1, Par 4, 400 yds. Proposed: Hole #10, Par 4, 420 yds.

**Tees -** The location and size of both the Championship and Men's tees are acceptable. However, both should be resurfaced to provide better turf conditions and level lies. The ladies tee should be relocated further right so that it is less visible from the back tees. During this process the new front tee should be shaped to the style of RTJ Sr..

**Bunkers**: The two right side fairway bunkers are barely visible from the tees. These bunkers should be rebuilt and relocated slightly to increase their visibility. A third fairway bunker should be added to the left side of the fairway closer to the green. This hazard will help defend the left side from long hitters without increasing the difficulty from the average players standpoint. The two left greenside bunkers are barely visible from the fairway and are pinched too close to the cart path on the left side. These bunkers should be relocated and reshaped to fit the newly proposed green complex.

**Green:** The green complex suffers from a lack of visibility from the fairway. The entire complex should be relocated to the right. During this process the green contours should be redesigned to accept shots from a slightly different angle. (See Green Sketch)

**Other:** The creek fronting the green has been artificially raised and does not look very natural. If regulations allow, this creek should be reshaped to improve it's visibility and aesthetic quality. If shaping is prohibited in this area, the rocks placed around the creek should be removed to improve its visual appeal.

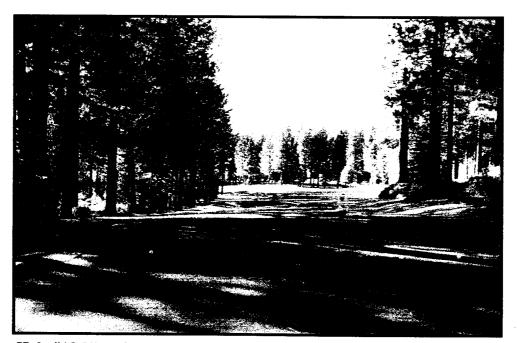
Hole #13-View from tee.

Tees: All three existing tees should be rebuilt in their current location with new drainage added.

**Bunkers:** The left side fairway bunker should be removed and this area reshaped to match the surrounding grades. A new bunker should be added in the middle of the fairway approx.100 yards from the middle of the green. This new bunker will add strategy to the hole, serve as a target bunker from the tees, and give the hole a completely different look from #11, which currently looks similar from the tee. All greenside bunkers should be rebuilt with new drainage added.

**Green:** The location and design concept of the green are good. Elevations should be measured and the green should be rebuilt to fit the original concept with slightly softened contours to allow for increased green speeds.
