INCLINE VILLAGE RECREATIONAL FACILITIES MASTER PLAN

FINAL REPORT
June 2000

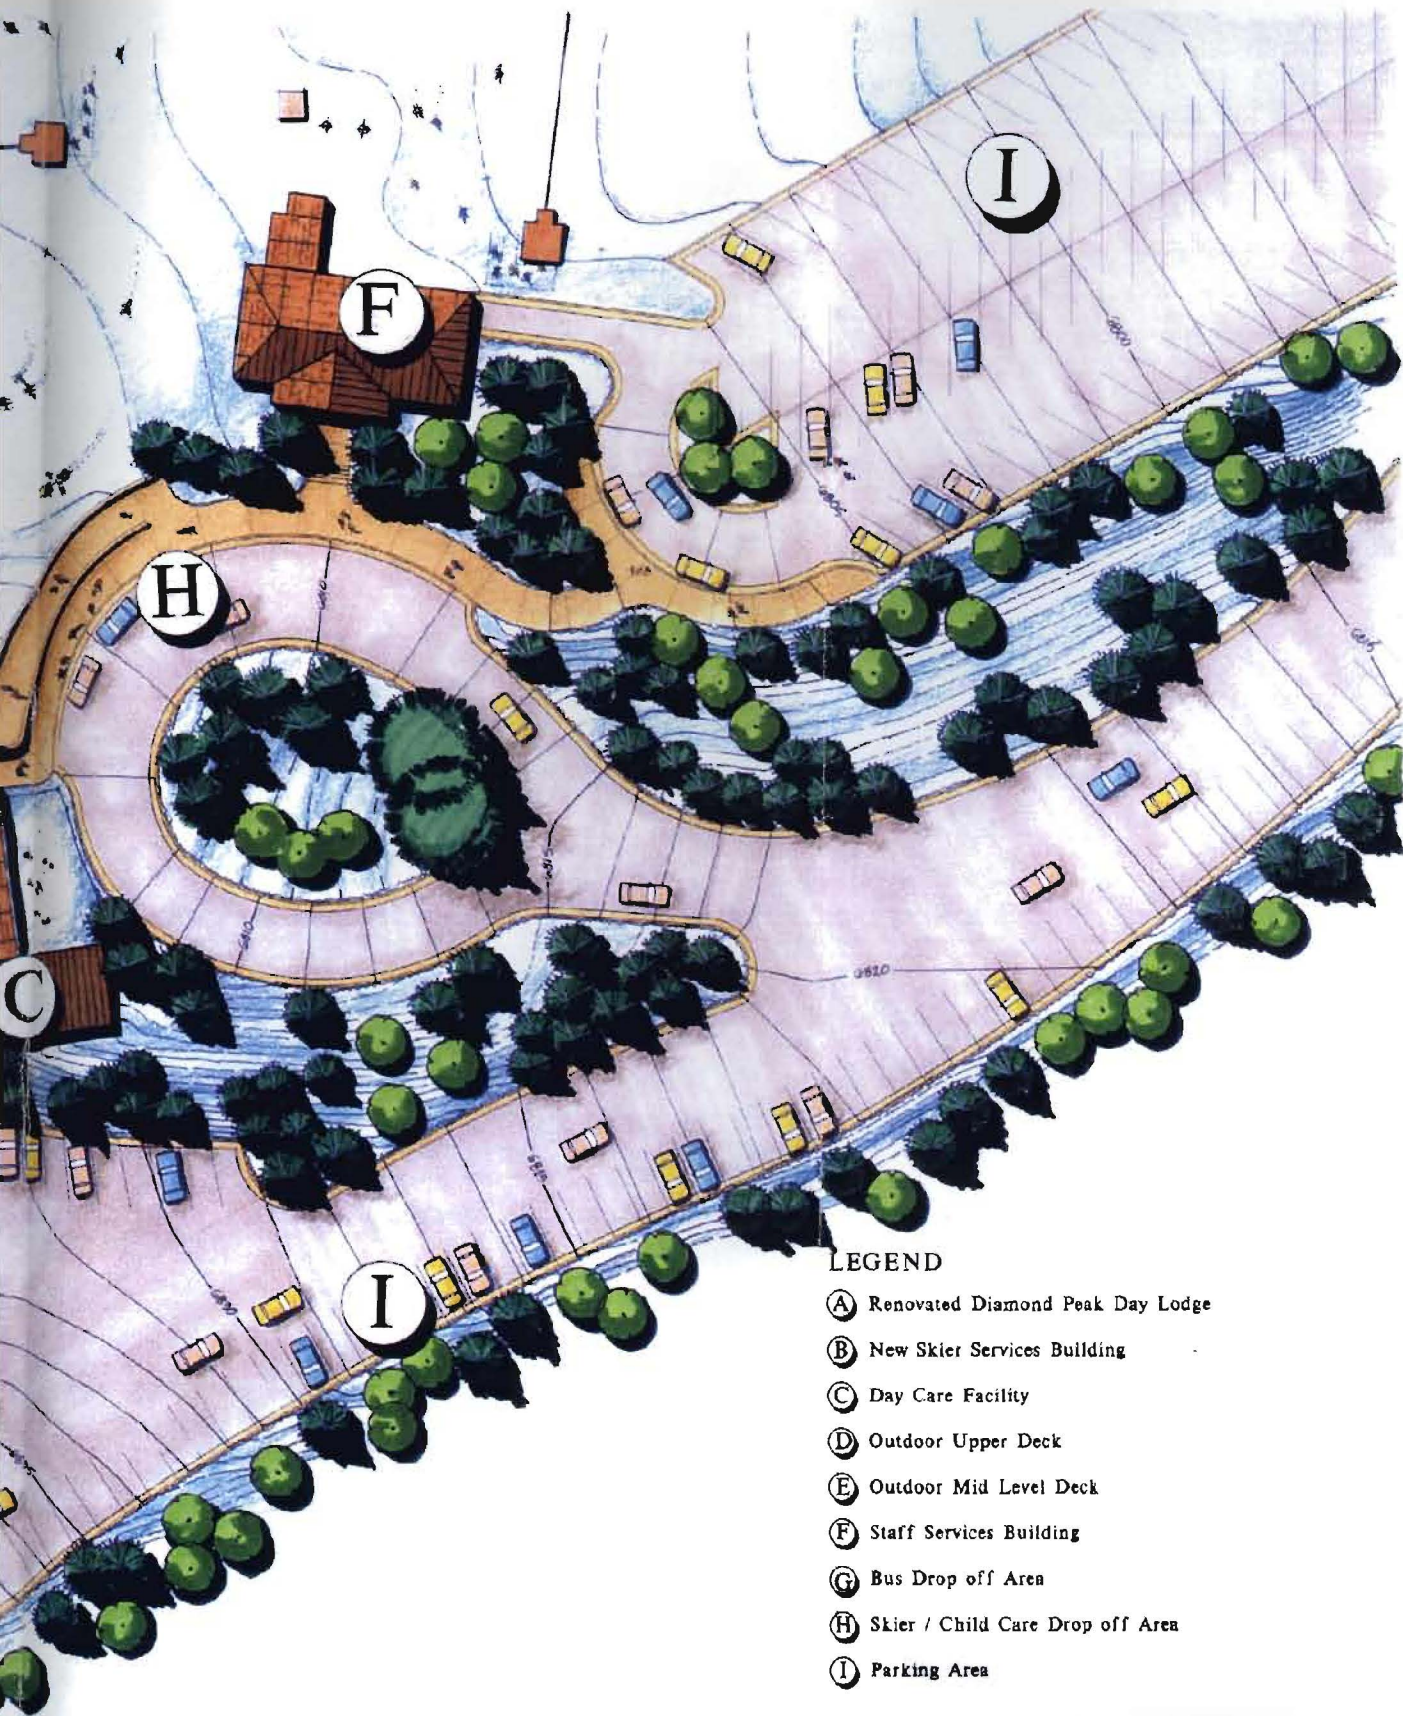
Diamond Peak Ski Resort

- Ⓐ Renovated Diamond Peak Day Lodge
- Ⓑ New Skier Services Building
- Ⓒ Day Care Facility
- Ⓓ Outdoor Upper Deck
- Ⓔ Outdoor Mid Level Deck
- Ⓕ Staff Services Building
- Ⓖ Bus Drop off Area
- Ⓗ Skier / Child Care Drop off Area
- Ⓘ Parking Area

The new skier services facility is three levels and totals 13,780 square feet. Housed within this

facility are nursery and day care facilities for one to four-year olds and four to twelve year olds, respectively. Guest services within the skier services building include ski rental, ski repair, retail, day lockers, ticket sales, bar, and restrooms. A barbeque facility is included in the outdoor program, adjacent to an expansive deck.

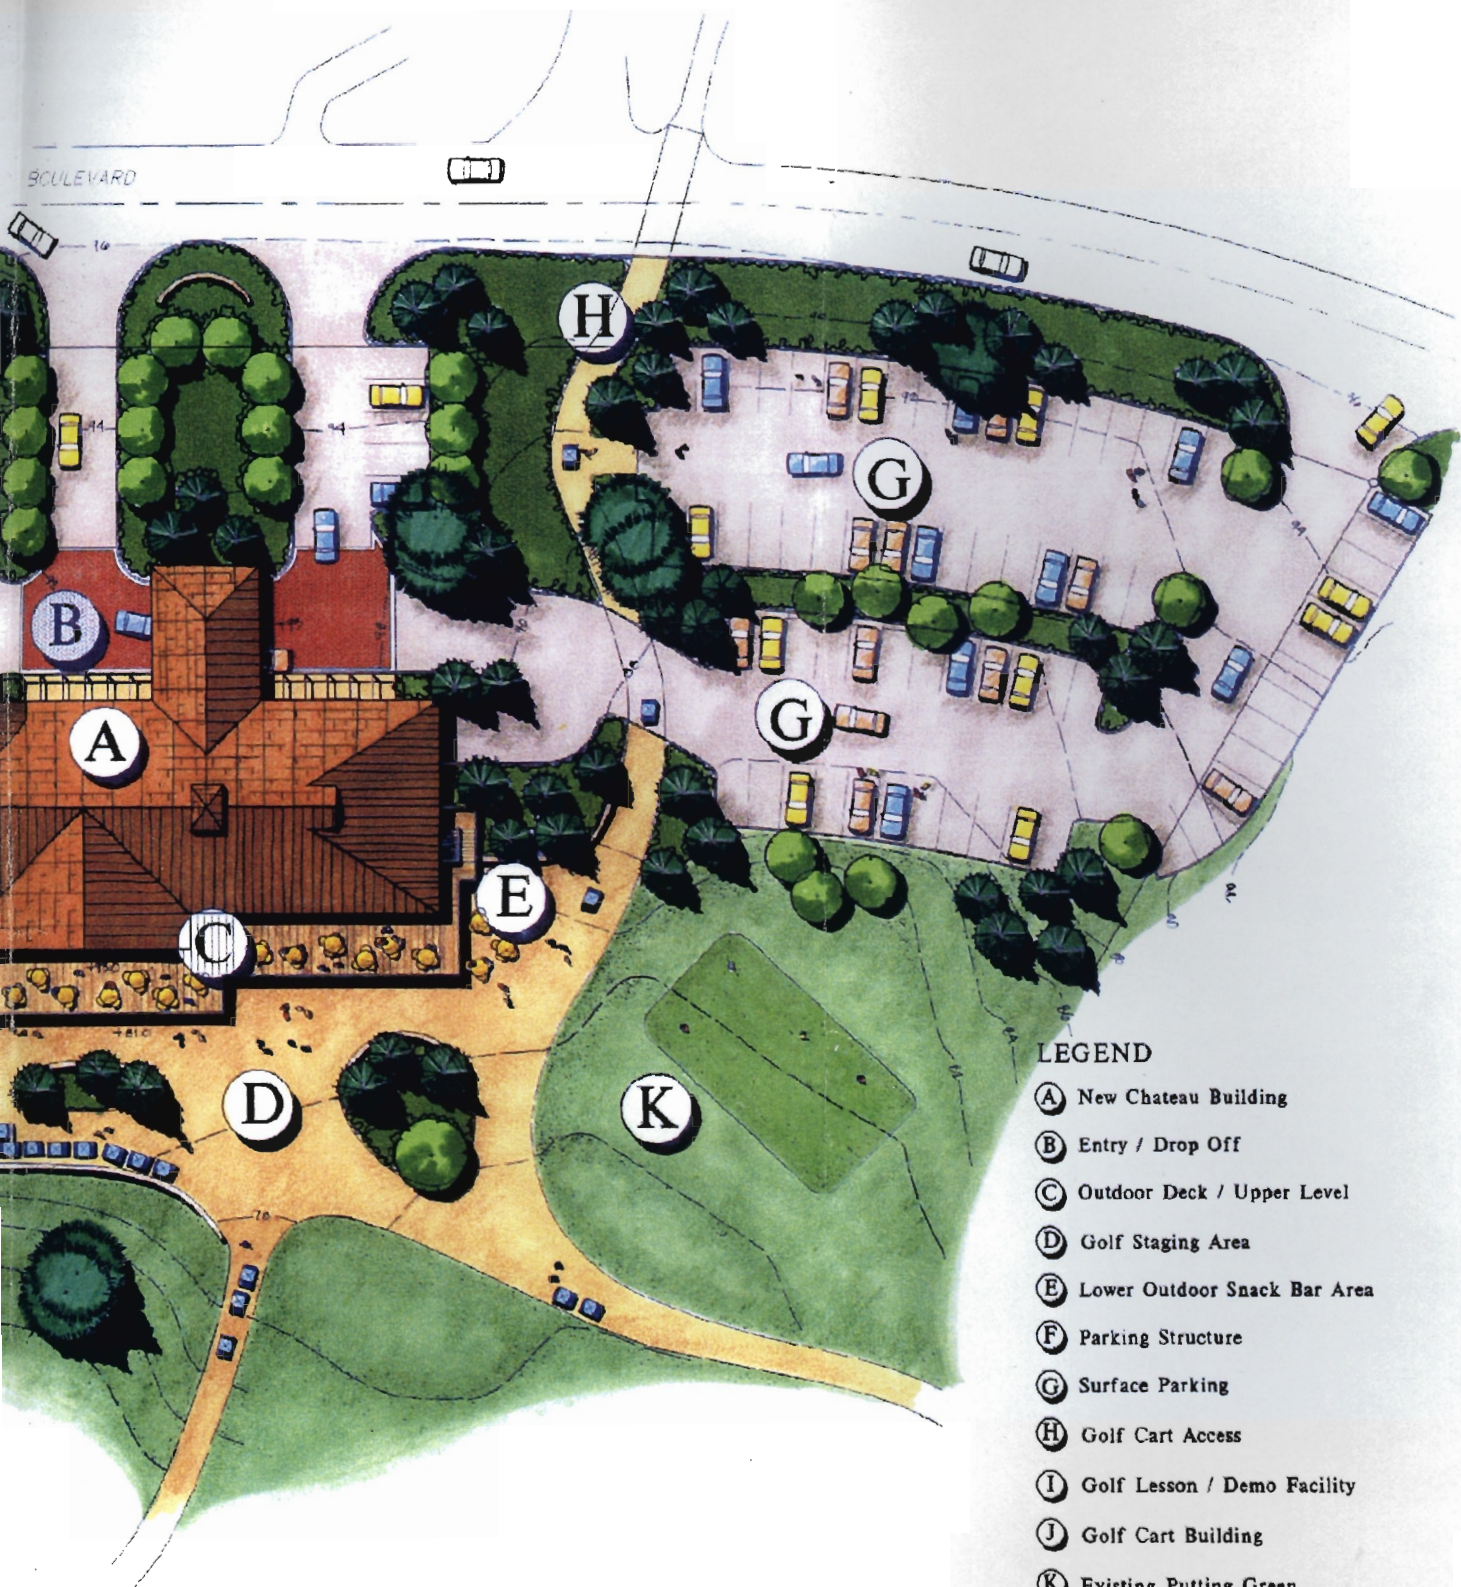
Championship Golf Course Facility

- (A) New Chateau Building
- (B) Entry / Drop Off
- (C) Outdoor Deck / Upper Level
- (D) Golf Staging Area
- (E) Lower Outdoor Snack Bar Area
- (F) Parking Structure
- (G) Surface Parking
- (H) Golf Cart Access
- (I) Golf Lesson / Demo Facility
- (J) Golf Cart Building
- (K) Existing Putting Green
- (L) Instructional Driving Range Tee Box
- (M) Renovated Driving Range & Tee Box

The Recreational Facilities Master Plan recommends constructing a new clubhouse. The new facility is two levels, totals 22,600 square feet and includes both golf and special event facilities. The first level of the new building houses a pro shop, complete with dressing rooms and a starter's desk; retail storage; offices for both the pro staff and administration; a snack bar; and men's and women's locker rooms and restrooms.
